# Energia, Ambiente e Innovazione

4-5/2012 - Parte II

**The Pianura Padana  
Emiliana Earthquake**

#### 58 Damage to religious buildings due to the Pianura Padana Emiliana earthquake

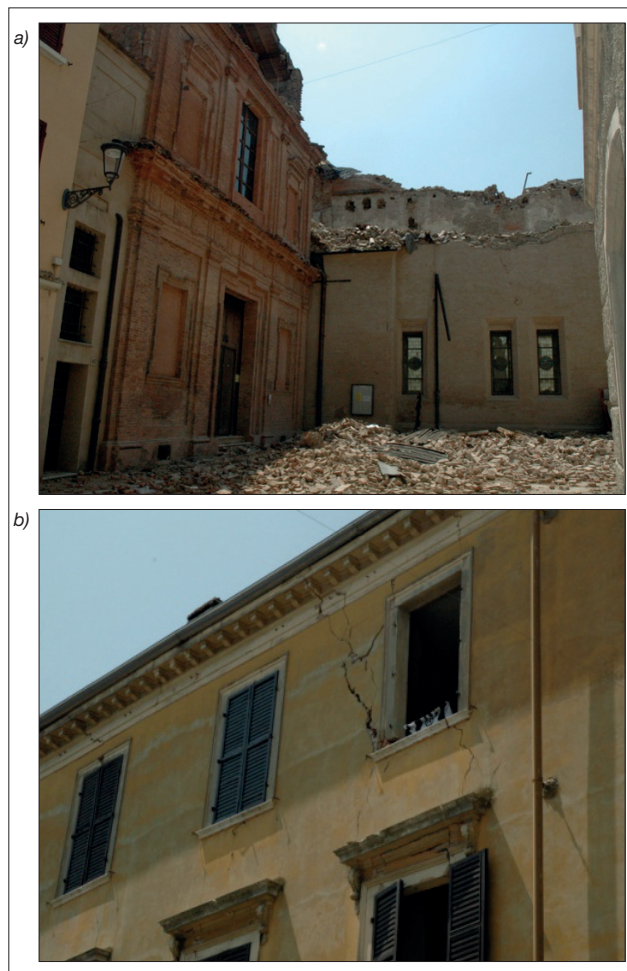
**FIGURE 12** Mirandola. Damage in the historical downtown  
Source: ENEA

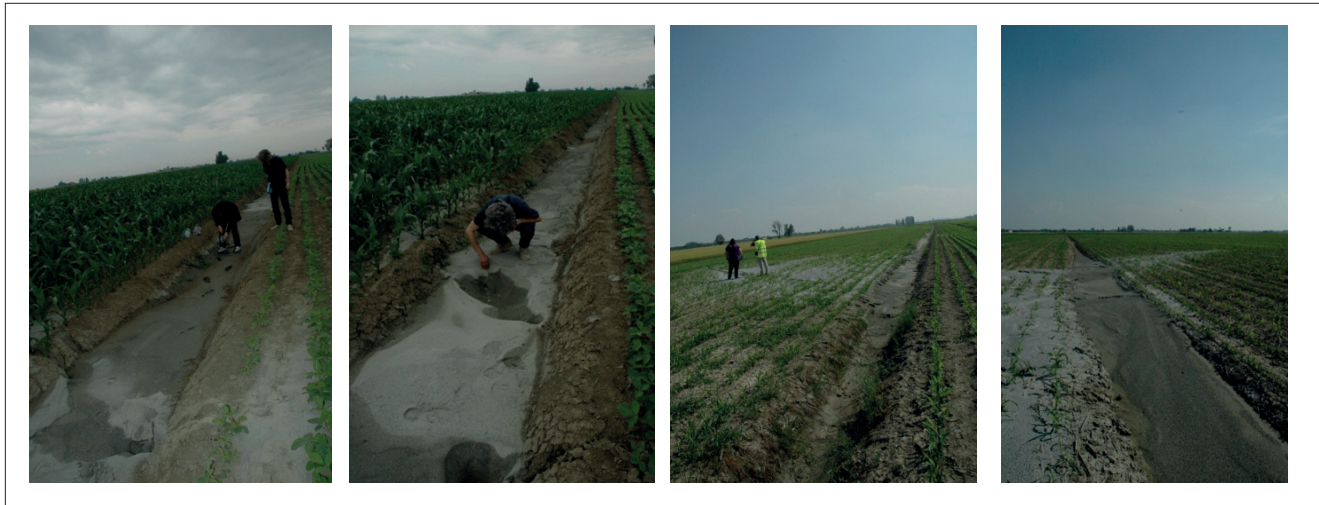
**FIGURE 11** Bondeno Municipality: sand spill that affected the irrigation channels in rural areas

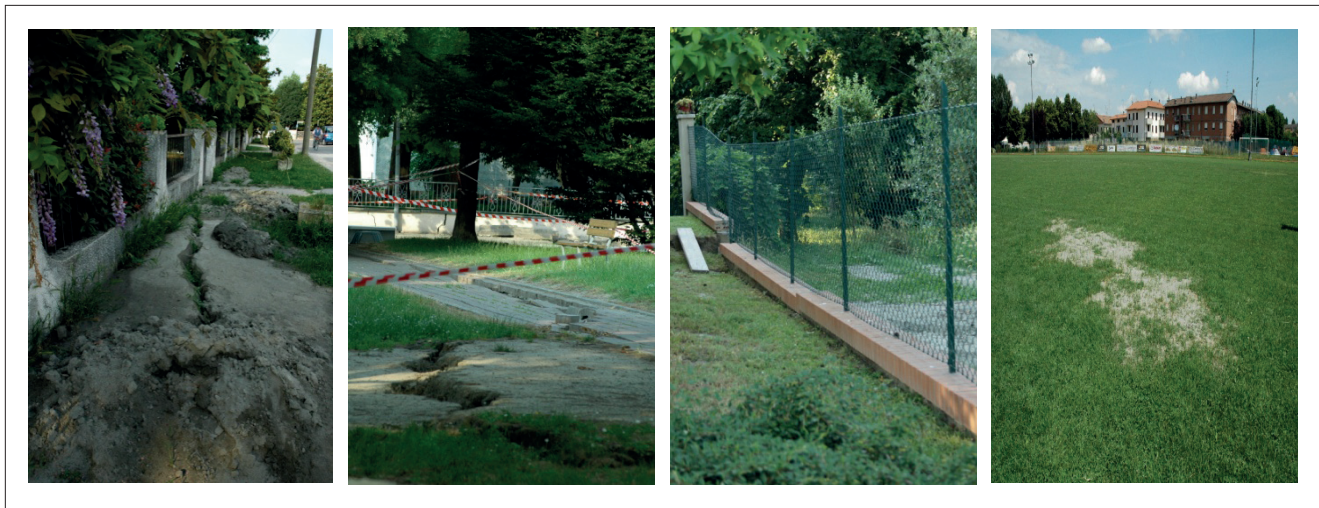
**FIGURE 12** Sant'Agostino Municipality: cracks with sand spill that affected the buildings and the road surface, and the sports field of San Felice

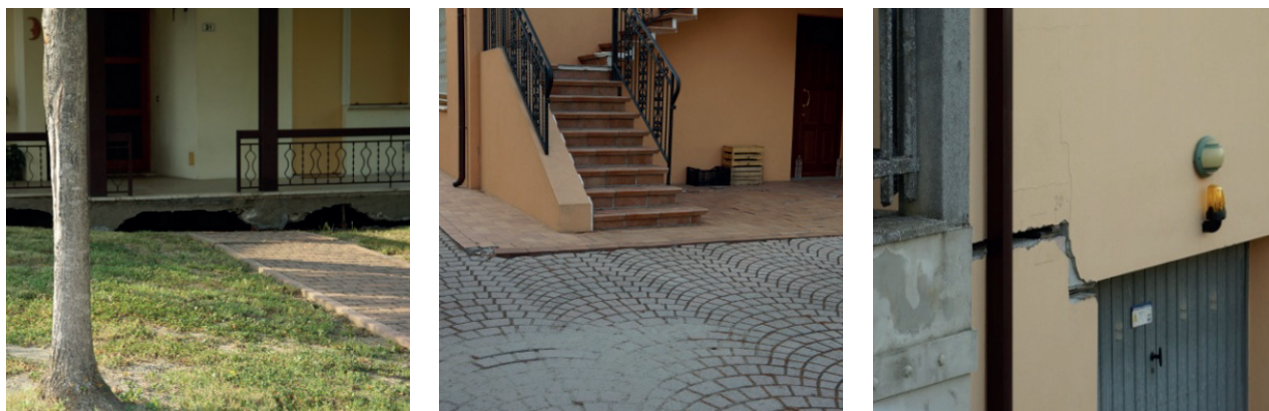
**FIGURE 13** San Carlo, Sant'Agostino Municipality: damage in residential buildings

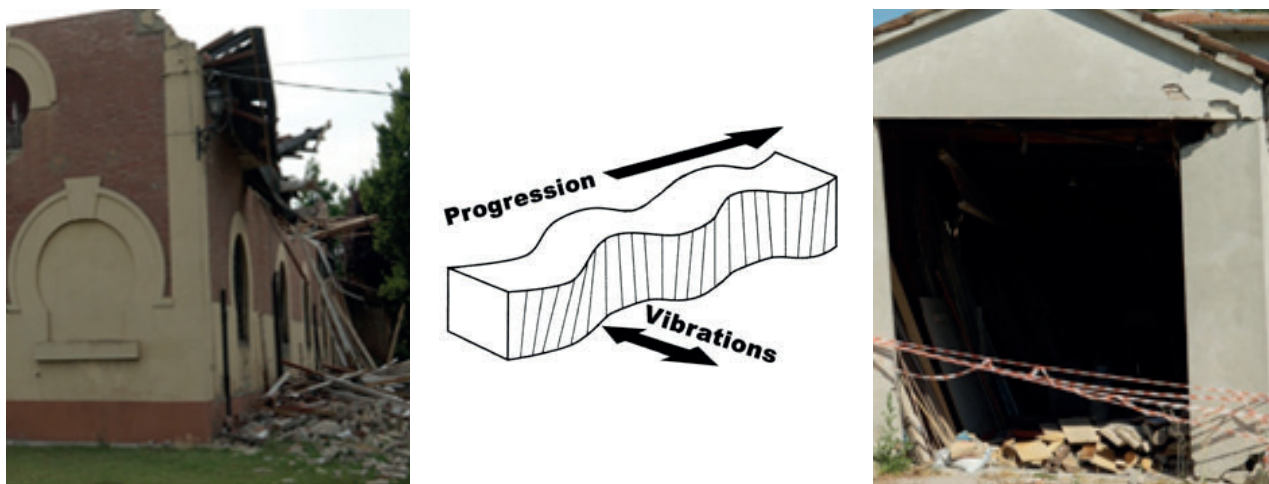
**FIGURE 14** Deformation by P waves due to L wave: rural buildings damaged in the Sant'Agostino area

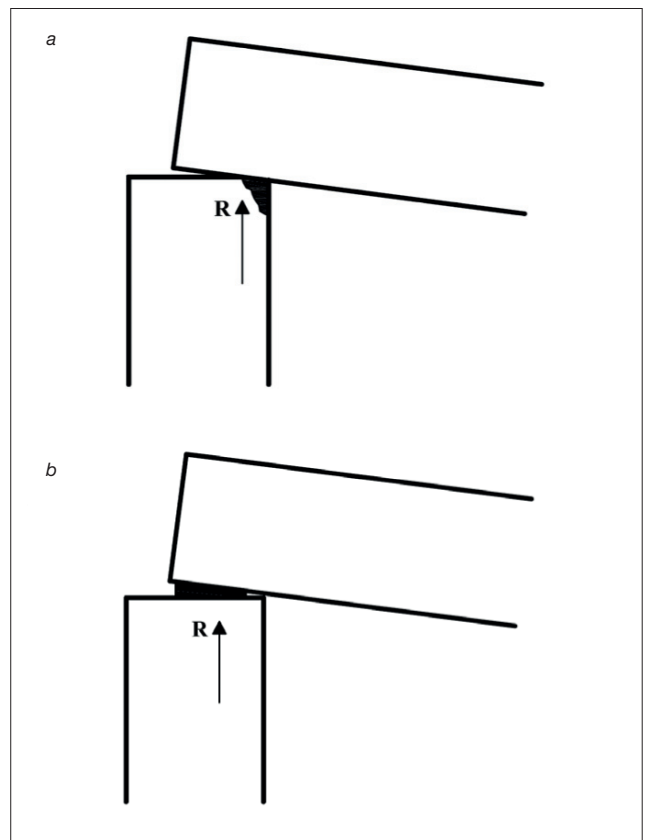
**FIGURE 4** Bending stresses and concrete spalling on the column, avoided by means of the interposition of bearing pads  
Source: ENEA

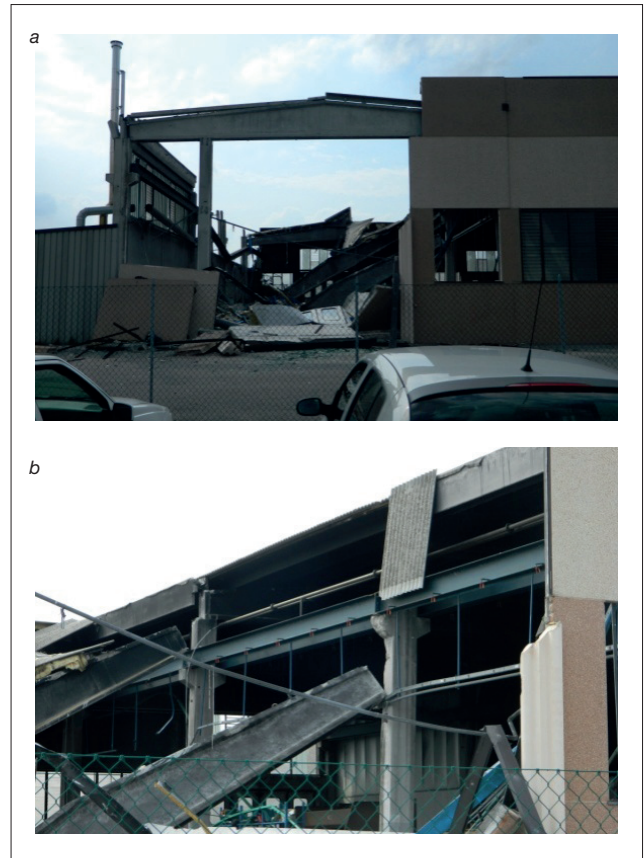
**FIGURE 6** Longitudinal toppling of beams for displacement limit  
Source: ENEA

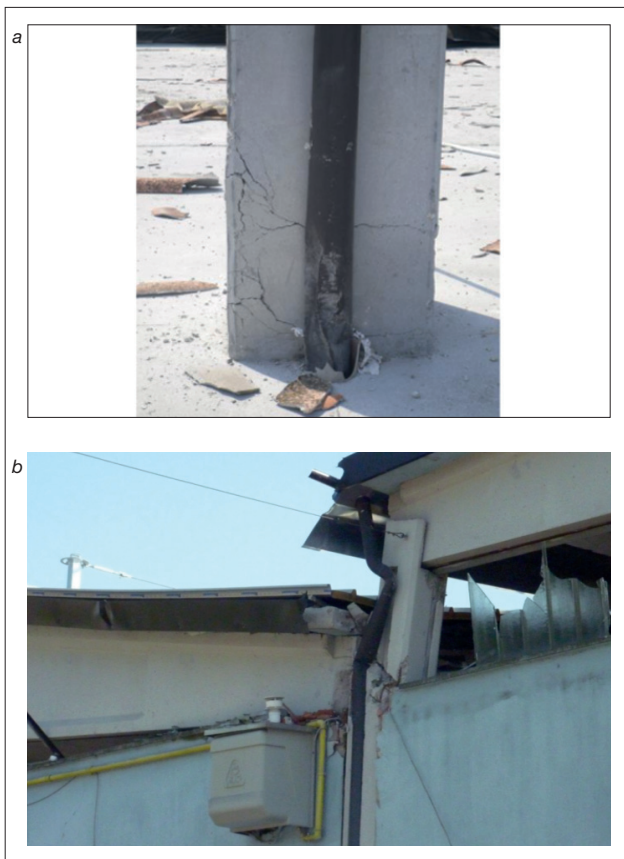
**FIGURE 11** Damage to columns  
Source: ENEA

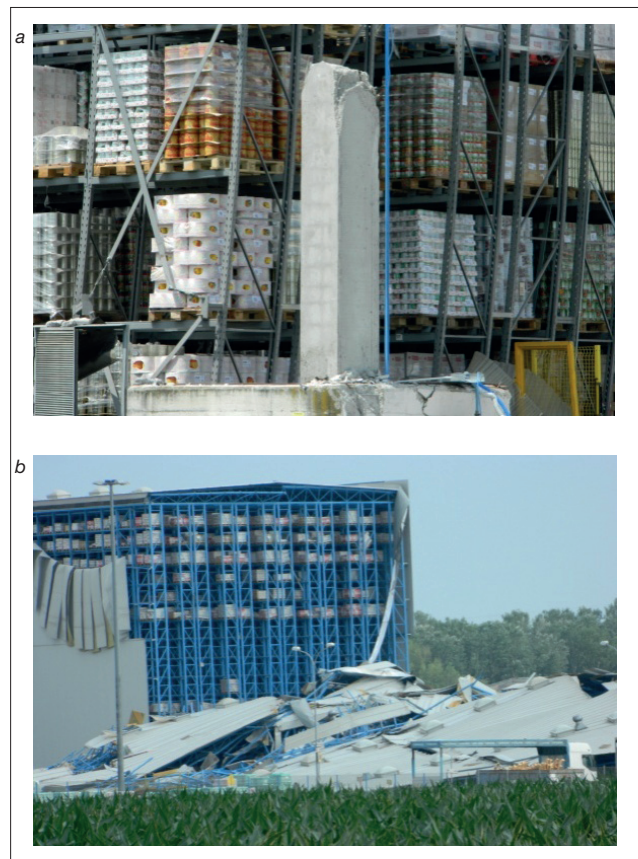
**FIGURE 12** Instability of shelves  
Source: ENEA

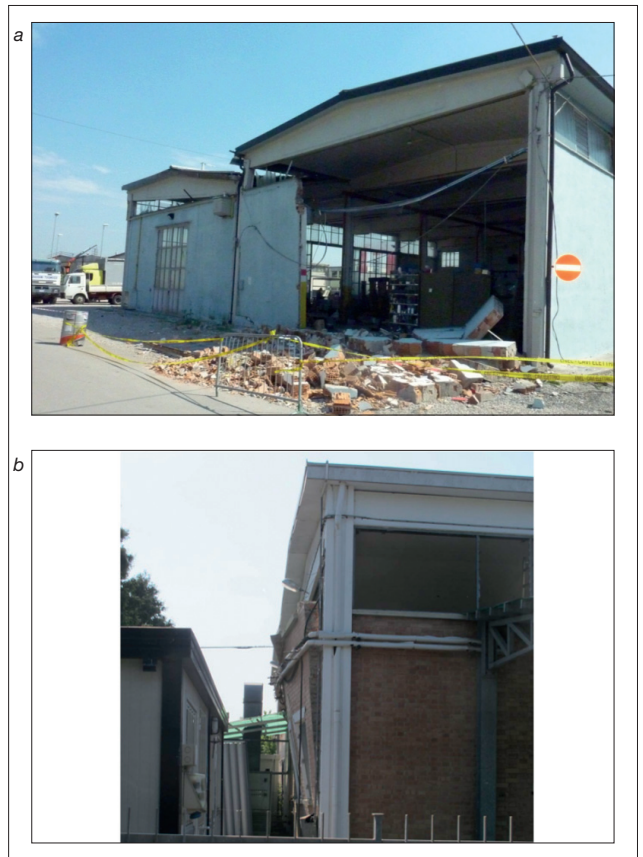
**FIGURE 14** Solid brick cladding damage  
Source: ENEA

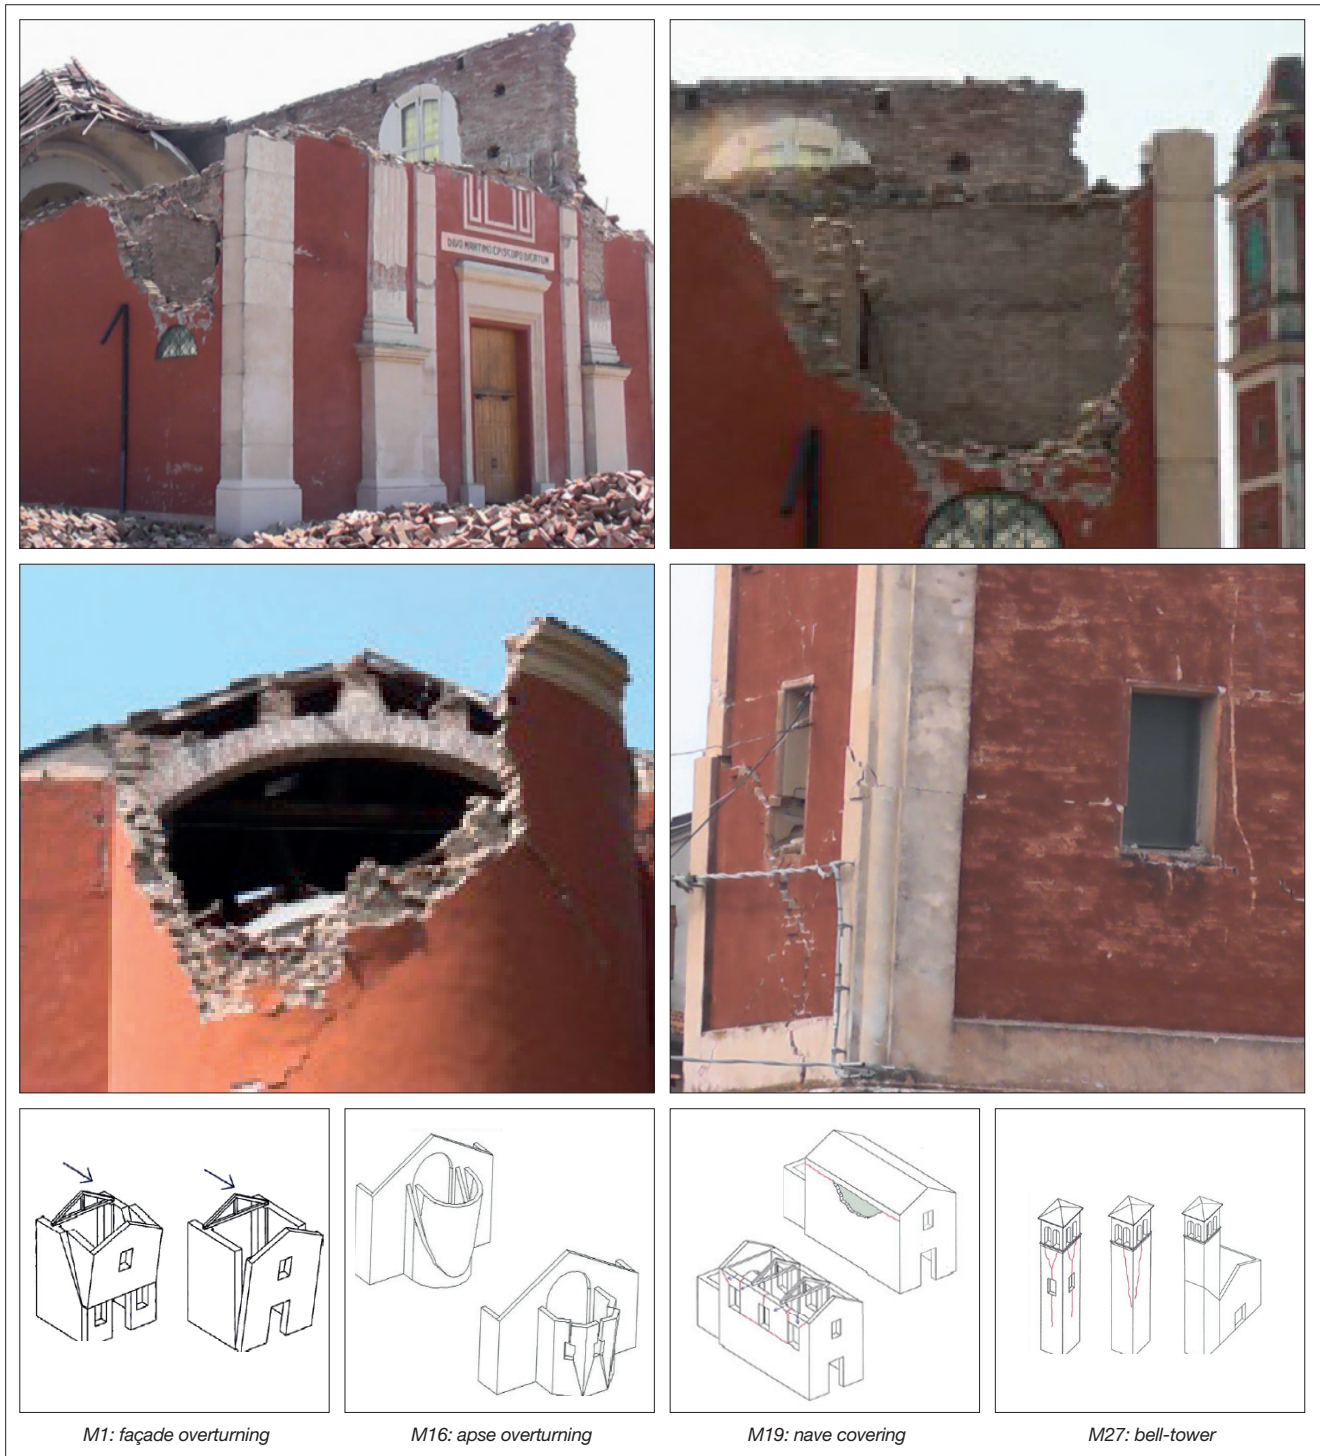
**FIGURE 5** Damage in the San Martino di Tours church and bell-tower in Buonacompra (Cento, Ferrara) and main collapse mechanisms

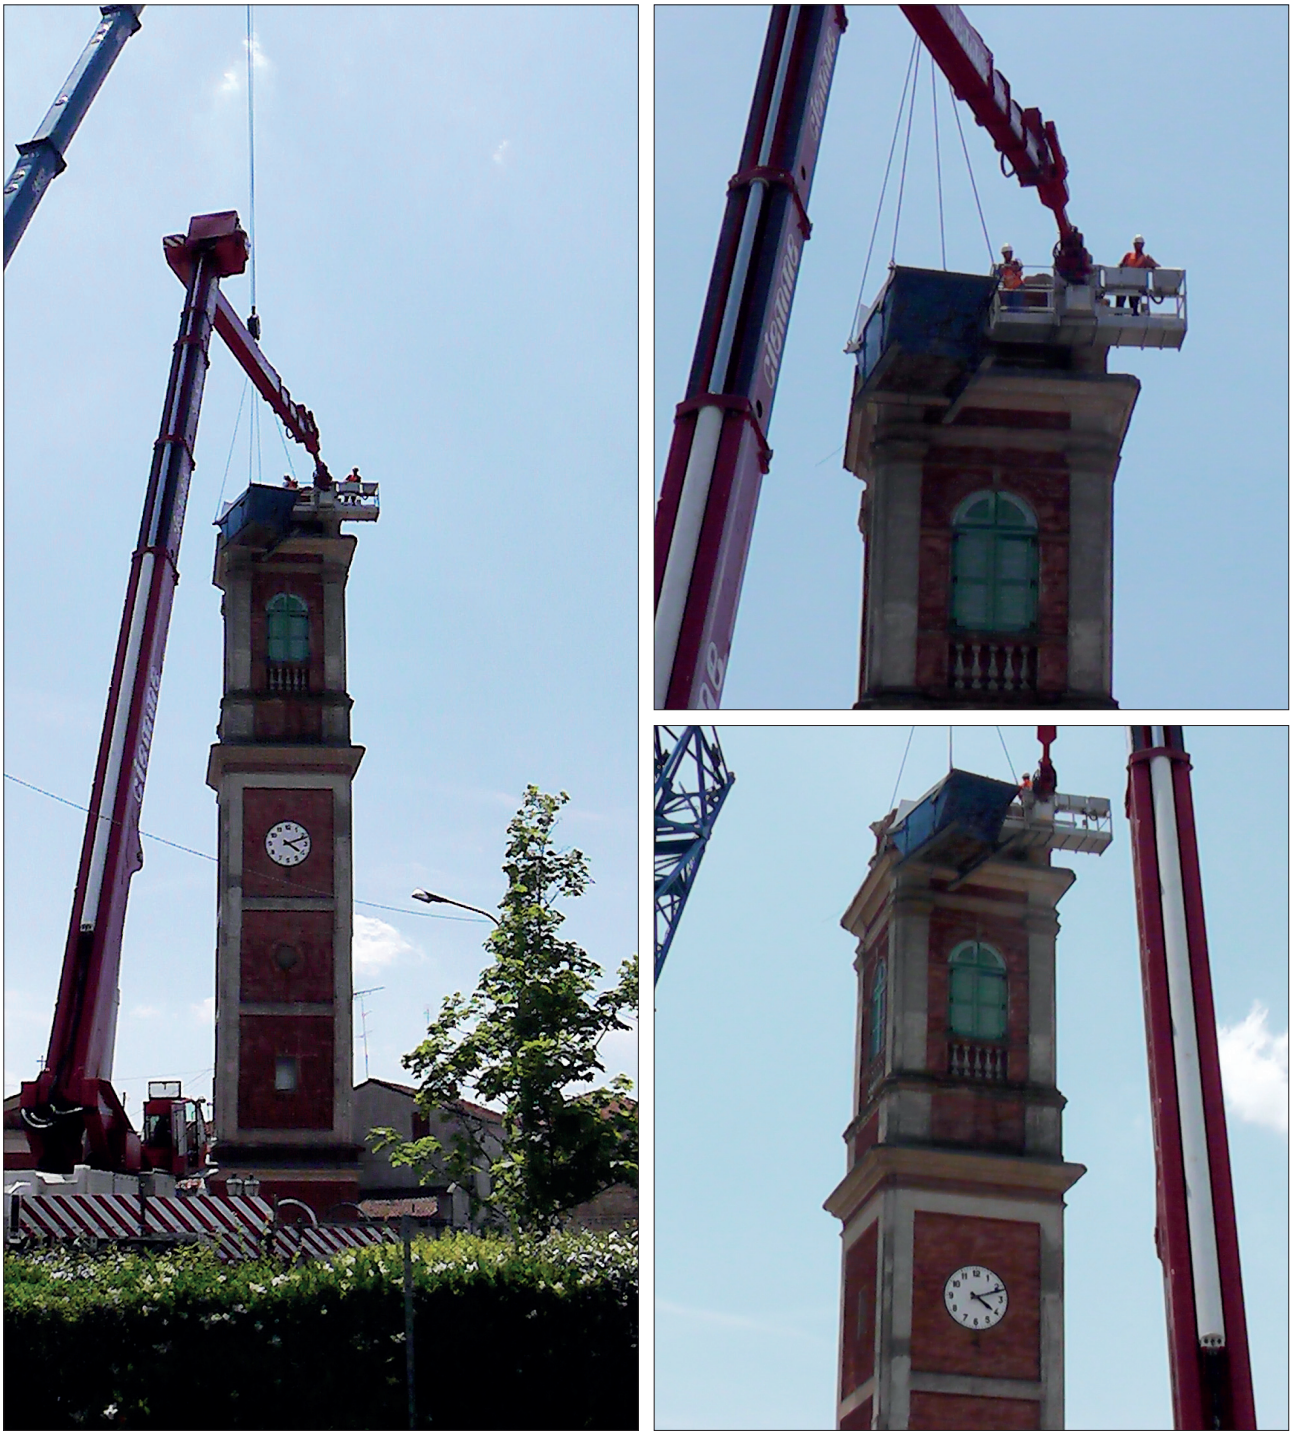
**FIGURE 6** Controlled demolition in the San Martino di Tours church bell-tower in Buonacompra (Cento, Ferrara)

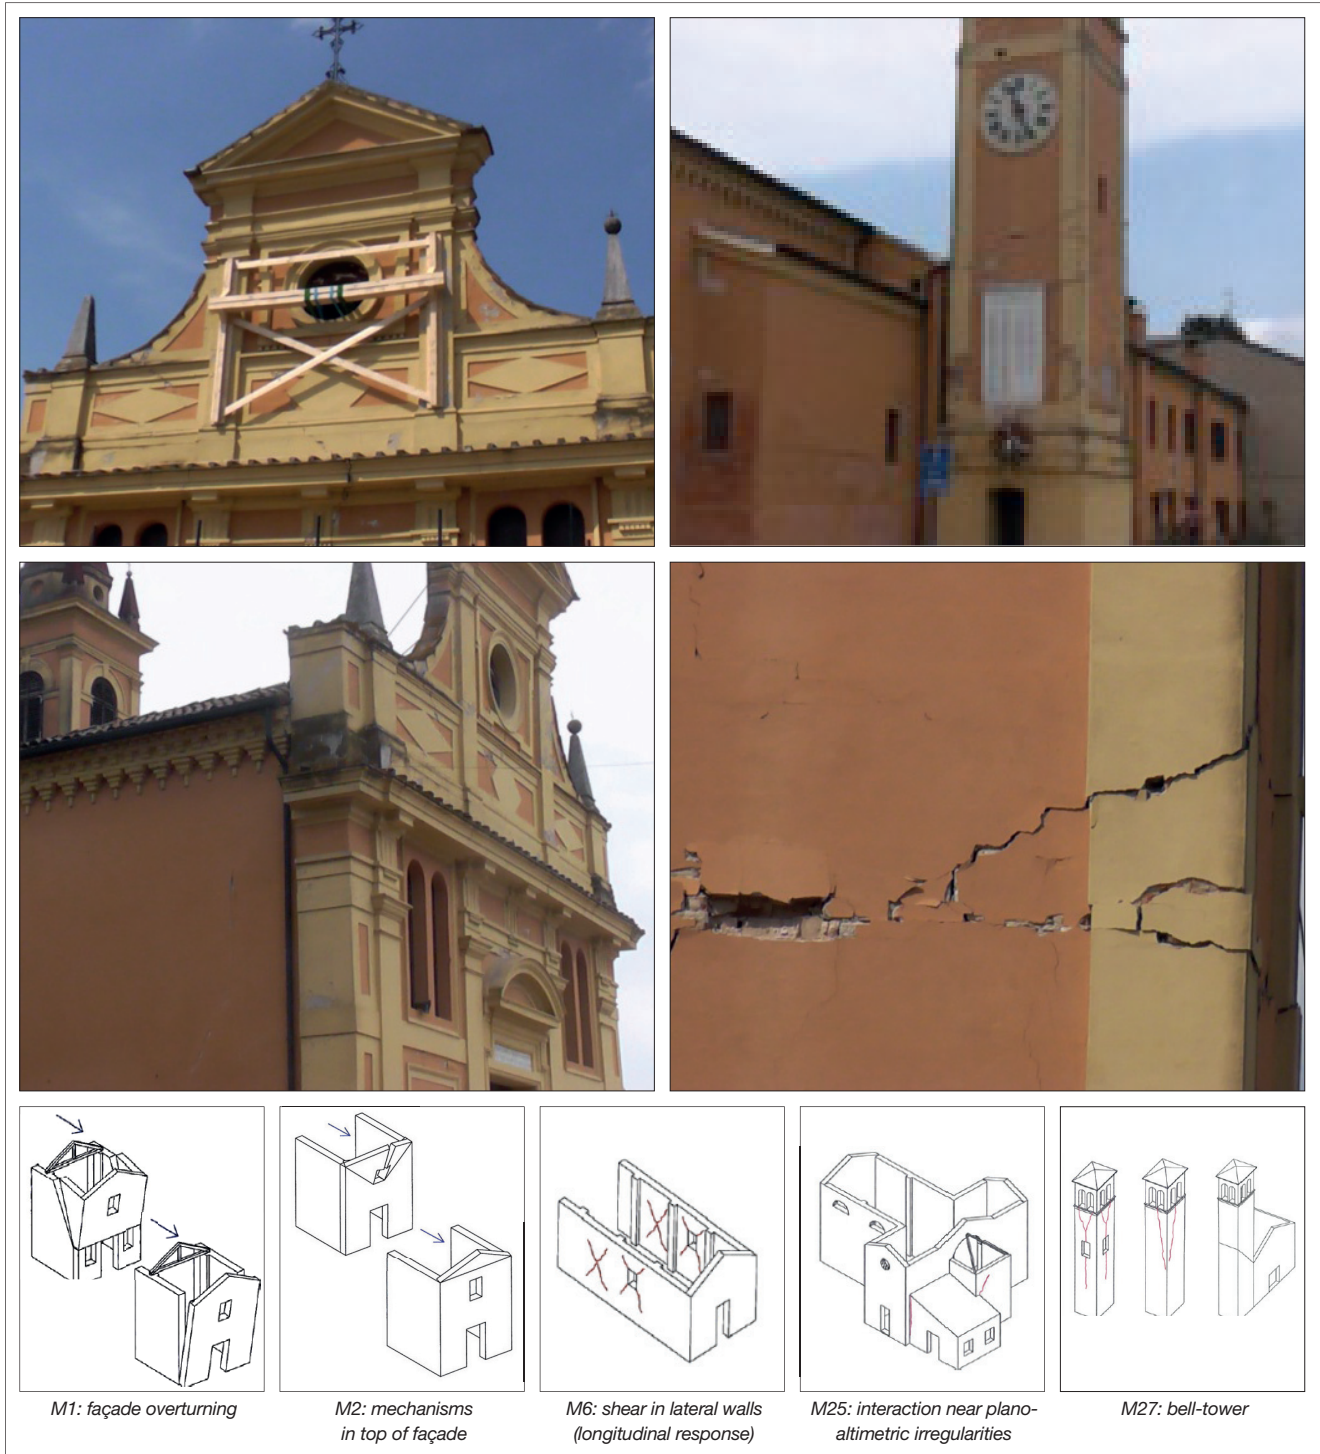
**FIGURE 7** Damage to the San Lorenzo church in Casumaro (Cento, Ferrara) and main collapse mechanisms

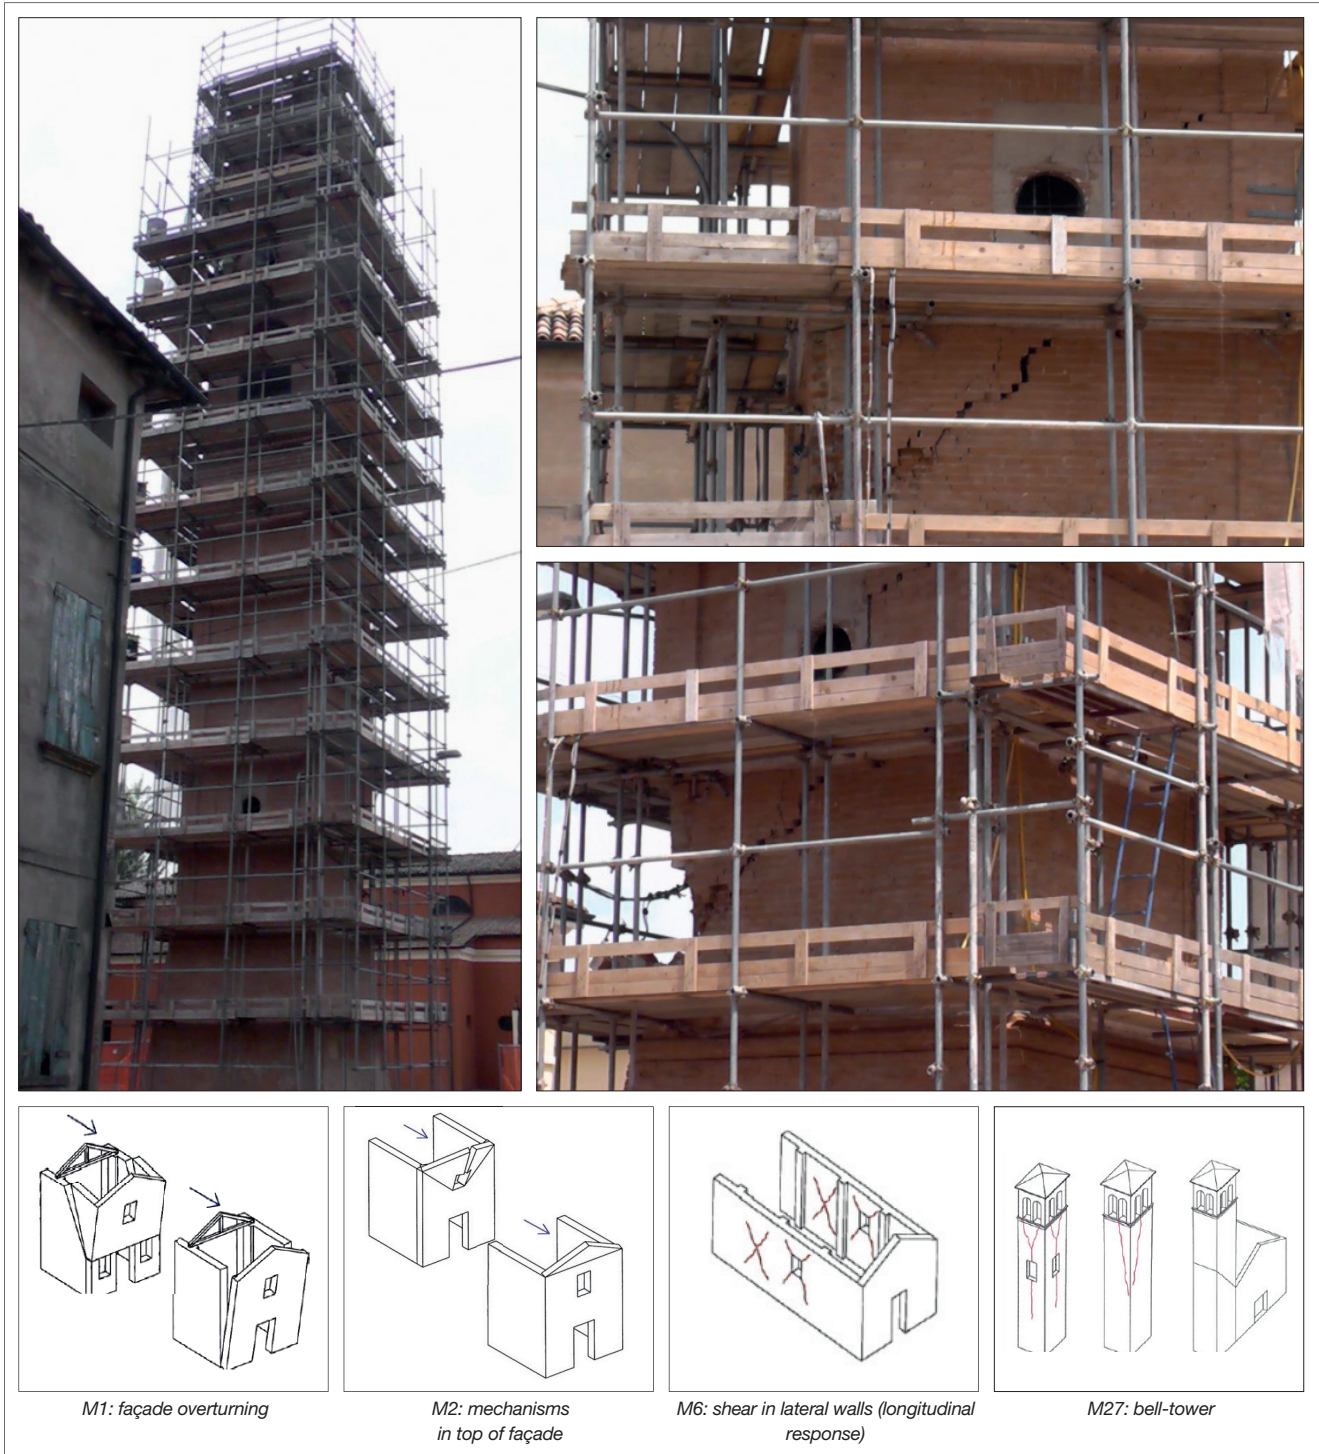
**FIGURE 8** Damage to the Sant'Anna church in Reno Centese (Cento, Ferrara) and main collapse mechanisms

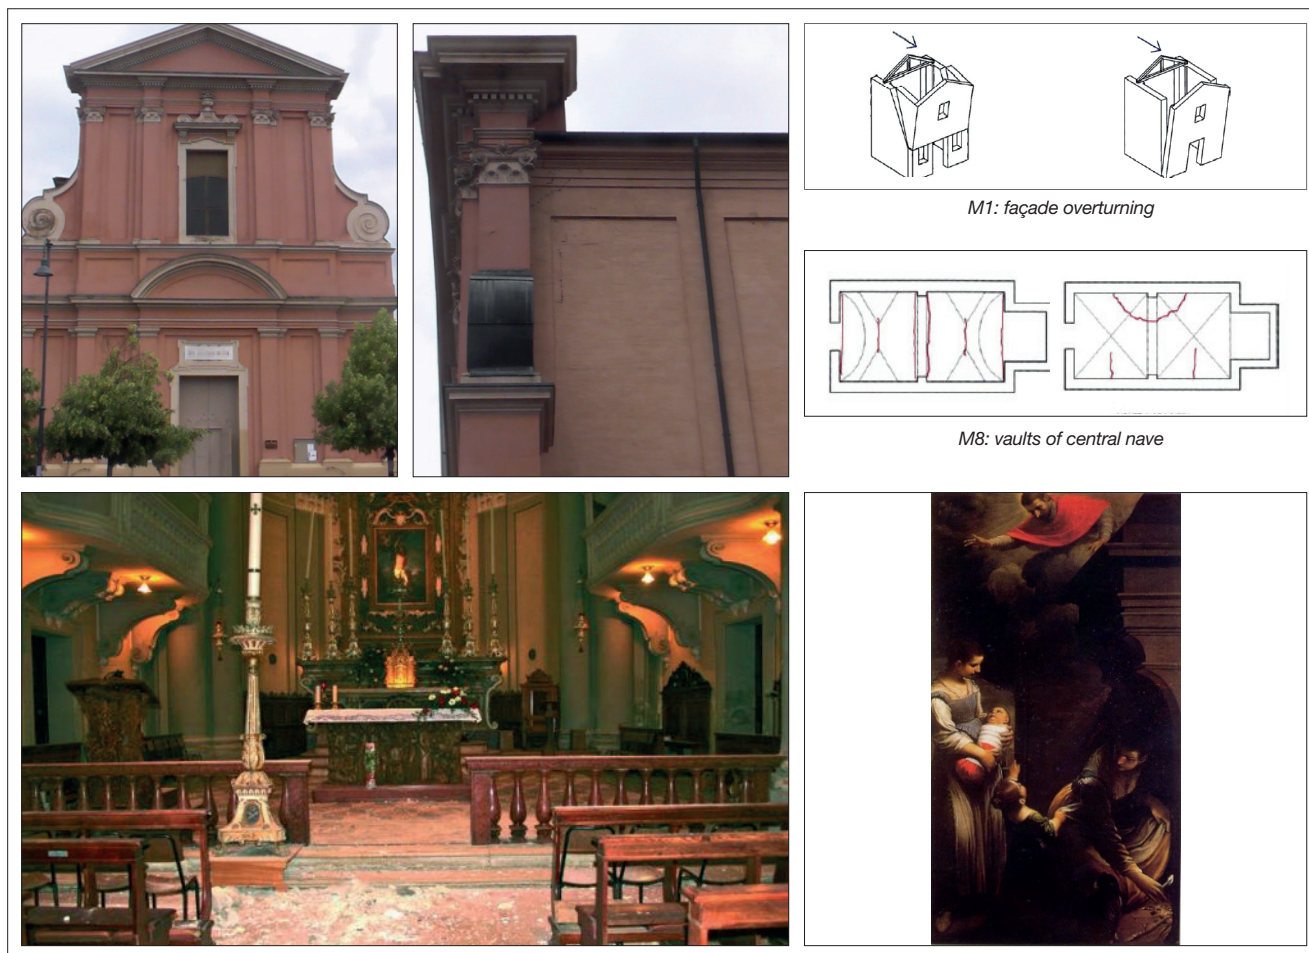
Also the church of San Sebastiano (XV century, modified in the XVIII) in Renazzo (Cento, Ferrara, PGAs as before) was damaged (Fig. 9). Several works of art were removed by the firemen, including a famous painting of Guercino (the miracle of San Carlo Borromeo), put in a temporary safe place.

**FIGURE 9** Damage to the Church of San Sebastiano in Renazzo (Cento, Ferrara) and main collapse mechanisms

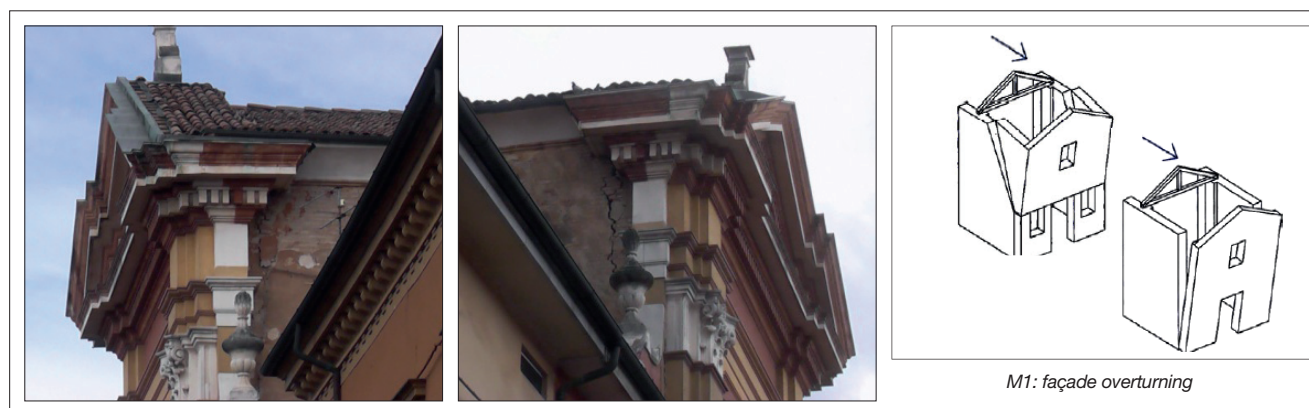
**FIGURE 10** Cento (Ferrara) historic centre: the church of San Filippo Neri and main collapse mechanisms

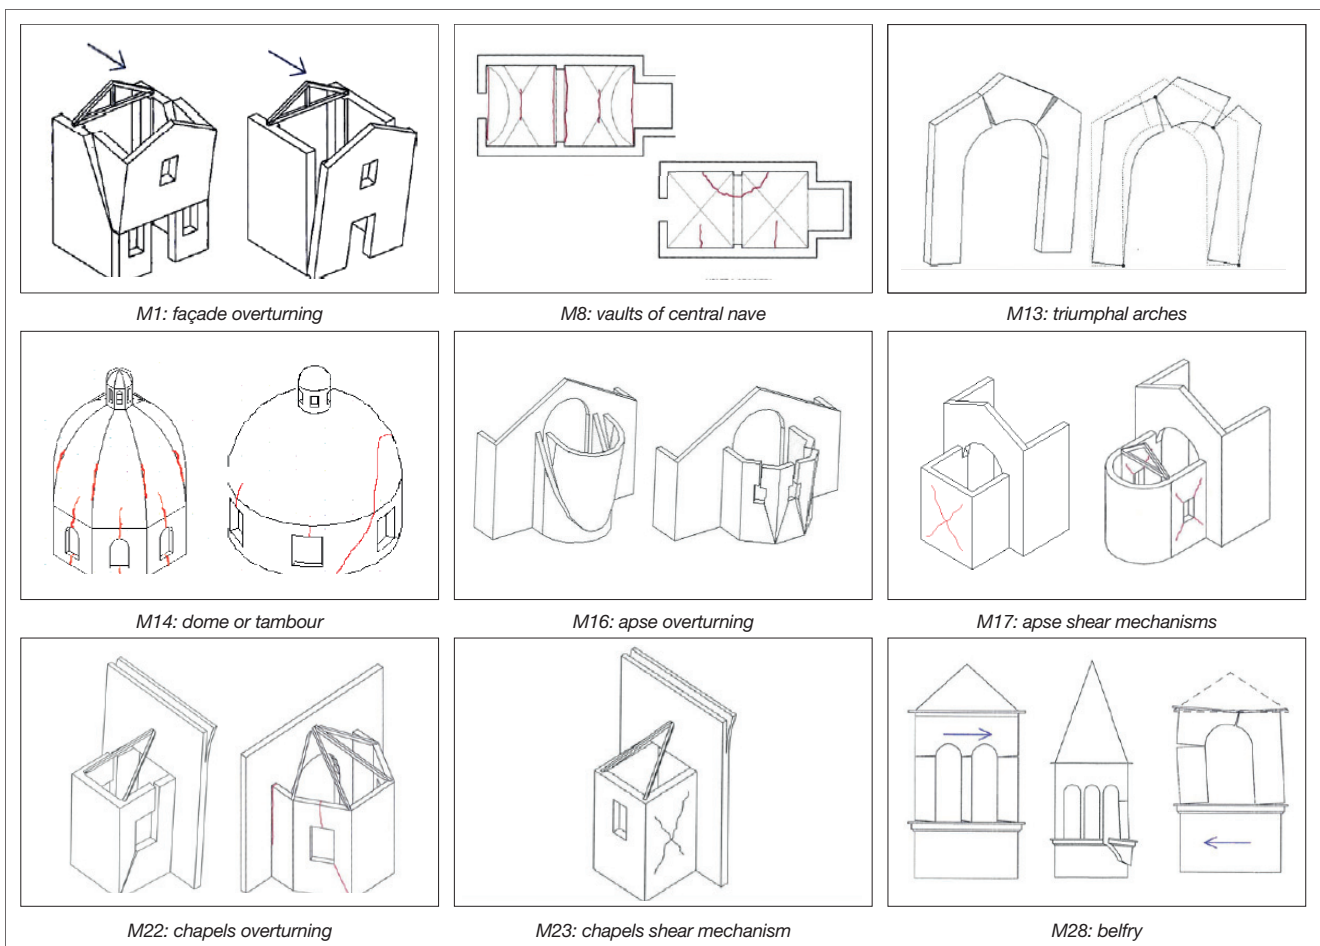
**FIGURE 18** Damage mechanisms observed in the Monumental Temple of Fallen (Modena)

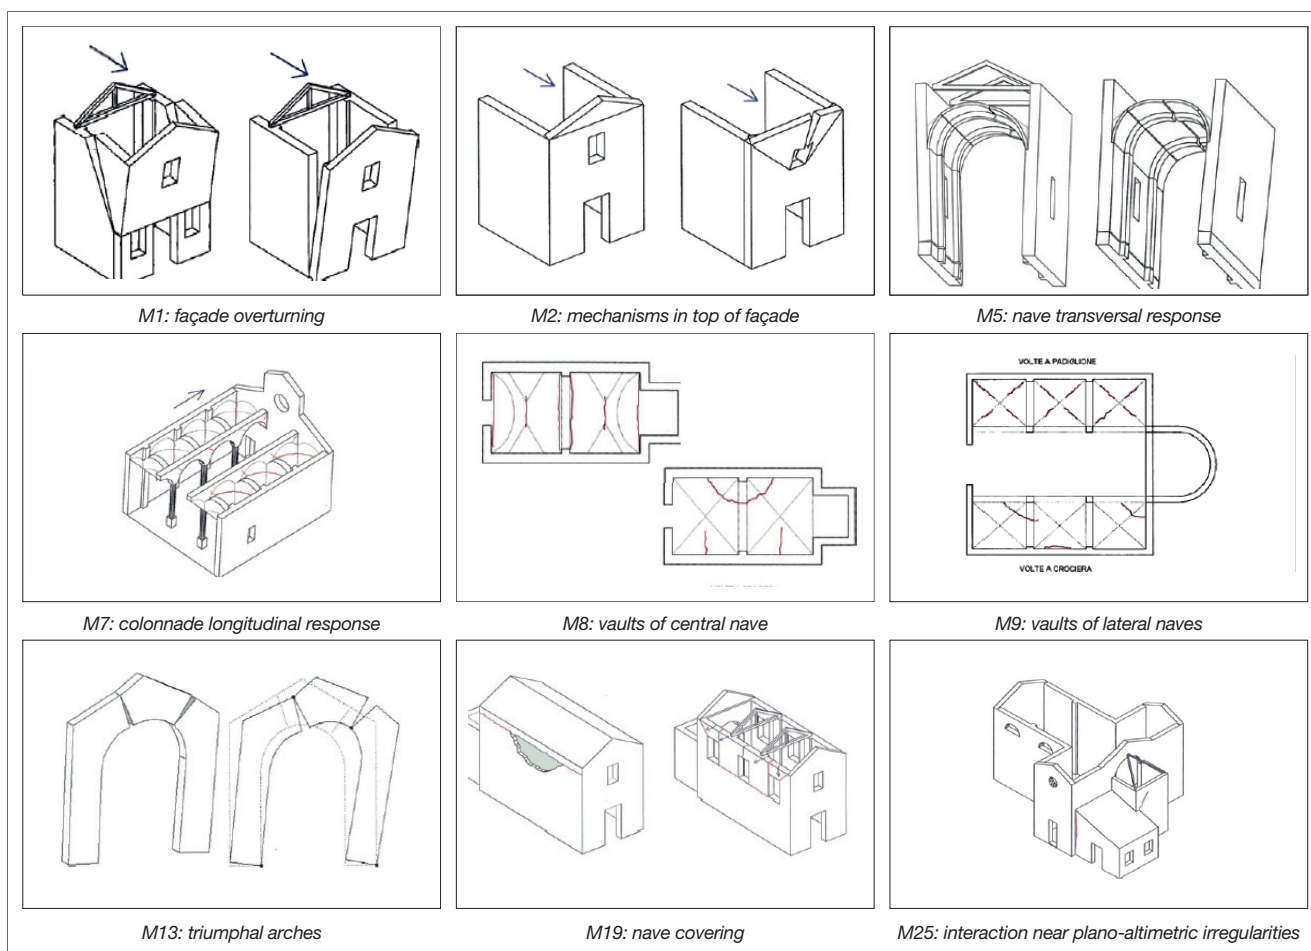
**FIGURE 26** Damage mechanisms in the Cathedral of San Geminiano (Modena)

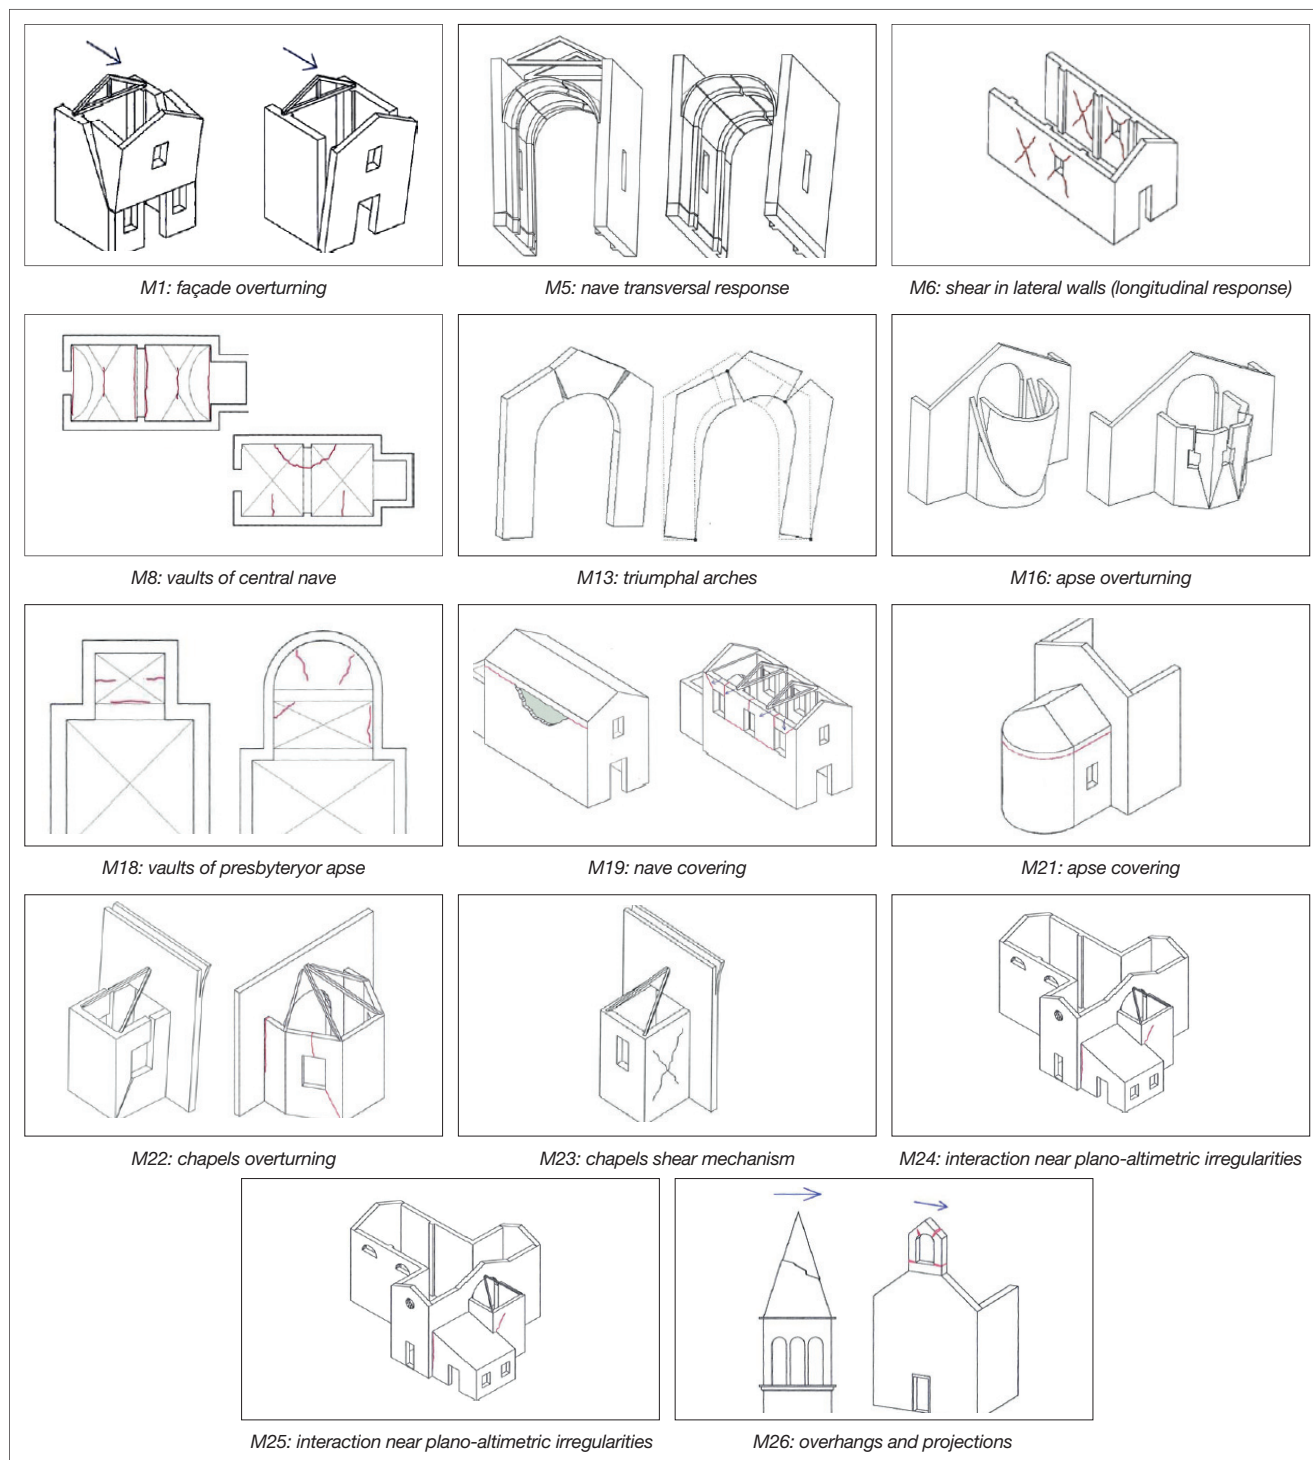
**FIGURE 30** Damage mechanisms in the Parish of San Giovanni Battista in Triario (Minerbio, Bologna)

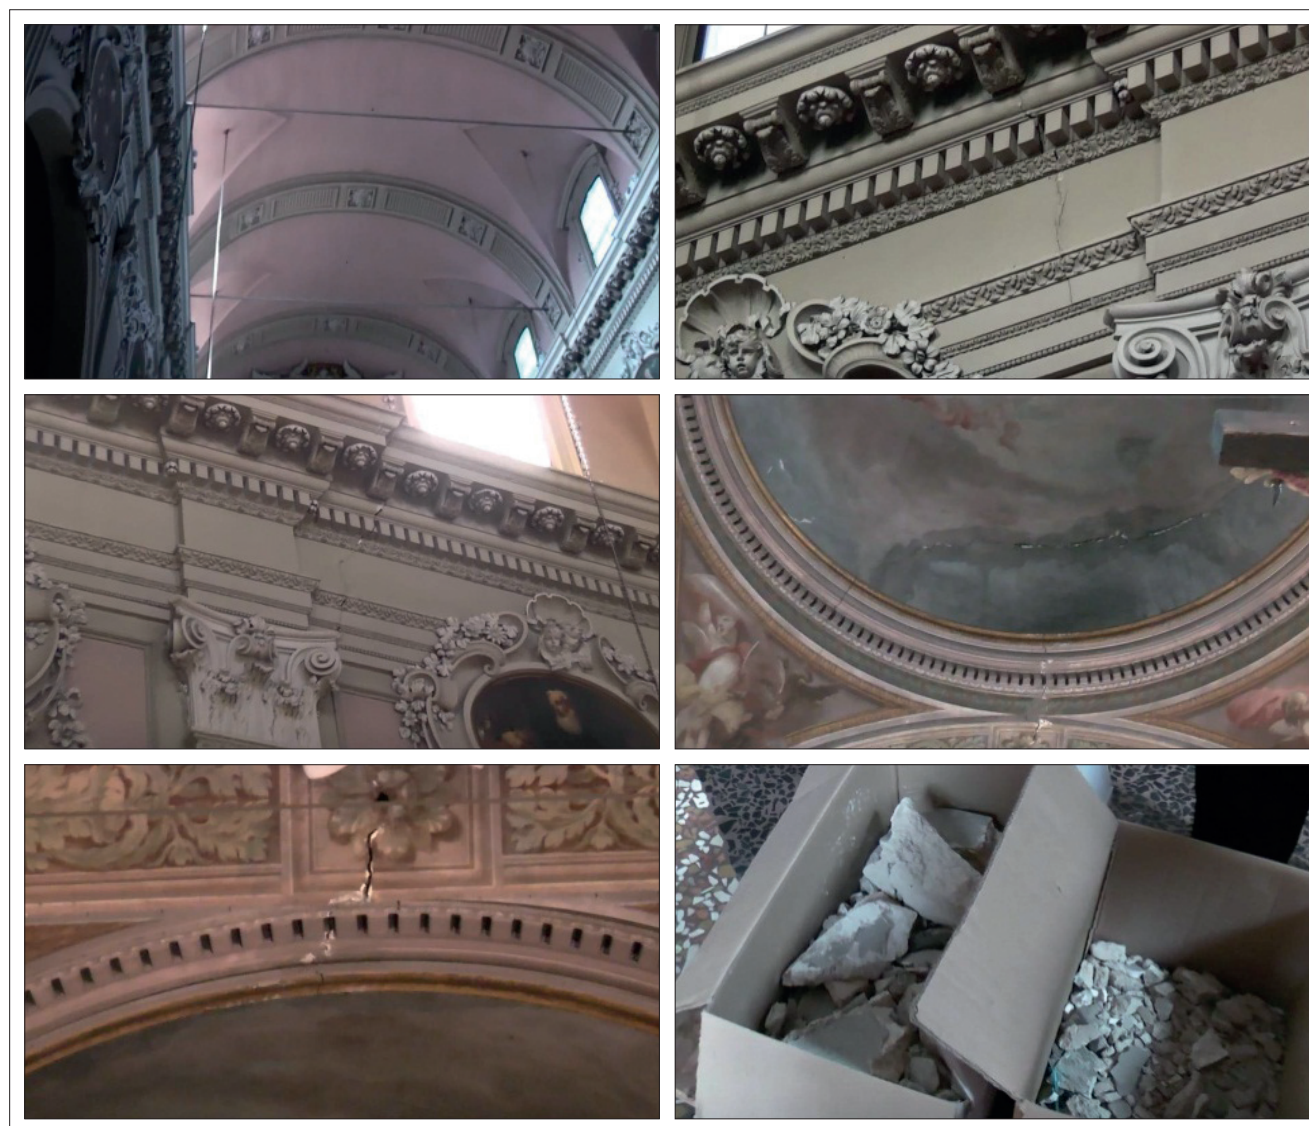
**FIGURE 32** Damage to the Church of San Lorenzo (Budrio, Bologna)

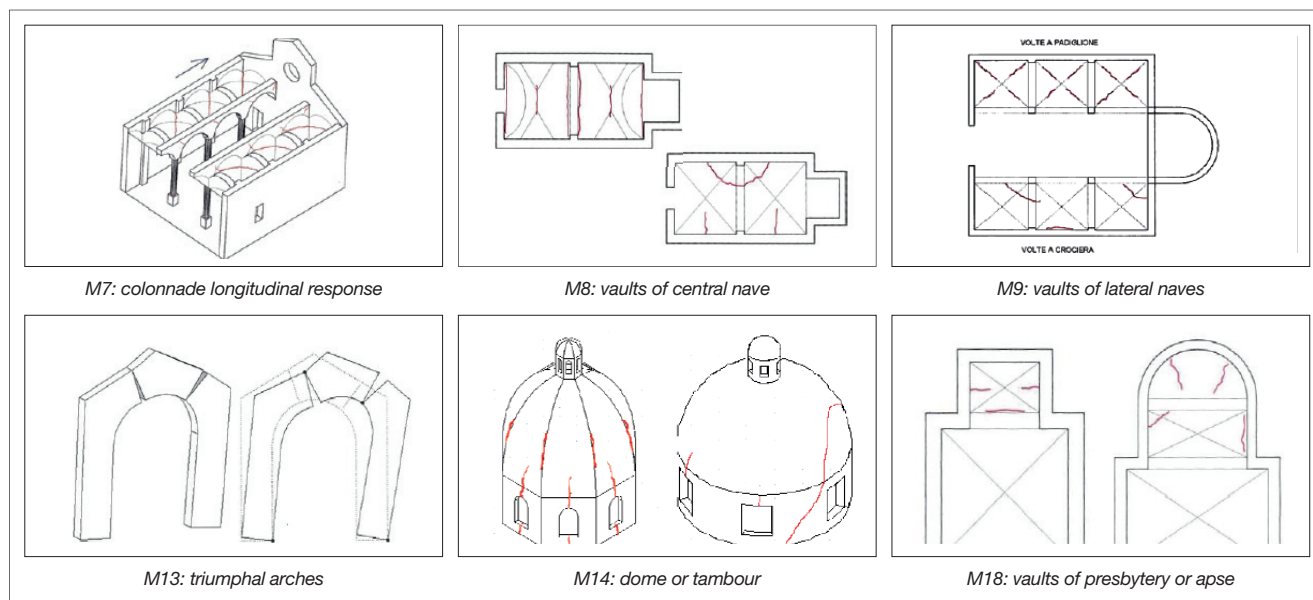
**FIGURE 33** Damage mechanisms in the Church of San Lorenzo (Budrio, Bologna)
