# Energia, Ambiente e Innovazione

4-5/2012 - Parte II

**The Pianura Padana  
Emiliana Earthquake**

#### 58 Damage to religious buildings due to the Pianura Padana Emiliana earthquake

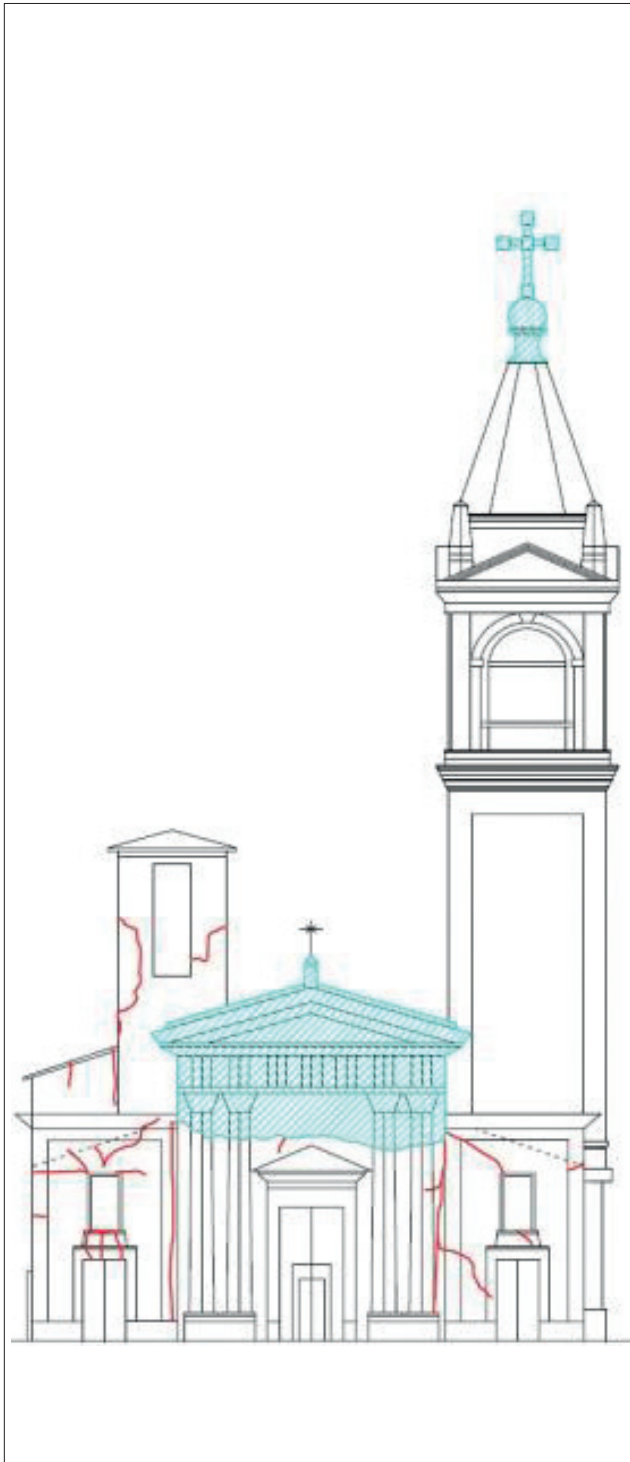
**FIGURE 6** Cracks on the main façade

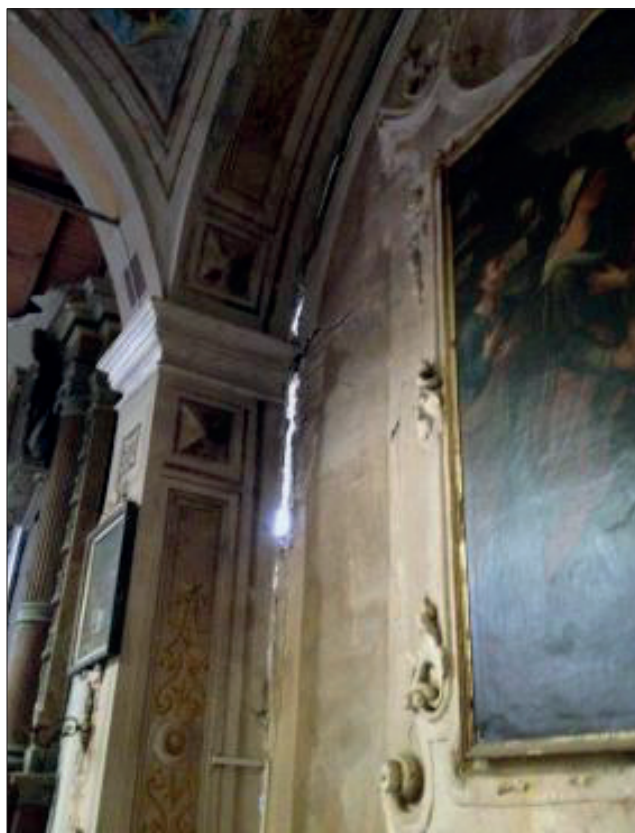
**FIGURE 13** Overturning mechanism of the walls on the left nave

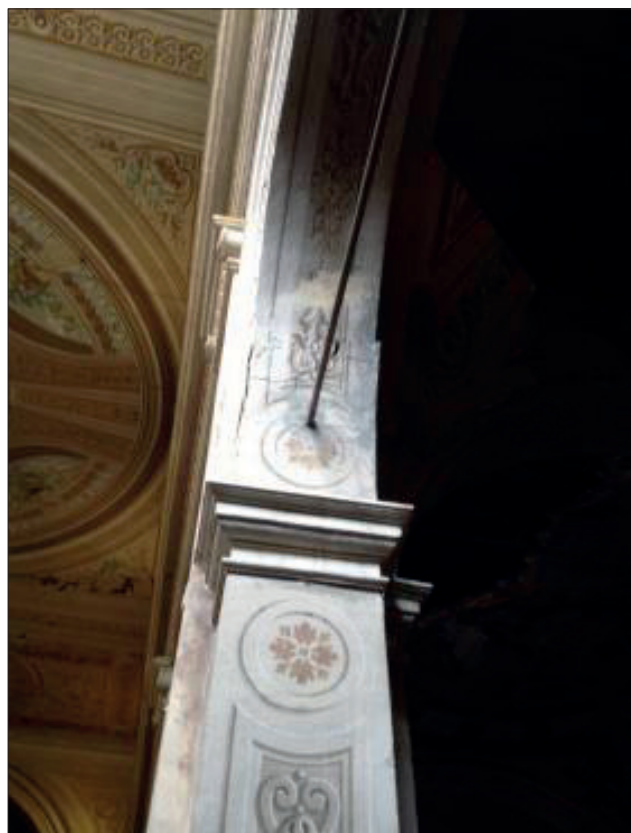
**FIGURE 14** Crack and translation on the arch

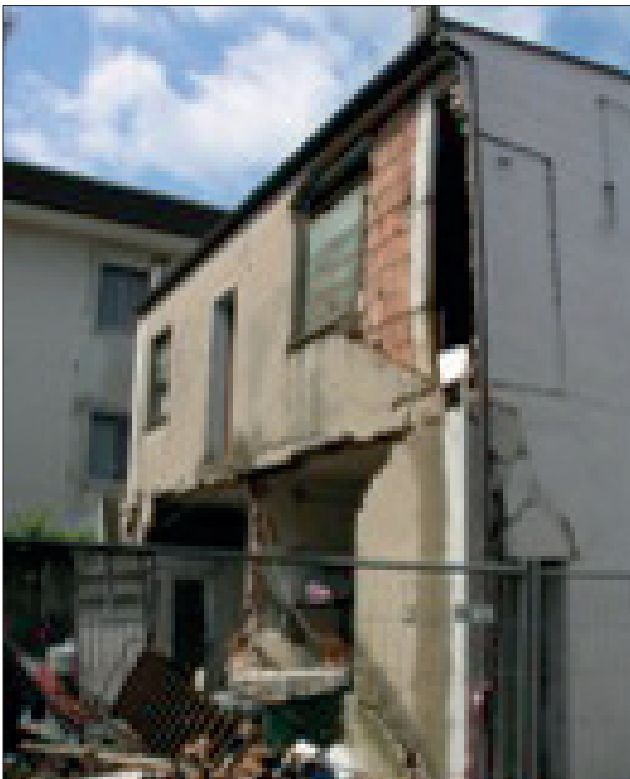
**FIGURE 7** Serious failure of the walls, the damage is grade 4

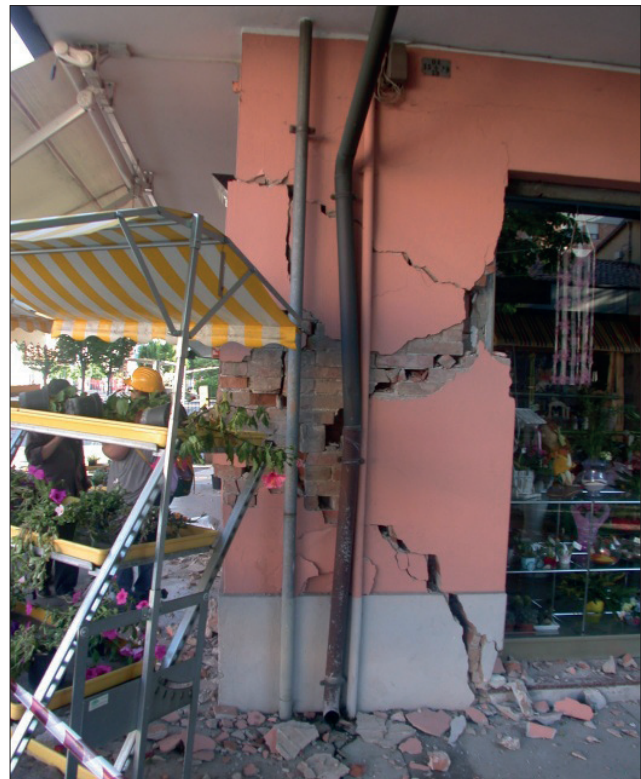
**FIGURE 8** Heavy diagonal cracks with partial loss of connection between external walls (damage of grade 4)

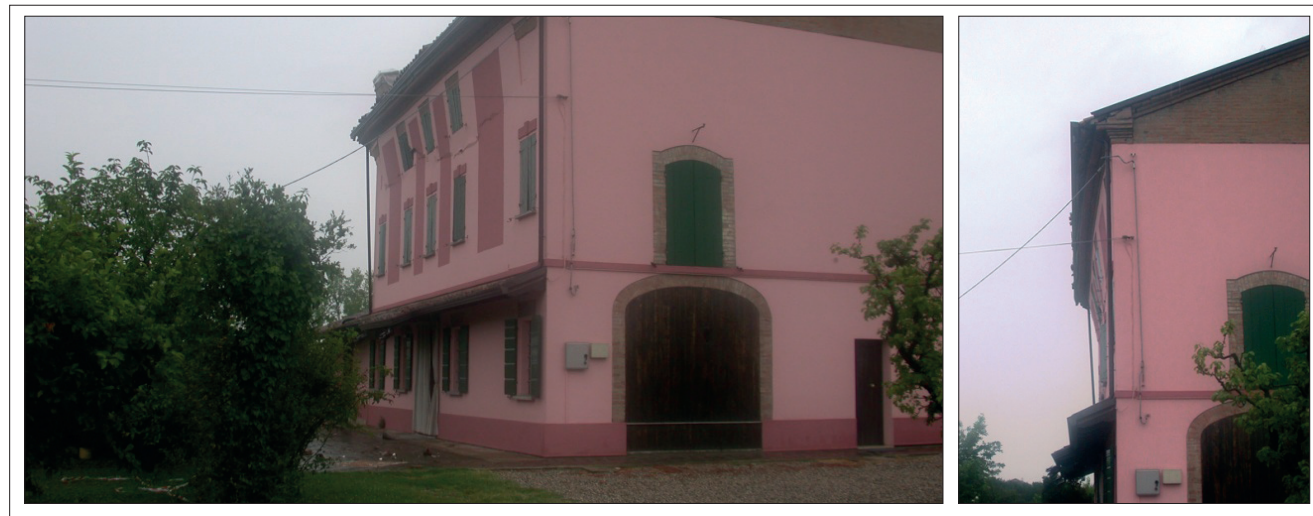
**FIGURES 9-10** Out-of-plane mechanism of the upper part of the longitudinal façade

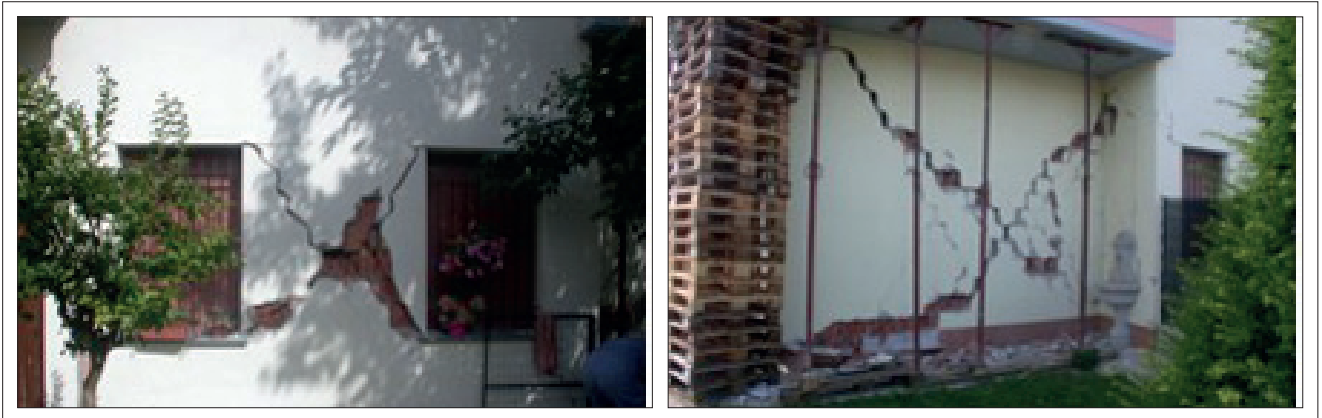
**FIGURES 14-15** Large shear cracks on exterior walls; the damage level il 3

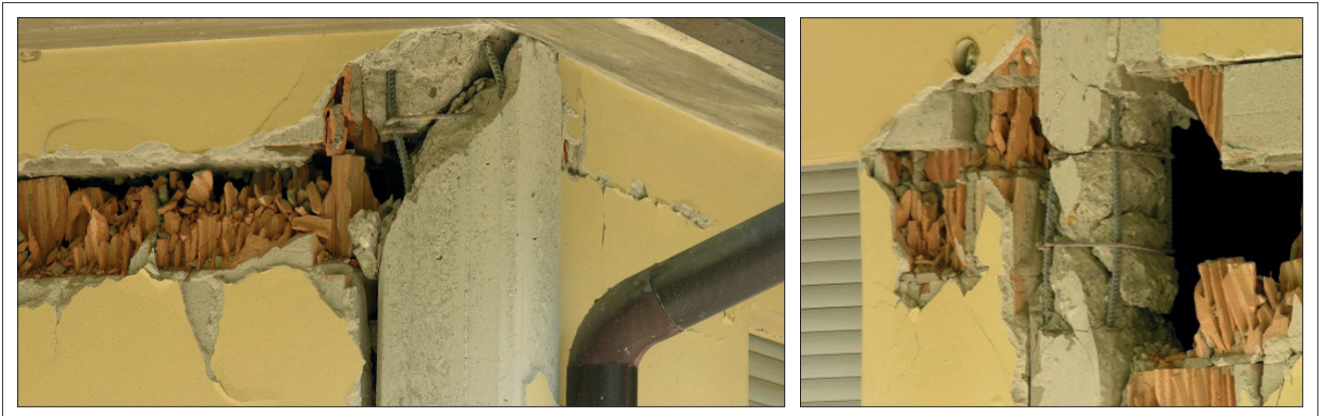
**FIGURES 18-19** Failure of RC columns

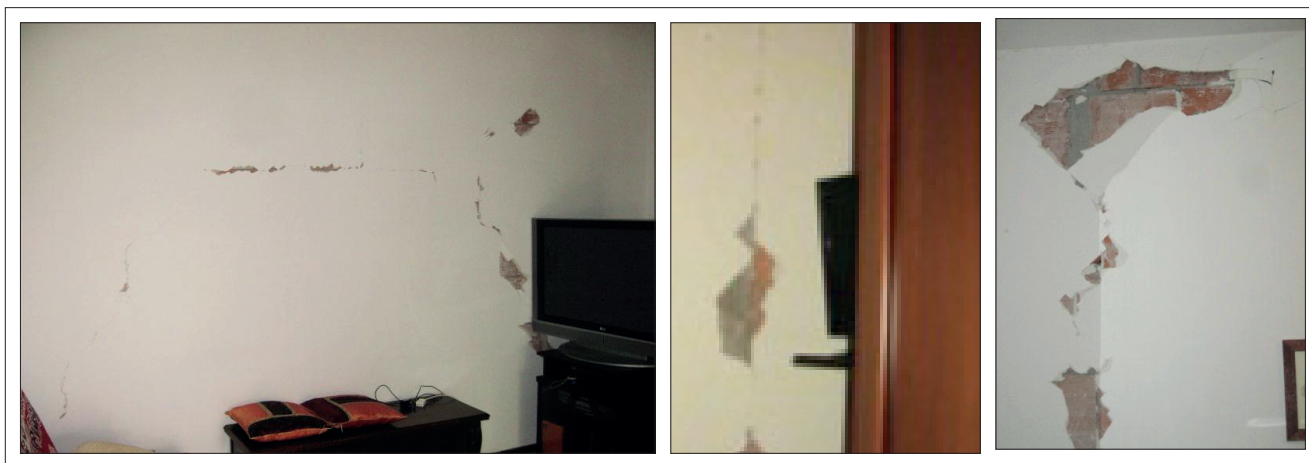
**FIGURES 23-24-25** Damage to the partition walls

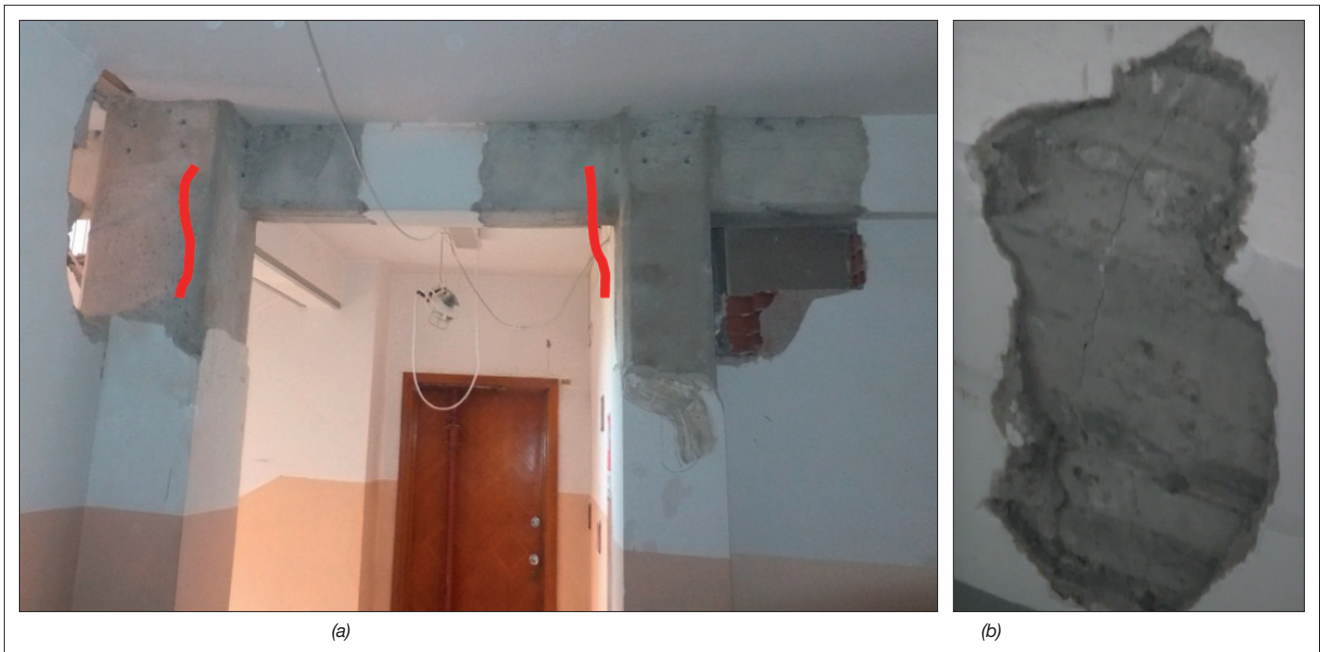
**FIGURE 32** Structural seismic damage: a) location of the cracks on the stair beams; b) crack detail

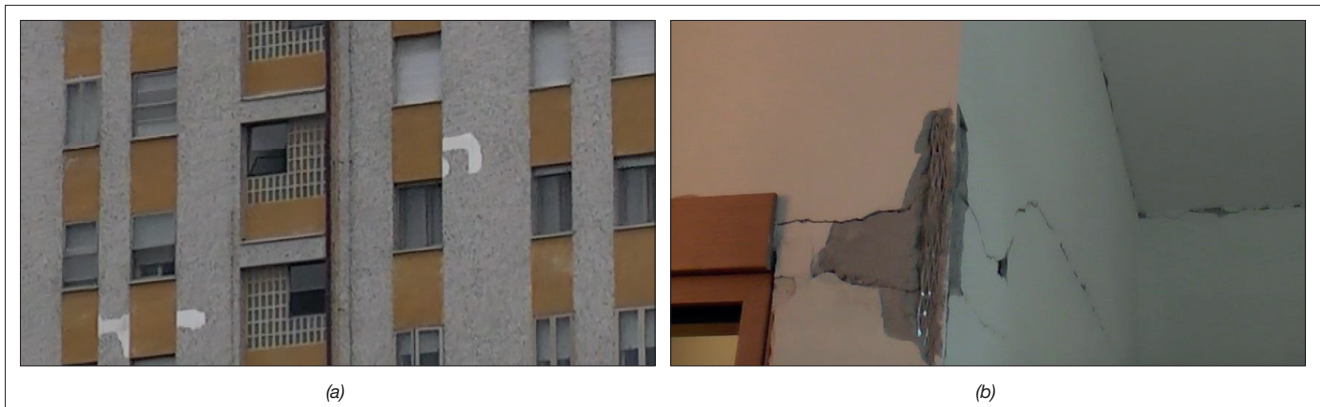
**FIGURE 33** Non-structural seismic damages: a) façade covering layers; b) partition walls
