# Energia, Ambiente e Innovazione

4-5/2012 - Parte II

**The Pianura Padana  
Emiliana Earthquake**

#### 58 Damage to religious buildings due to the Pianura Padana Emiliana earthquake

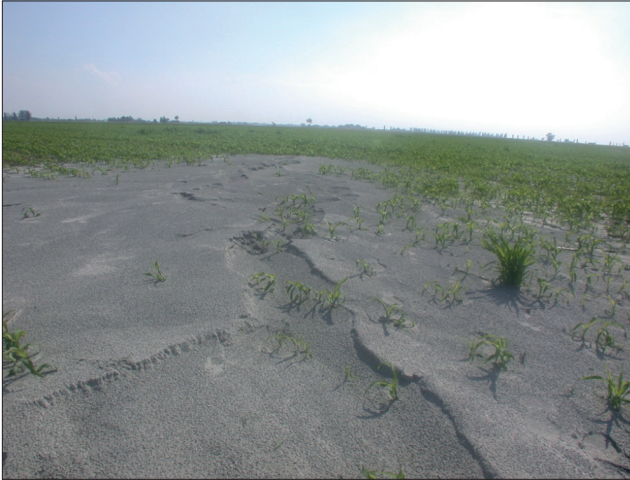
**FIGURE 9** Soil liquefaction near Bondeno  
Source: ENEA

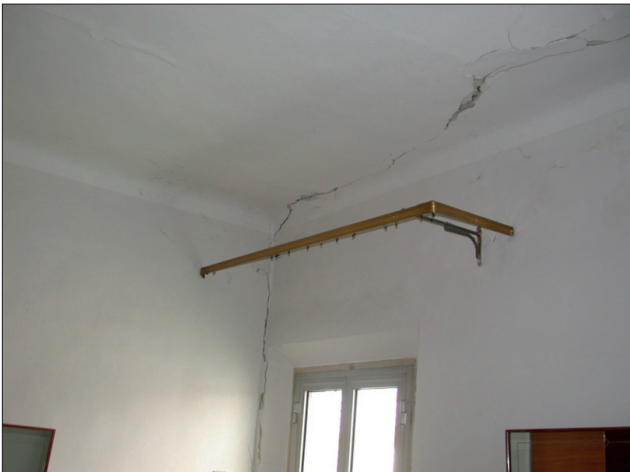
**FIGURE 10** Bondeno: damage of grade 2-3  
(EMS98 classification)  
Source: ENEA

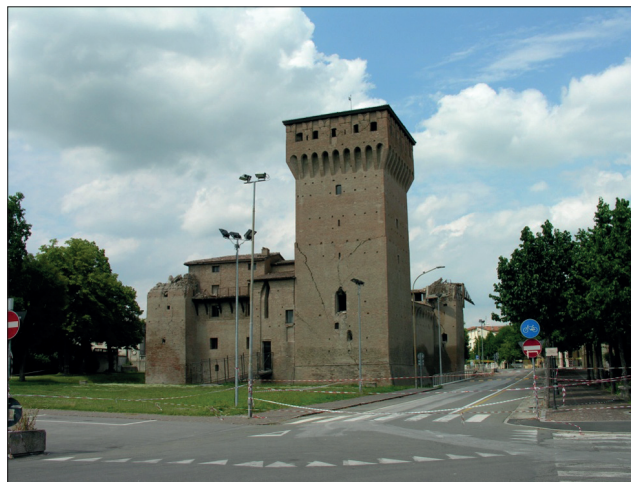
**FIGURE 11** The damaged fortress of San Felice sul Panaro  
Source: ENEA

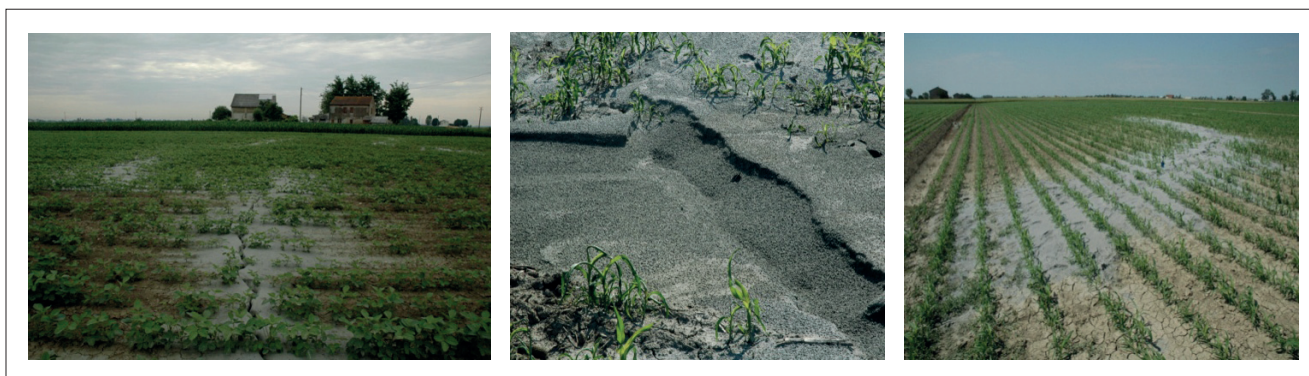
**FIGURE 5** Sand liquefaction phenomena within an agricultural area

The phenomenon of sand release has manifested a series of en echelon iso-oriented fractures, that despite the modest extension (usually around meters) are expression of local environmental geo-tectonics. From the geomorphology point of view, the structures are characterized by large sandy plateau with a central ridge along the fracture line and with very light slopes to the outside (Figs. 5-6-7).

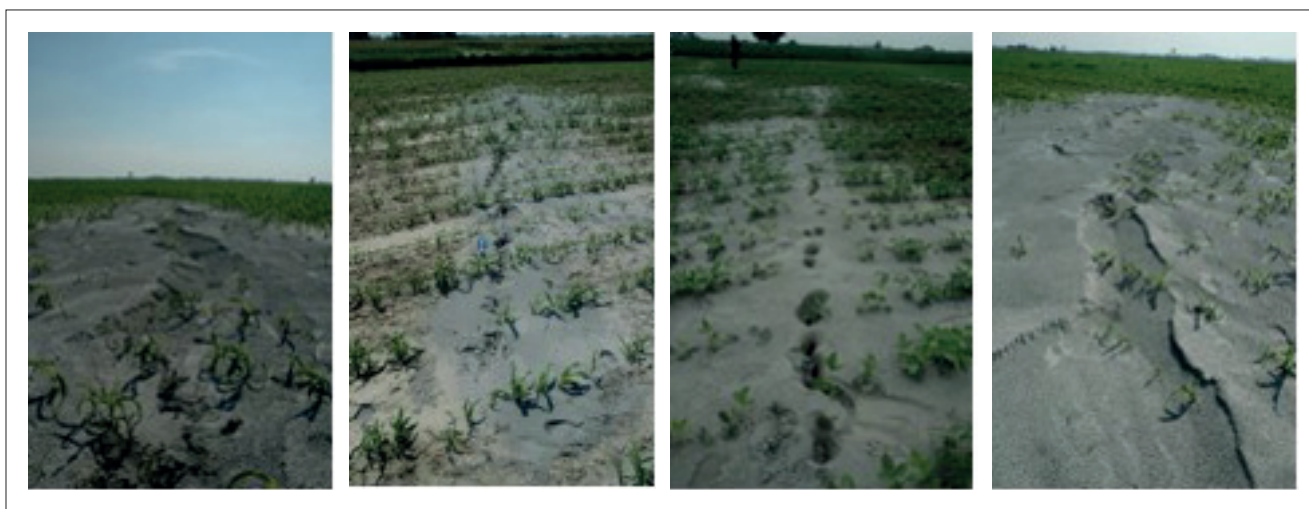
**FIGURE 6** Morphological structures of casting sand

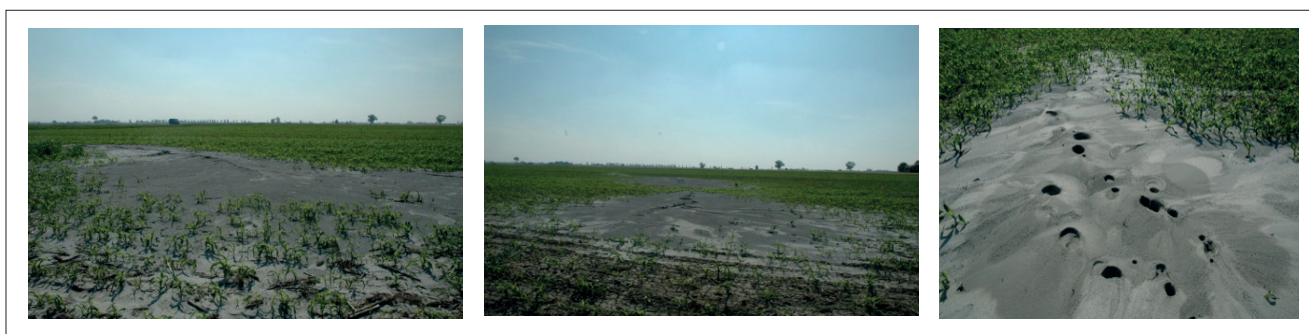
**FIGURE 7** The structures are characterized by large sandy plateau

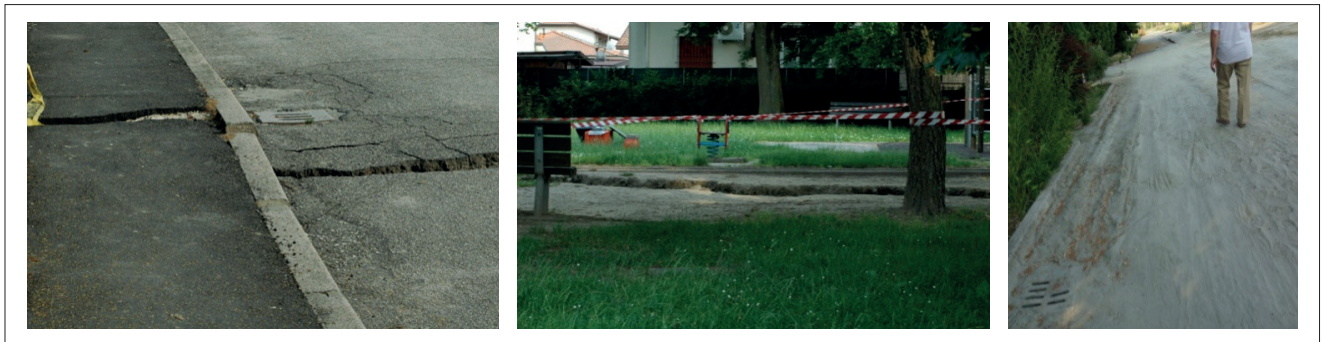
The phenomenon is most evident in Sant'Agostino, particularly in the urban area of San Carlo (Fig. 10), the most damaged by the May 20th earthquake, where a great fracture has affected the city centre. During the

**FIGURE 10** Sant'Agostino Municipality: one of the most damaged town by the earthquake of May 20<sup>th</sup>

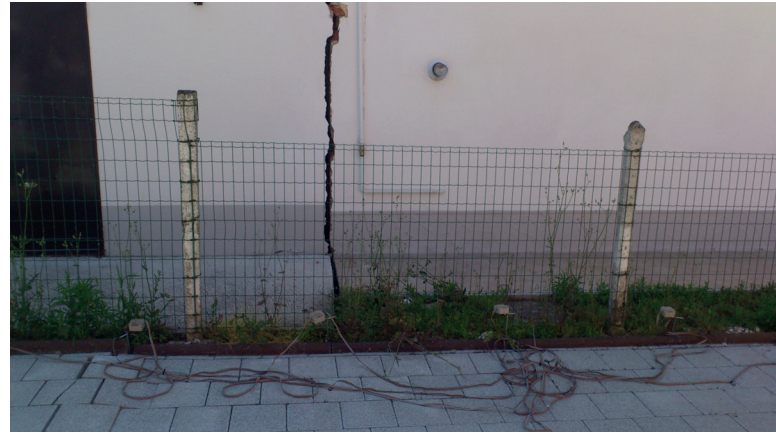
The test site (1 in Fig. 1), represented by a residential building that was affected by surface ruptures (Fig. 3), is situated in Via Argine Postale, 57 (south-western part of the village centre). In this site we accomplished several 2D GPR and seismic reflection profiles. Details regarding the employed techniques can be found in specific literature<sup>1</sup>. Concerning the GPR application for the investigation of seismically-induced fractures, we came across

**FIGURE 3** Side view of the investigated building with structural damage. The residential building is situated in Via Argine Postale, 57, Mirabello village (Italy). Near the fence, the seismic cables with geophones can be seen

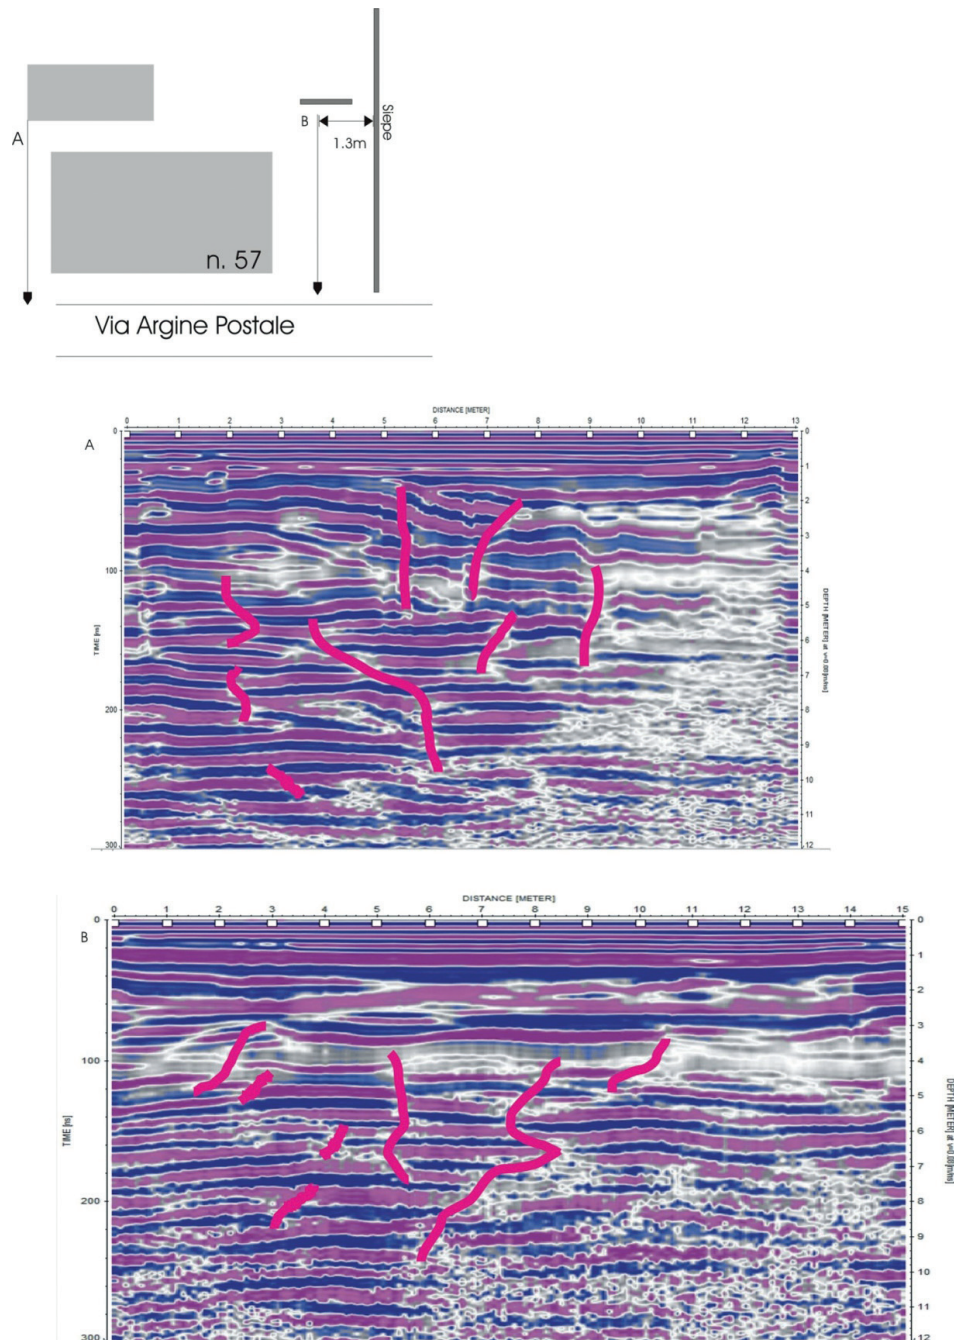
The interpretation of processed sections shows the presence of reflectors characterized by several horizontal unconformities and phase changes that could be associated to fractures or infiltration of sand (red lines). Reflectors associated to clay/sand interfaces are in general not parallel to the surface but show undulated geometries, probably associated to alternances of paleo erosion and sedimentation surfaces. It could also refer to the sediments used in the construction of the embankments. For the transformation of time sections to depth, a velocity of 8 cm/ns – typical of this type of soil (relative dielectrical permittivity “ $\epsilon_r$ ”: 14-15) –, has been applied.

**FIGURE 5** Example of GPR sections, 100 MHz, recorded on the side of building in via Argine Postale 57 at Mirabello. Possible fractures and/or sand intrusions are highlighted in red. The upper left insert shows the position of the GPR and seismic profiles with respect to the building. A and B: GPR sections. Thick vertical line: seismic reflection profile

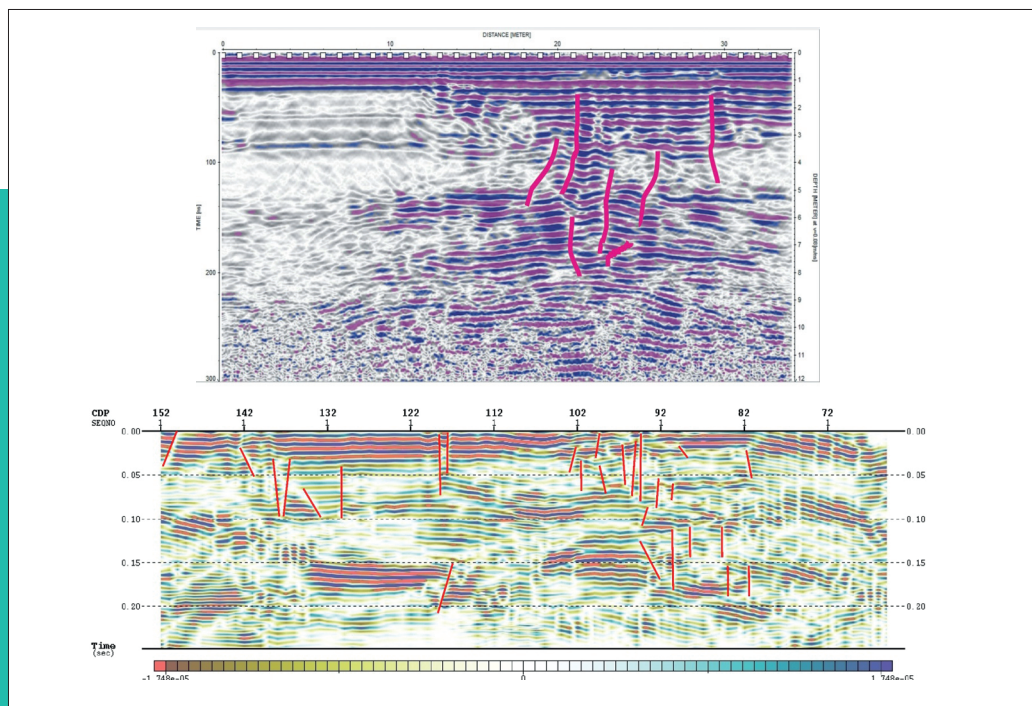
a) GPR (100 MHz) and  
b) seismic reflection  
section. Fractures and  
sand intrusions are  
highlighted in red colour

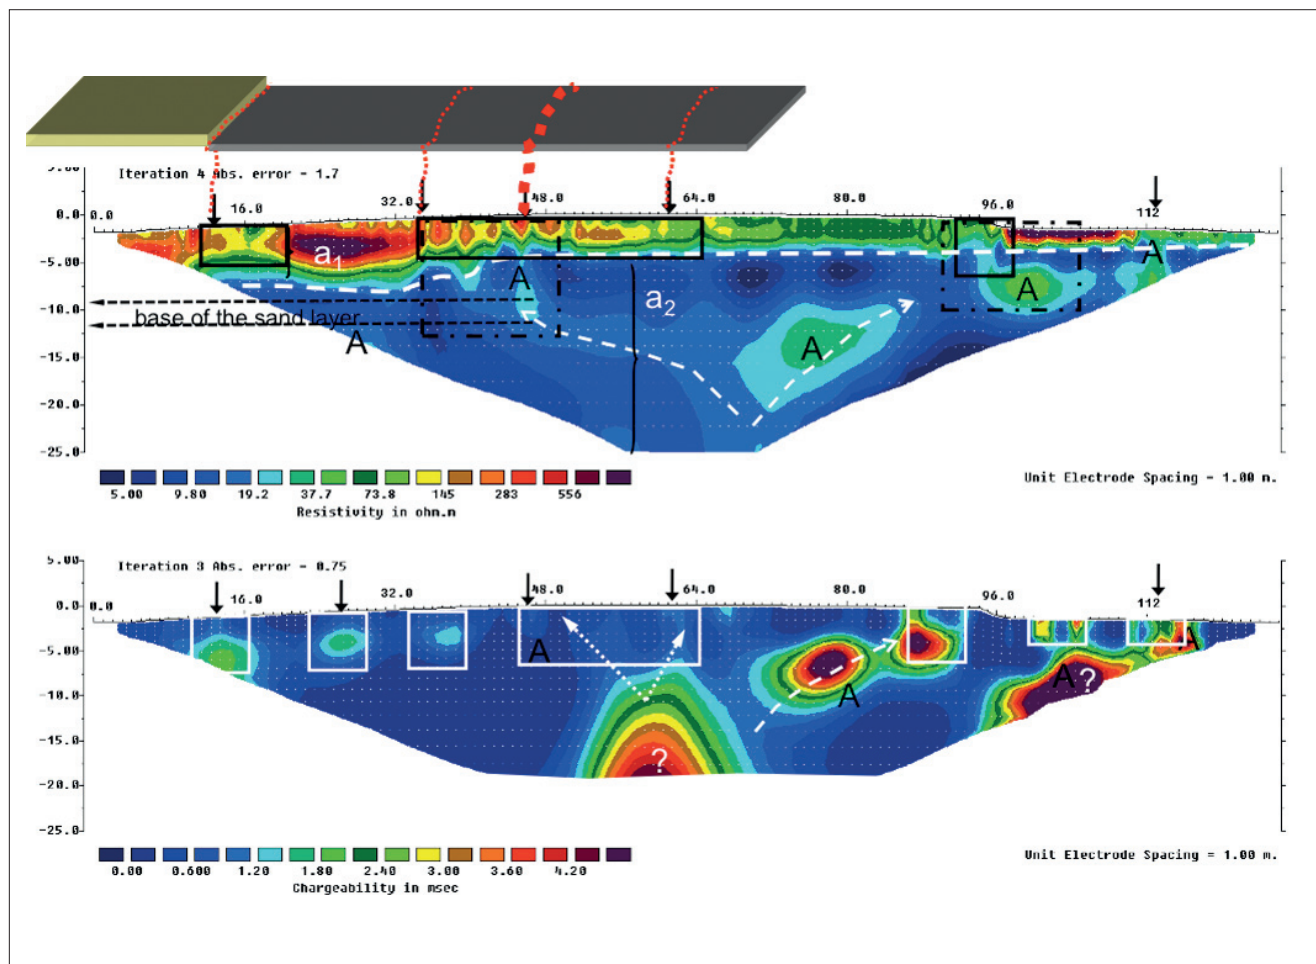
**FIGURE 4** 2D inverted resistivity (upper) and chargeability (lower) models. a1: resistive horizon and a2: conductive horizon. A: resistivity anomaly due to lithologic variation (silt and fine sand). Dashed white line: possible paleo-soil surface representing the old right embankment of the Reno River. The two shaded areas indicate the extension of the industrial warehouse with respect to the profile. The left one is related to the extreme western portion of the building that was severely damaged and subsequently demolished. ?: further analyses are needed to reveal the nature of these IP anomalies

As regards the first level, the resistivity model suggests the presence of lateral heterogeneities at the following chainages: 12 m, 35-65 m, and around 96 m. These are believed to be associated with subsurface fractures whose traces were visible on the surface at the moment of data acquisition.

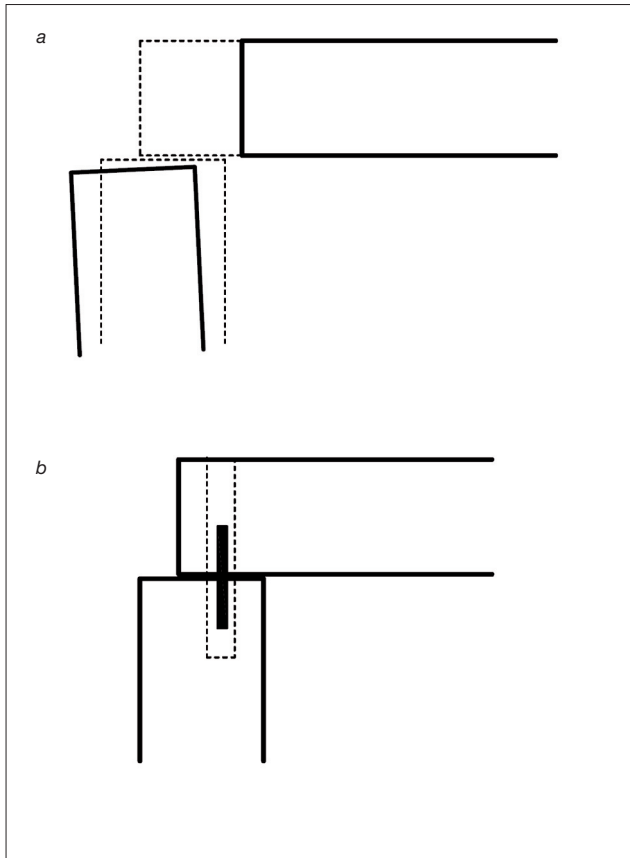
**FIGURE 5** Possible relative displacement induced by external forces and insertion of a steel dowel to increase the shear resistance  
Source: ENEA

The bending rotation of the beam creates a stress concentration at the top of the pillar, with possible spalling of the concrete (Fig. 4a). This suggests the interposition of a bearing pad (Fig. 4b). If a horizontal force overcomes the friction force, the beam can lose its bearing. A steel dowel or a reinforcing bar can prevent this kind of collapse (Fig. 5).

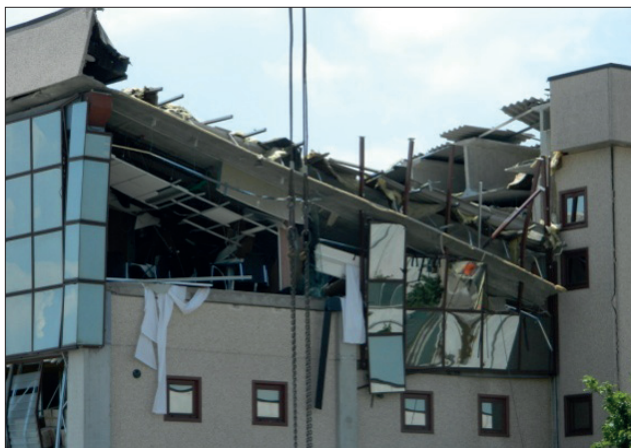
**FIGURE 7** Longitudinal slipping of the roof beams  
Source: ENEA

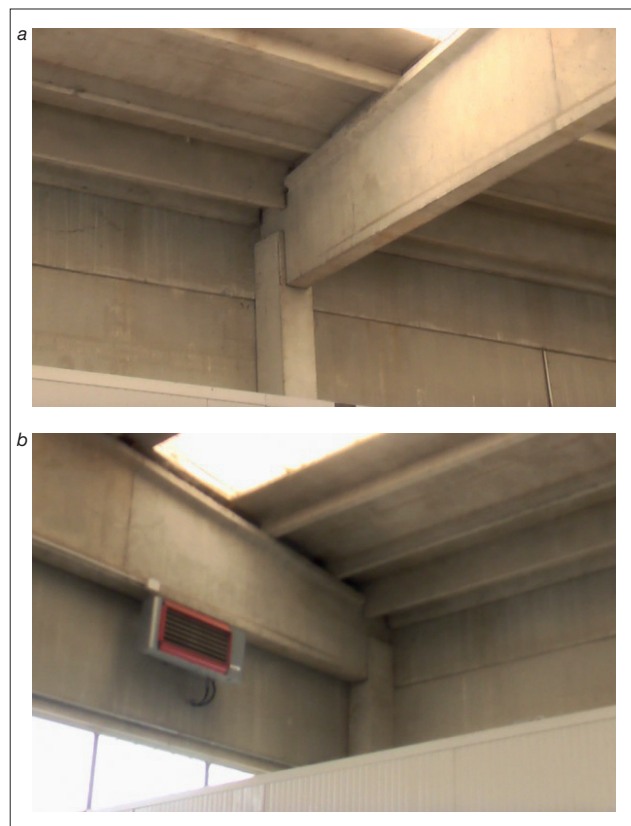
A surprising case of undamaged factory is sketched in Fig. 9. It shows a similar construction system, but a significant difference in the constraint details, due to the shape

**FIGURE 9** Undamaged structure: a) covering structure to beam connection; b) corner configuration  
Source: ENEA

of the covering tiles, realising a tile/beam connection, effective in the seismic direction as a tying system.

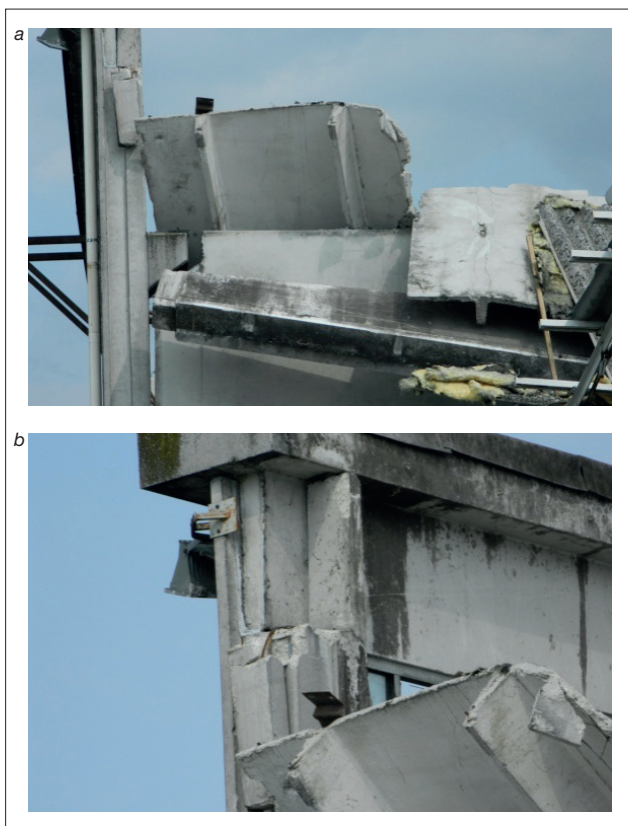
**FIGURE 10** Lateral toppling of the beam  
Source: ENEA

In some cases the beam toppled down laterally, as shown in Fig. 10, after the failure of the lateral restraint present at the top of the columns, unable to resist to horizontal actions. Clearly, the failure mechanism depended also on the prevalent direction of the seismic motion. Different types of damage to columns are shown in Fig. 11.

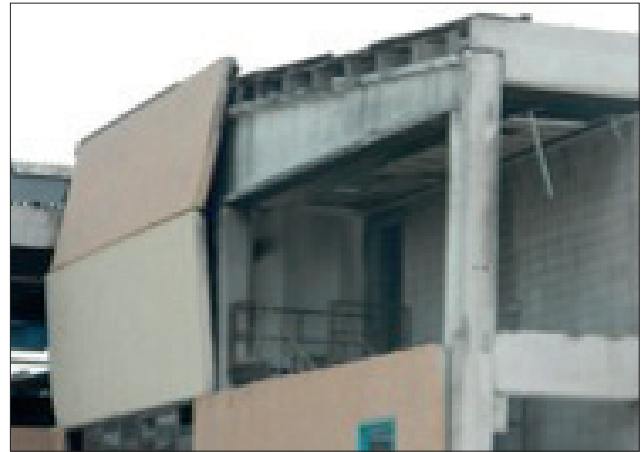
**FIGURE 13** Detachment of the external wall  
Source: ENEA

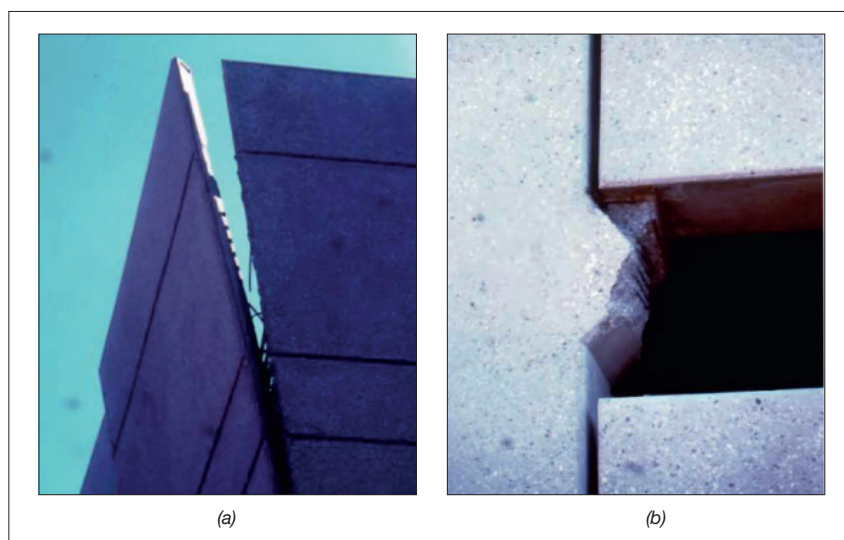
For example, after the January 17<sup>th</sup>, 1994 Northridge earthquake (California, USA,  $M_w=6.7$ ), several parking lots suffered widespread damage or collapse [6]. Among others, a typical example was the Cigna Garage, a multi-storey assemblage of precast and cast in-situ elements (Fig. 15), located at a distance of

**FIGURE 15**  
Cigna Garage damaged by the 1994 Northridge earthquake [7]

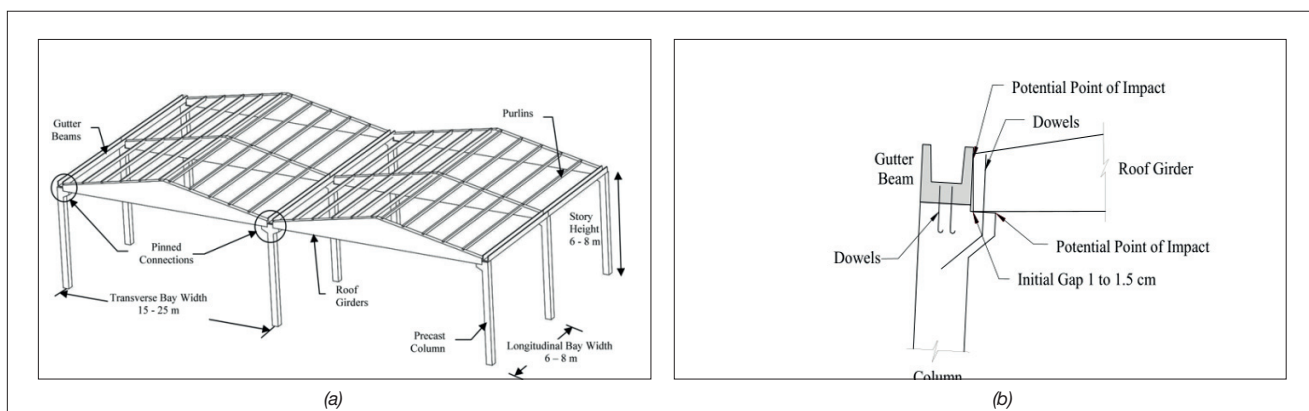
**FIGURE 16** A Turkish typical configuration of one storey precast construction near Kocaeli and details [11-14]

hand, collapse and extensive damage was concentrated in pre-1981 r.c. and steel stock. Some typical one-storey industrial pre-cast structures (Fig. 16), located in the epicentre area of the August 17<sup>th</sup>, 1999, Kocaeli earthquake (Turkey,  $M_w=7.4$ ), didn't show good results, while others remained undamaged (Fig. 17) [10].

The collapse was mainly due to poor design, detailing, and construction, leading to the lack of diaphragm action caused by the inadequate connections (pinned or dowel, simple to realize by the prefabricators) between columns and beams. In addition, buildings under construction were susceptible to collapse when the roof girders rotated off their supports.

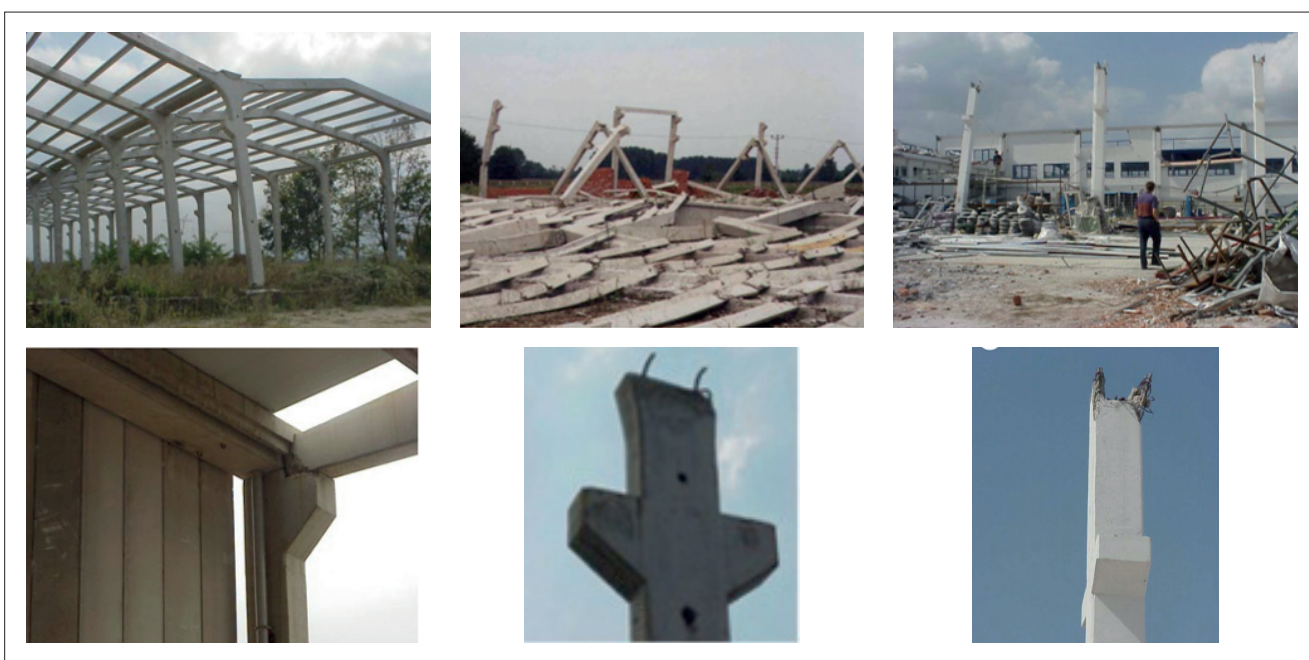
**FIGURE 17** P/p. r.c. structures, with different stages of construction and seismic behaviour, located in the epicenter area of the Kocaeli earthquake, and details of the connections [11-14]

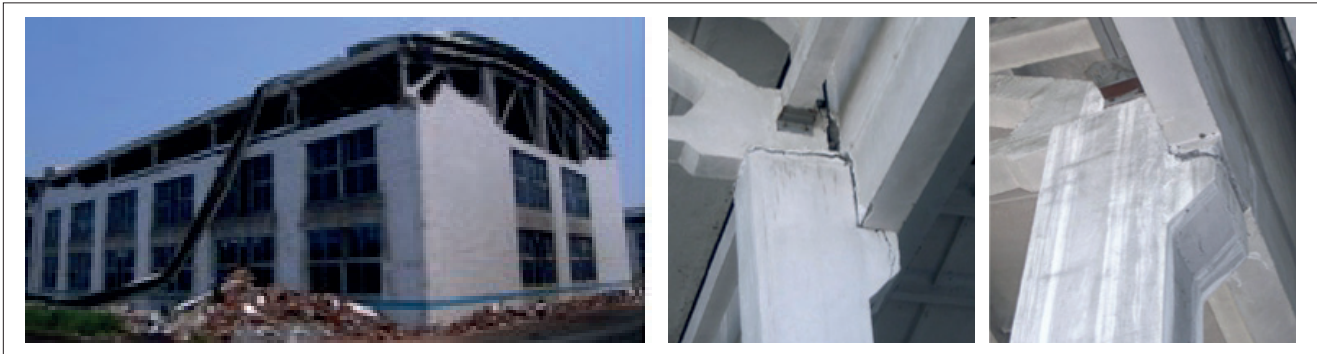
**FIGURE 18** Damage and partial collapse of the Xiting Package Ltd. Factory complex in Mianzhu City, Wenchuan, China [15]

Also after the May 12<sup>nd</sup>, 2008, Wenchuan earthquake (China,  $M_w=7.9$ ), industrial buildings and facilities in the area near the fault rupture were severely affected, as shown in Fig. 18 [15].

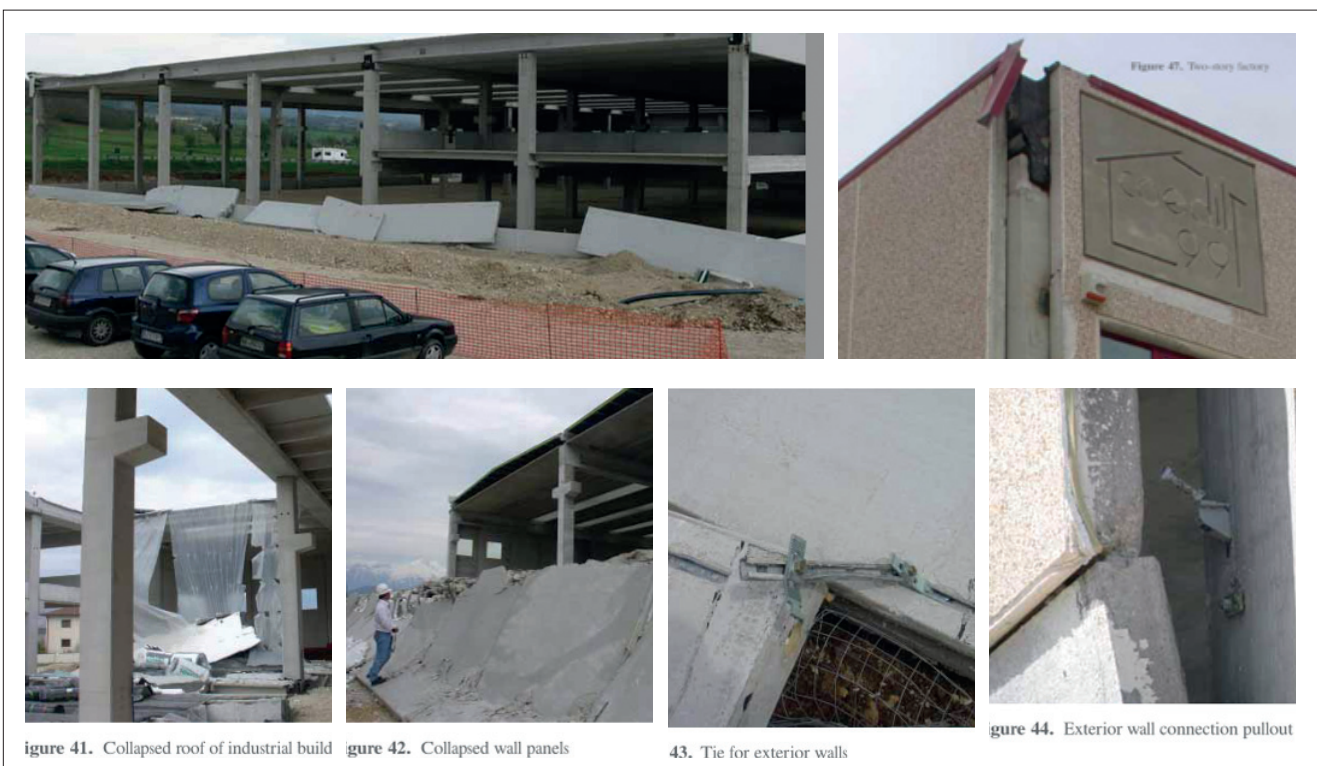
**FIGURE 19** Collapse due to lack of adequate anchoring in p/p. r.c. structures in L'Aquila [17]

The April 6<sup>th</sup>, 2009, Abruzzo earthquake (Italy,  $M_w=6.3$ ) again seriously affected some p/p. r.c. buildings, generally unanchored or inadequately braced [16, 17]; taking into account the relatively new vintage and the

existing seismic classification of the area before the event, the level of damage was surprising (Fig. 19).

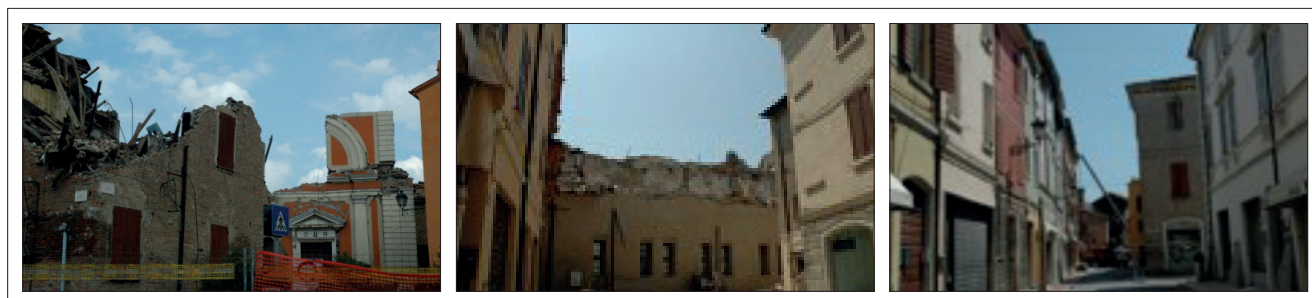
**FIGURE 3** Historic centres of San Felice sul Panaro (photo 1) and Mirandola (photos 2 & 3)

quake of May 20<sup>th</sup>. The first photo of Figure 3 shows a view of the square in front of the cathedral of San Felice sul Panaro, with the church damaged by repeated shocks; photos 2 and 3 of the same figure show two views of the historic centre of Mirandola, the first close to the cathedral whereas the second offers a view of what remains of the church of San Francesco.

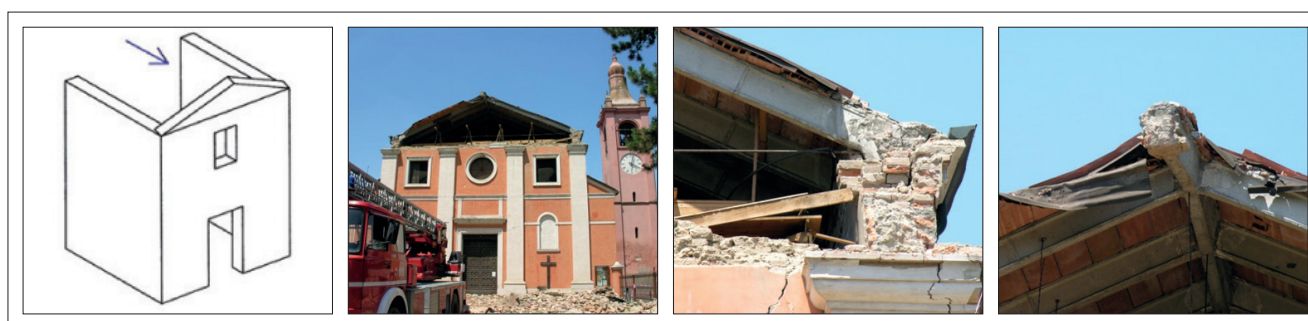
**FIGURE 4** Church of Natività, Rivara, San Felice sul Panaro (drawing by [2])

One of the most common failure mechanisms in cases of severe damage was the out-of-plane collapse of the tympanum. In some cases the damage displays a horizontal crack and the collapse of the entire macroelement (Figs. 4 & 5).

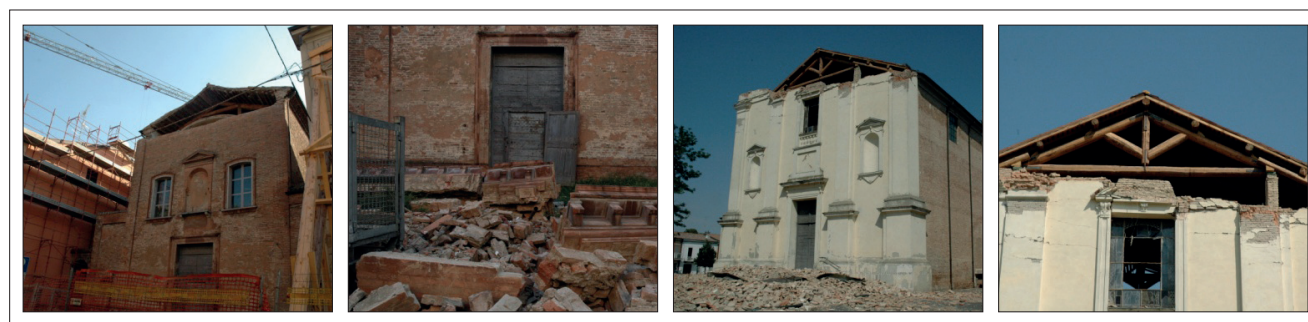
**FIGURE 5** Church of Annunziata in Finale Emilia (photos 1&2); Church of S. Possidonio, San Possidonio (photos 3&4)

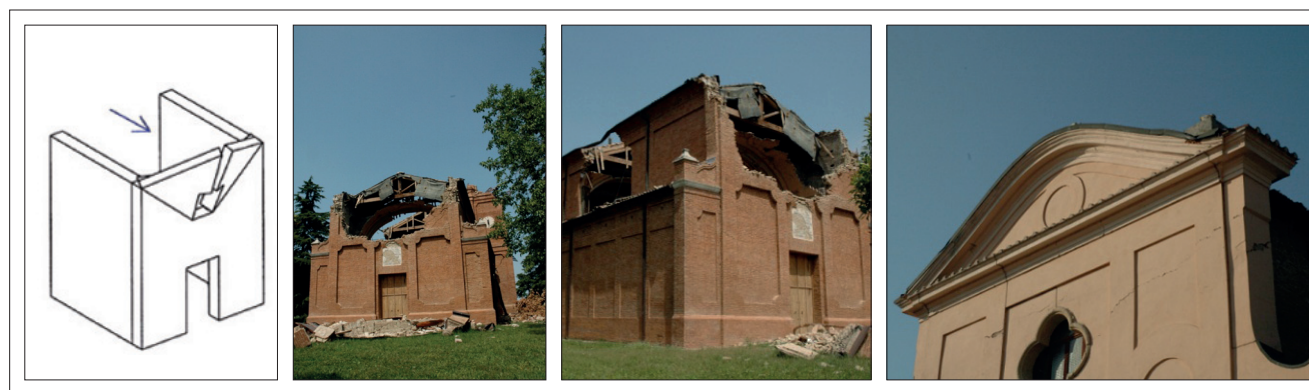
In other cases, the collapse occurred with a V shaped crack and the crumbling of the masonry, as in the badly damaged church of S. Luca in Camurana (photos 1 & 2 in Fig. 6). Another case of V shaped crack is shown in the church of S. Francesco d'Assisi in Finale Emilia (photo 3 in Fig. 6).

**FIGURE 6** Church of S. Luca, Camurana, Medolla (photos 1&2), Church of San Francesco d'Assisi, Finale Emilia (photo 3) (drawing by [2])

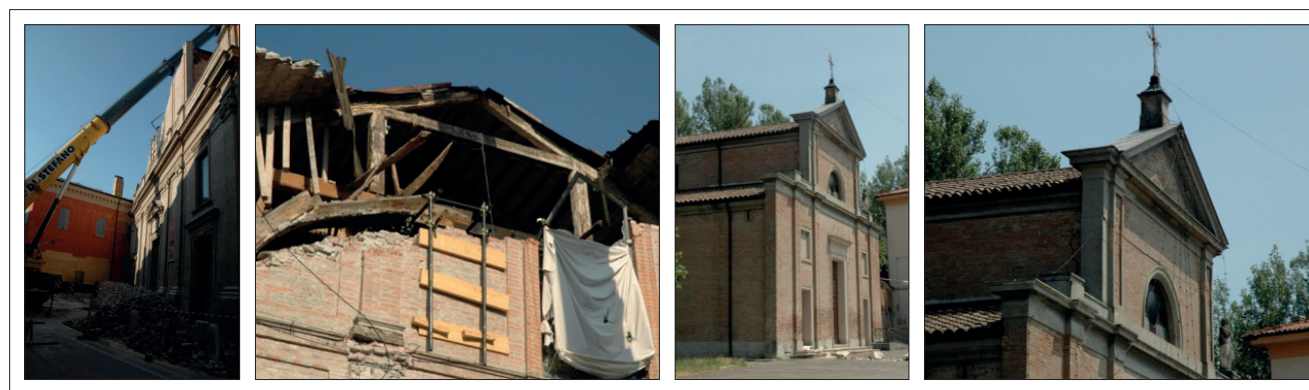
masonry in such a way as not to make the collapse mechanism clear (photos 1 & 2 in Fig. 7), or cases of horizontal cracks in a position lower than the base of the tympanum (photos 3 & 4 in Fig. 7).

**FIGURE 7** Church of SS Filippo e Giacomo, Cathedral, Finale Emilia (photos 1&2), Church of Santi Senesio e Teopompo Martiri, Medolla (photos 3&4)

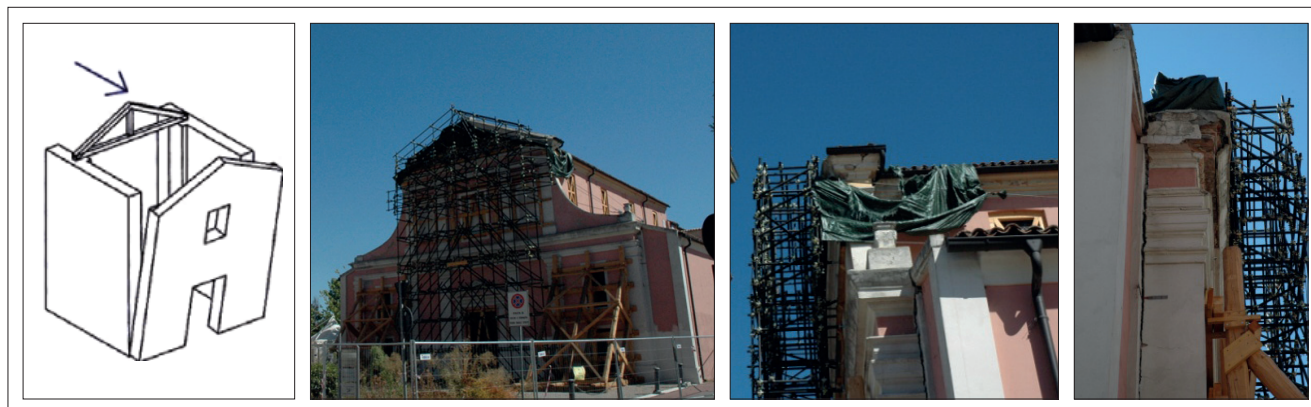
Another mechanism observed in many damaged churches is the detachment with consequent overturning of the façade as in the church in Vigarano Mainarda (Fig. 8). The beginning of the mechanism in the top part is quite widespread, and required many interventions for safety with provisional tie rods (photo 3 in Fig. 12).

**FIGURE 8** Church of Natività della Beata Vergine Maria, Vigarano Mainarda (drawing by [2])

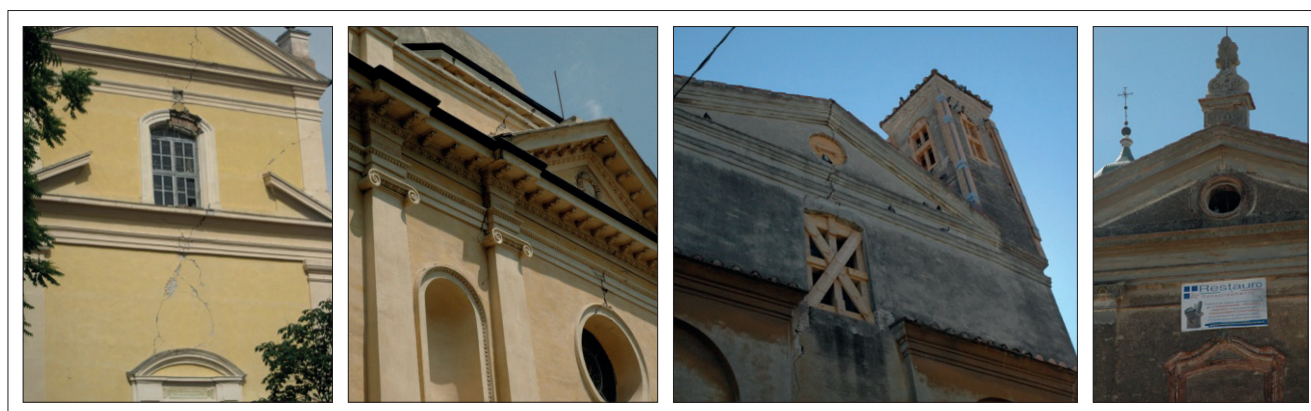
**FIGURE 9** Church in Finale Emilia (photo 1); Church of Madonnina, Mirandola (photo 2); Church of SS. Rocco e Sebastiano (photo 3), Pieve di Cento; Church of S. Giovanni, Bondeno (photo 4)

In plane, the damage mechanism of the façade – often with vertical cracks from the tympanum to the architrave of the entrance portal through the rose windows of the churches – has been observed too. Figure 9 shows the various severity levels of this type of damage.

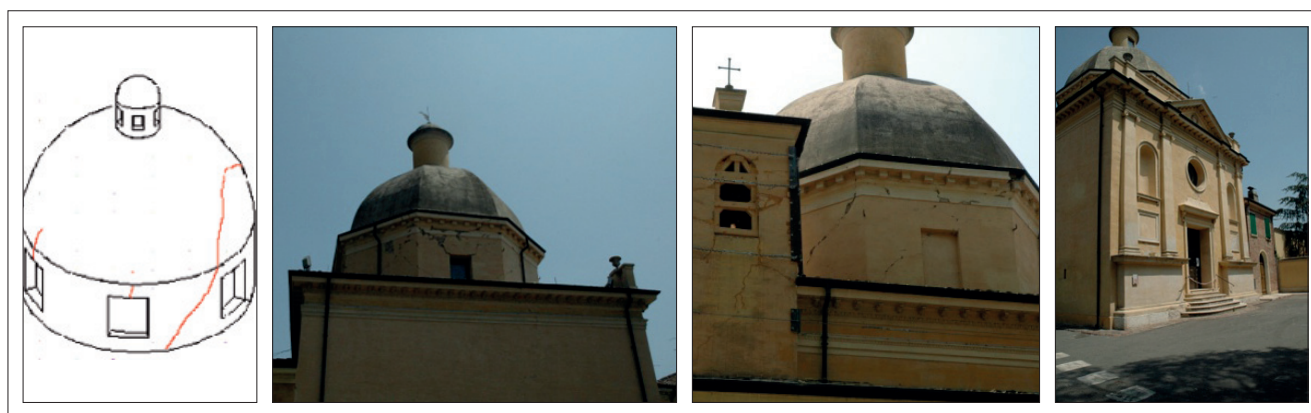
**FIGURE 10** Church of the Madonnina, Mirandola (drawing by [2])

The figures below show some cases of this typology of damage. The drum of the Church of Madonnina in Mirandola was seriously damaged, from the outside it is not possible to see any damage to the dome because of the covering.

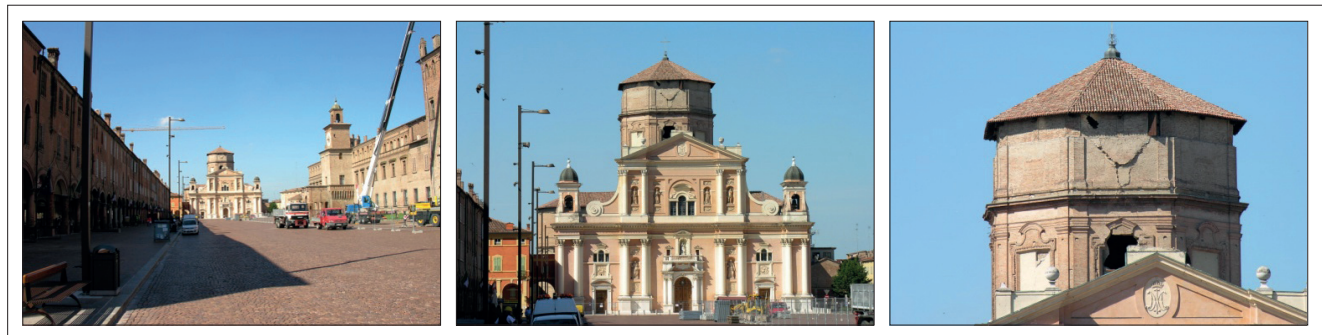
The *tiburium* of the cathedral of Carpi shows clearly visible cracks in the front facing the square (Fig. 11), whereas the dome of the church of S. Maria Maggiore in Pieve di Cento has completely collapsed and its drum is now bounded with provisional tie rods (Fig. 12).

**FIGURE 11** Cathedral of S. Maria Assunta, Carpi (MO)

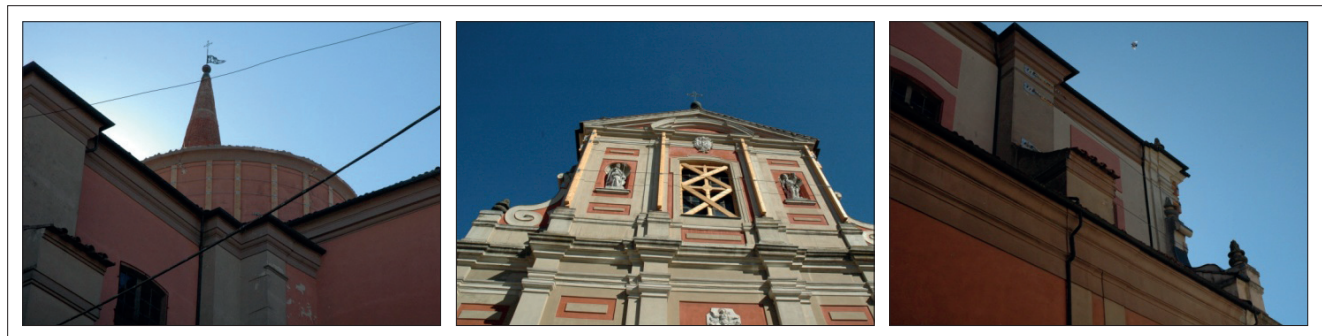
**FIGURE 12** Church of S. Maria Maggiore, Pieve di Cento (BO)

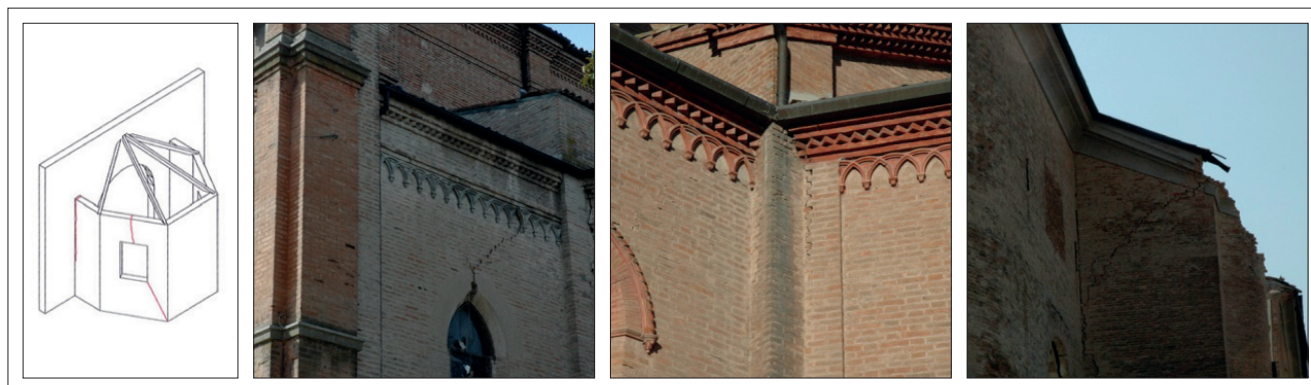
Significant shear cracks are present in the lateral chapels of several churches. The detachment of the outer walls of the chapels from the walls of the church and shear cracks in the walls of chapels and side aisles are often observed (Fig. 13).

**FIGURE 13** Church of S. Silvestro, Crevalcore (BO); Church of San Michele Arcangelo, Poggio Renatico (FE); Church of San Possidonio, San Possidonio (MO); (drawing by [2])

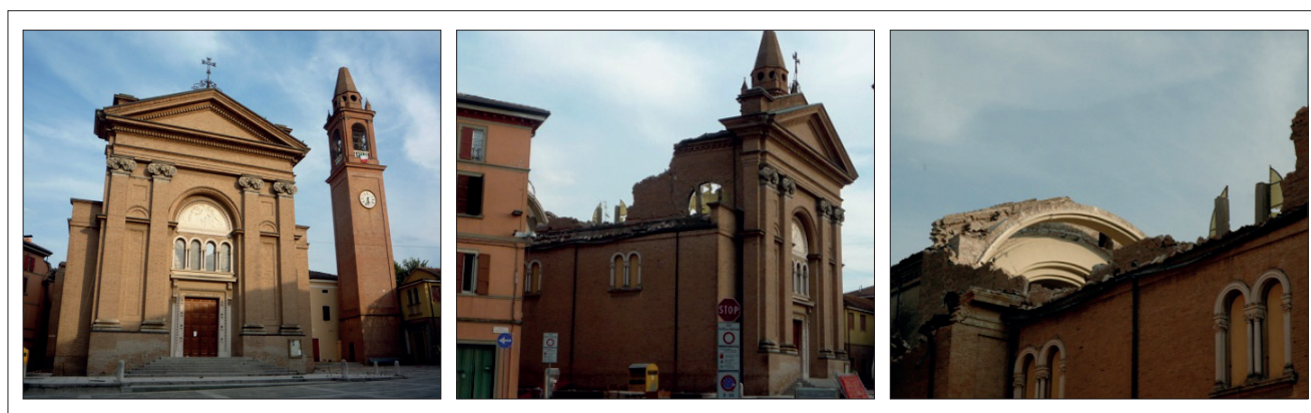
The figures below show some important collapses of structural parts. The church of S. Egidio Abate in Cavezzo was particularly damaged with the collapse of roof and vault. The first photo of Fig. 15 shows the church of S. Francesco, already severely damaged by the earthquake of May 20<sup>th</sup>, almost completely collapsed after the event of May 29<sup>th</sup>.

**FIGURE 14** Church of Sant'Egidio Abate, Cavezzo (MO)

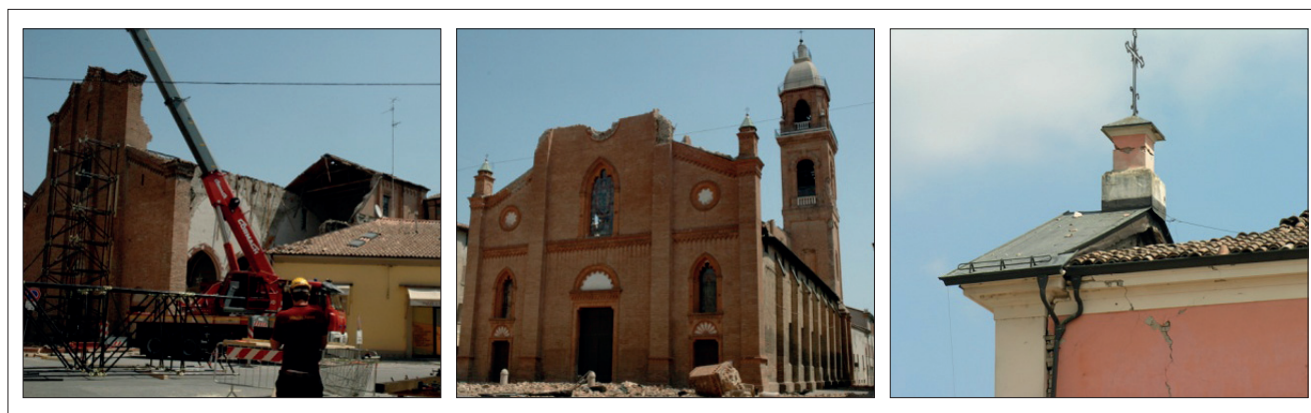
Already damaged by the earthquake of May 20<sup>th</sup>, also the cathedral of Mirandola, with the event of May 29<sup>th</sup>, saw the partial collapse of the façade and the roof. The roof

**FIGURE 15** Church of S. Francesco (photo 1) and Cathedral (photo 2) in Mirandola; Church of Santa Caterina d'Alessandria, Rovereto di Novi (photo 3, by courtesy of P. Clemente)

collapse in the badly damaged church of Santa Caterina d'Alessandria in Rovereto di Novi, in Novi di Modena town, has become infamous for causing the death of the priest. Little is left – except for the perimeter walls and piles of rubble to recover – of the church of S. Martino in Buonacompria, and of the Oratorio Ghisilieri in San Carlo, in Sant'Agostino town.

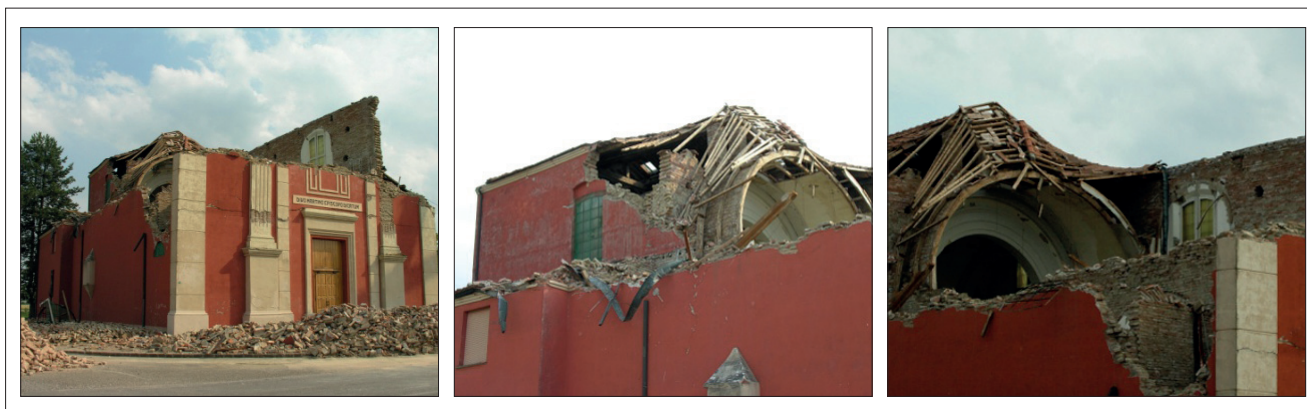
**FIGURE 16** Church of S. Martino, Buonacompria, Cento (FE)
