# Energia, Ambiente e Innovazione

4-5/2012 - Parte II

**The Pianura Padana  
Emiliana Earthquake**

#### 58 Damage to religious buildings due to the Pianura Padana Emiliana earthquake

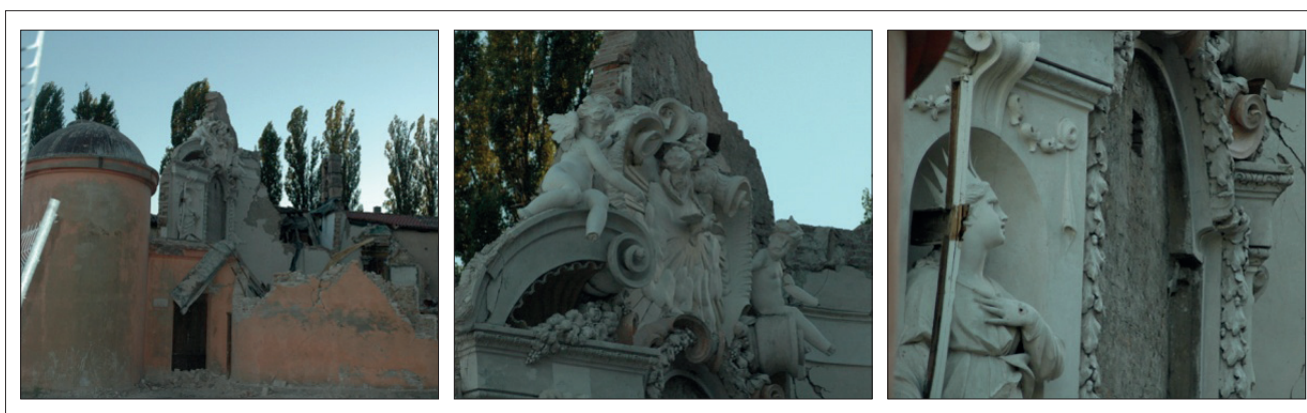
**FIGURE 17** Oratorio Ghisilieri, San Carlo, Sant'Agostino (FE)

collapse in the badly damaged church of Santa Caterina d'Alessandria in Rovereto di Novi, in Novi di Modena town, has become infamous for causing the death of the priest. Little is left – except for the perimeter walls and piles of rubble to recover – of the church of S. Martino in Buonacompria, and of the Oratorio Ghisilieri in San Carlo, in Sant'Agostino town.

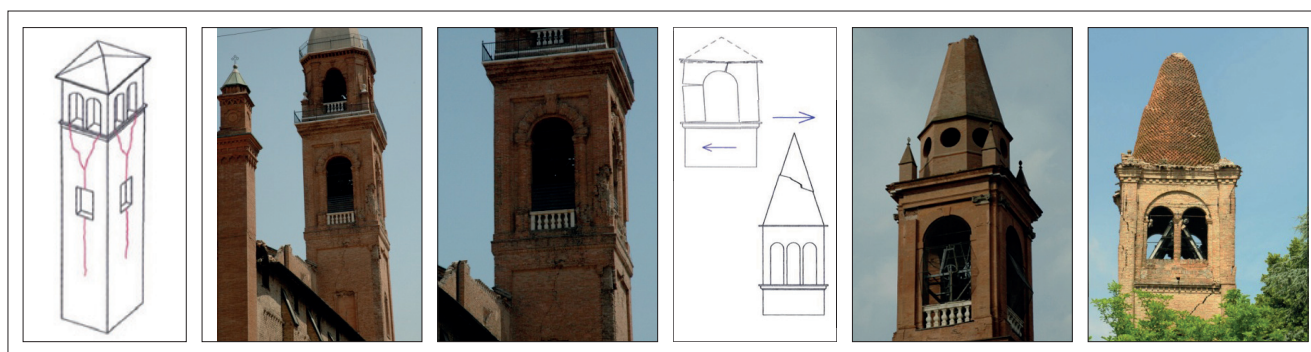
tion (frequent cases in the area where inclined steeples are found) and to masonry in bad state of conservation. The bell cells, with large openings, show serious shear cracks in the little columns, with sliding in the most severe cases (Fig. 18). Some of them are disaggregated under the action of the earthquake, others have been

**FIGURE 18** Steeples of: Cathedral, Mirandola (photos 1 & 2); Church of Sant'Egidio Abate, Cavezzo (photo 3); Church of Santa Caterina d'Alessandria, Rovereto di Novi, (photo 4, by courtesy of P. Clemente), (drawings by [2])

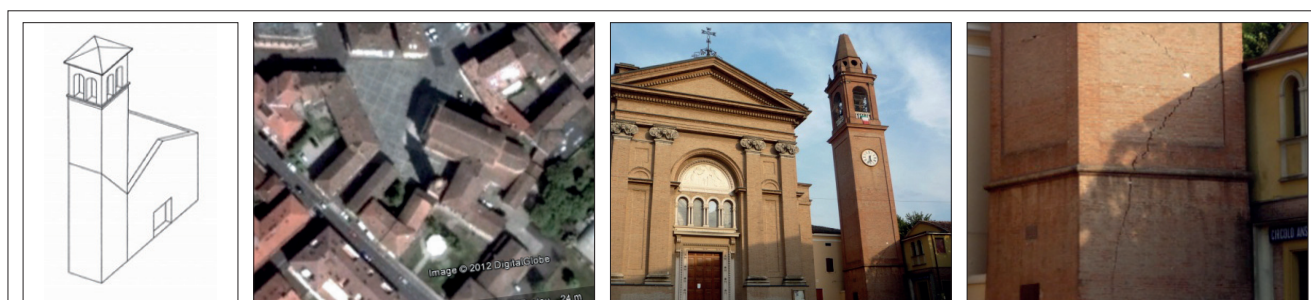
removed from firefighters, others made safe. When the steeple is placed in contact with other structures of lower height, this can cause local damage; an example is the bell tower of church in Cavezzo (Fig. 19). In the pictures in Fig. 20, two cases of severe damage are reported; the first two photos show the bell tower

**FIGURE 19** Steeple of Sant'Egidio Abate Church, Cavezzo (drawing by [2], photo 1 by Google maps)

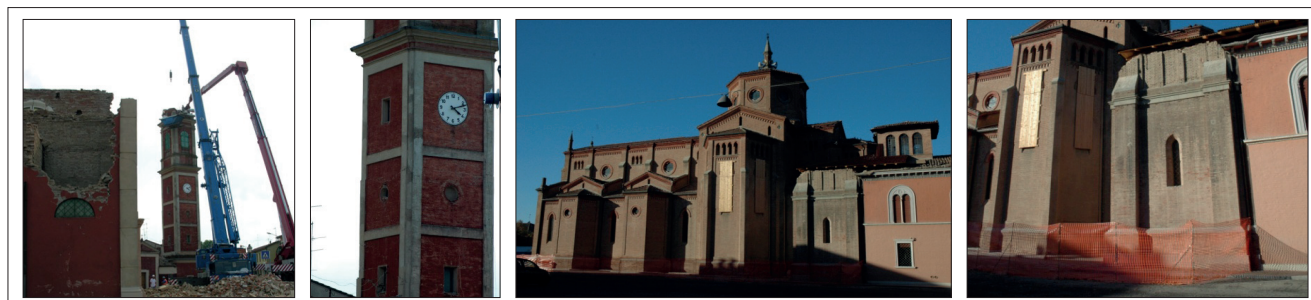
**FIGURE 20** Steeples of: Church of S. Martino, Buonacompra, Cento (FE), Church of S. Michele Arcangelo, Poggio Renatico (FE)

of the Church in Buonacompra during the demolition. Photo 2 shows the severe shear two-level damage, due to torsional stress, that led to the decision to demolish the tower. The last two pictures in Fig. 20 show the church of S. Michele in Poggio Renatico deprived of its bell tower, blown up as a threat to public safety due to its serious structural problems.

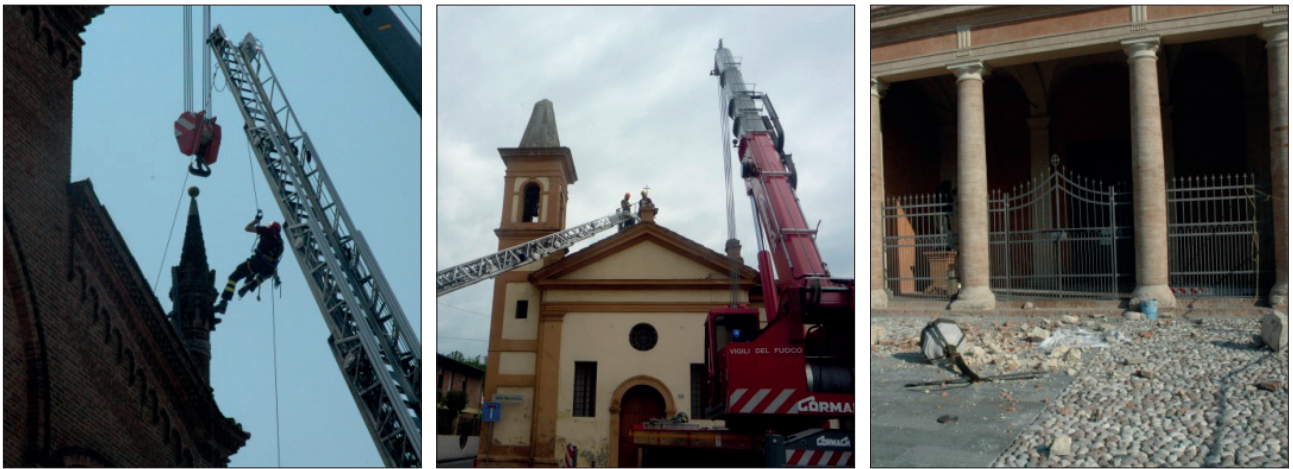
Firefighters intervened many times on the top of the church façades and bell towers to remove slender elements, such as statues and spears, with vulnerability due to their low vertical load and weight, which provides a limited stabilizing effect in regard to the turnover. Spiers, crucifixes, statues that fall from the church roofs, often with metal anchors

**FIGURE 21** Church Matildica and Church of the Sante Grazie in Bondeno; Church of San Bartolomeo, Finale Emilia

weak or too short, represent a danger often underestimated.

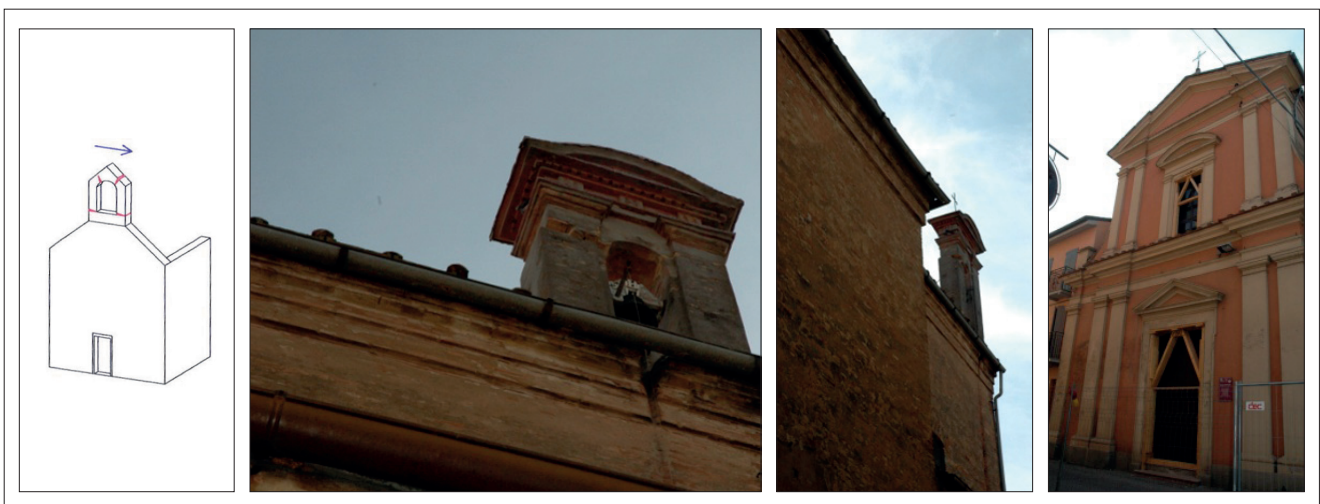
**FIGURE 22** Church of Santa Croce, Crevalcore (BO), (drawing by [2])

Many interventions have been made to put the bell cells in safety and, in some cases, disassemble them. In other cases, overhang host bells have reported shear cracks with displacements due to sliding along the shear cracks, as in the church of Santa Croce in Crevalcore (Fig. 22).

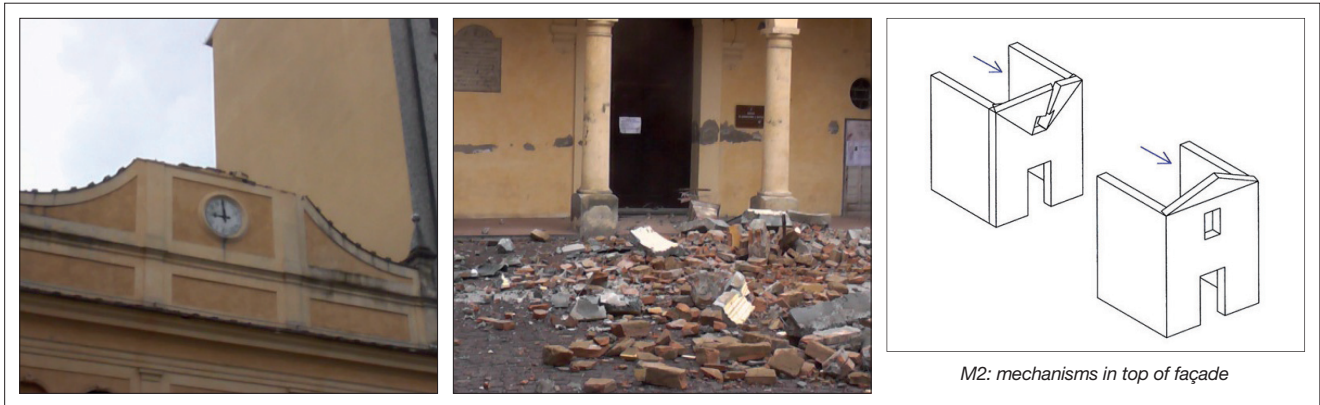
**FIGURE 11** Cento (Ferrara) historic centre: the Church of San Sebastiano and San Rocco (Convent of Friars Capuchins) and main collapse mechanisms

Inside the historic centre of Cento (Ferrara), most of the damage occurred after the shock of May 29<sup>th</sup> (Cento recording station, PGA 0.30g): Church of San Filippo Neri (detachment of the façade, Fig. 10); Church of San Sebastiano and San Rocco (collapse of the tympanum, Fig. 11); Church of San Biagio (instability of the top part of the bell-tower, Fig. 12); Church of San Pietro (detachment of the façade, Fig. 13); Church of the Rosario (vault collapse, Fig. 14).

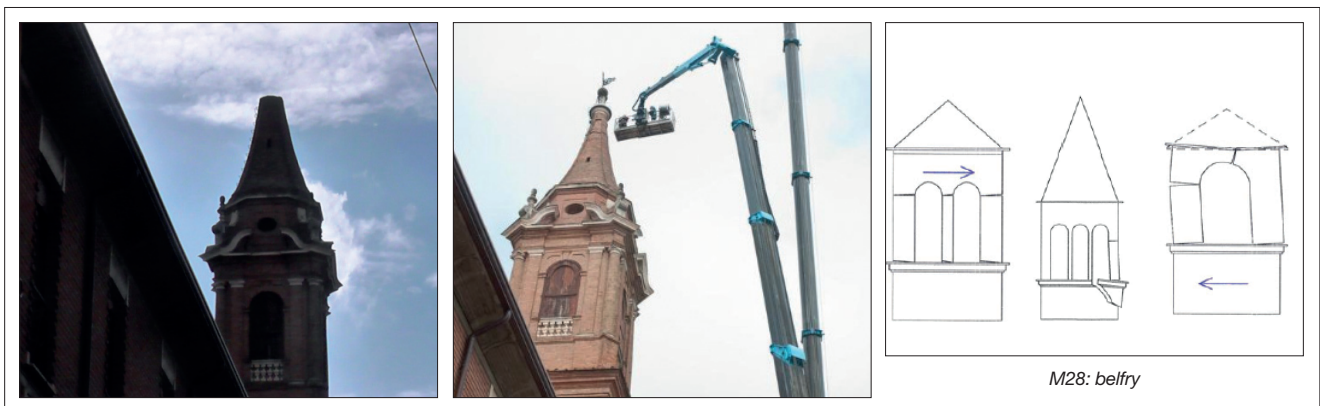
**FIGURE 12** Cento (Ferrara) historic centre: the Church of San Biagio and main collapse mechanisms

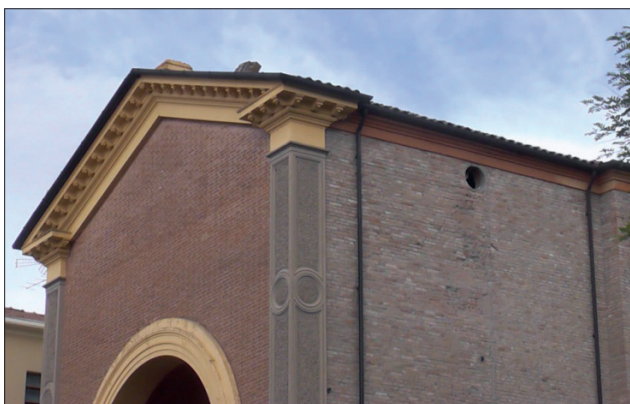
**FIGURE 13** Cento (Ferrara) historic centre: the Church of San Pietro and main collapse mechanisms (middle above)

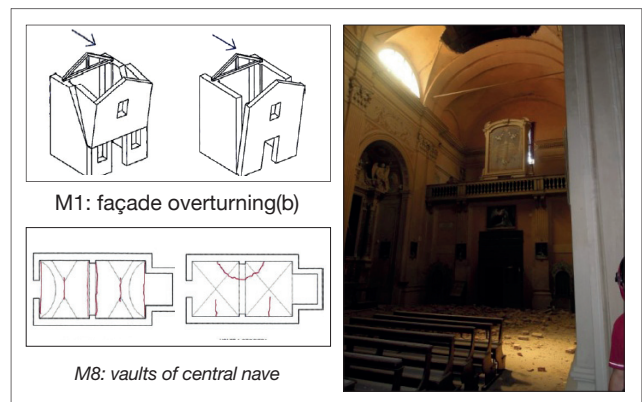
**FIGURE 14** Cento (Ferrara) historic centre: the Church of the Rosario and main collapse mechanisms (middle bottom)

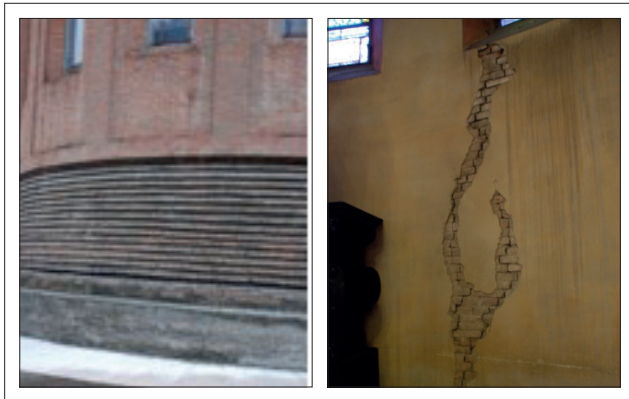
- The survey evidenced damage due to the recent seismic event, but also previous ones. The latter are caused by subsidence, because of different soil mechanical properties.

The old cracks (Fig. 16) increased with the recent earthquake, which originated new local/global damage mechanisms.

**FIGURE 16** Subsidence phenomena: a) external view; b) internal view

Finally, a damage index of about 0.27 has been obtained. Soil geotechnical survey and seismological microzoning is considered mandatory, in order to evaluate how to enhance the foundations.

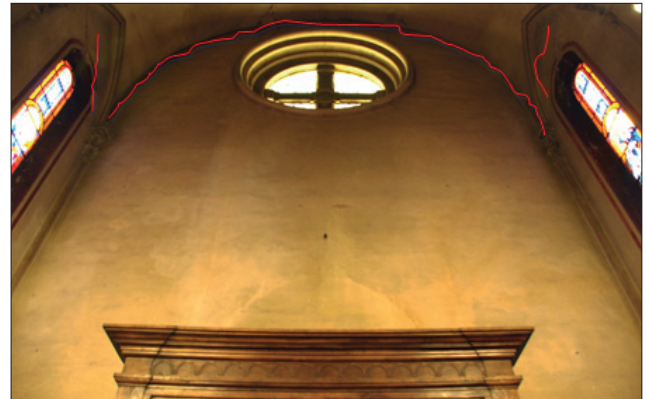
The major cracks of the main façade are highlighted with a red line (Fig. 17), and the mechanisms plotted in Fig. 18. It is worth noticing that the mechanisms related to church lateral apses have been considered as chapel mechanisms (M22 and M23).

**FIGURE 17** Façade overturning mechanism (M1), internal view

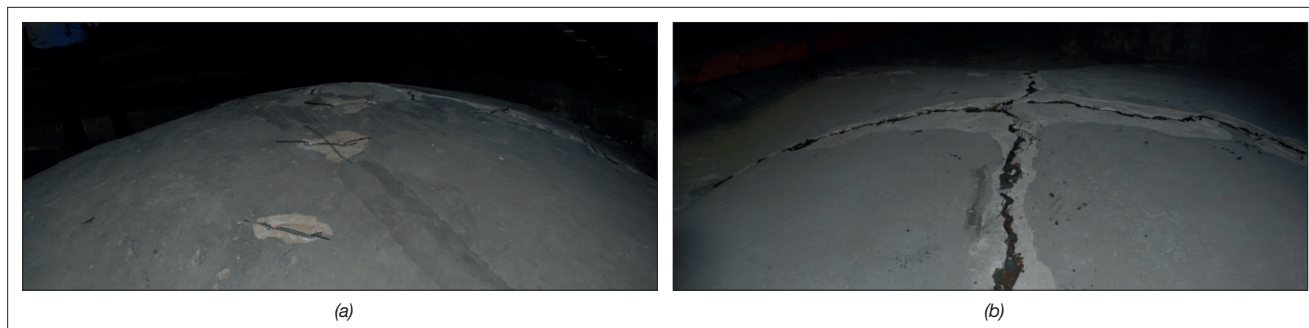
- The cathedral survey permitted to detect some damage, mainly related to the masonry cross-vaults of

the lateral nave. Cracks along the ribs and falling of bricks were found. Such damage has been repaired through prompt interventions (almost completed at the time of our visit), ringing of the ribs with metallic plates fixed to the vaults (Fig. 23a), and filling the cracks with resin (Fig. 23b).

**FIGURE 23** The San Geminiano Cathedral: a) ringing of the vault ribs; b) filling of the cracks

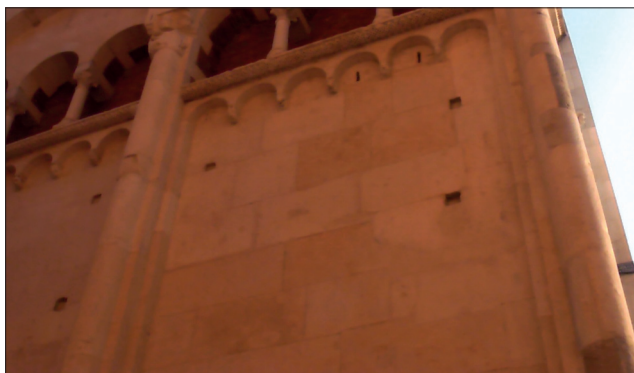
In addition, the main façade showed a potential overturning mechanism, slightly triggered, highlighted with a black line in Fig. 24. Moreover, the opening of the transversal walls (corresponding to the lateral nave) from the longitudinal one has been observed (Fig. 25), due to the variability of the mechanical properties of the soil foundation.

**FIGURE 24** The San Geminiano Cathedral: potential overturning of the façade

The following several interventions were suggested after the investigation: structural re-establishment of damaged vaults, arches, ribs and unconnected wall portions. The implementation of the monitoring system – for a deep and permanent dynamic characterization of the whole complex, evaluating in particular church/tower interactions – is considered necessary and propaedeutic to complete the existing strengthening systems, in both the Cathedral and the Ghirlandina.

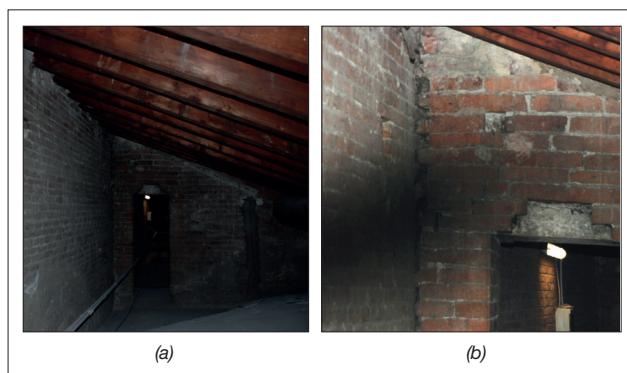
**FIGURE 25** The San Geminiano Cathedral: overturning of the lateral transversal walls

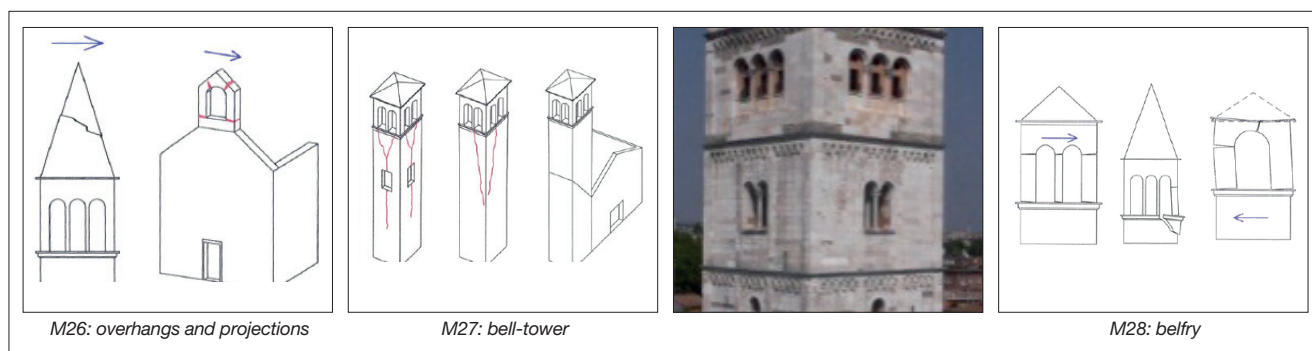
All the detected main mechanisms are summarised in Fig. 26 (Cathedral, global damage index equal to 0.16) and Fig. 27 (Ghirlandina, global damage index equal to 0.27), respectively.

**FIGURE 27** Damage mechanisms in the Ghirlandina Tower (Modena)

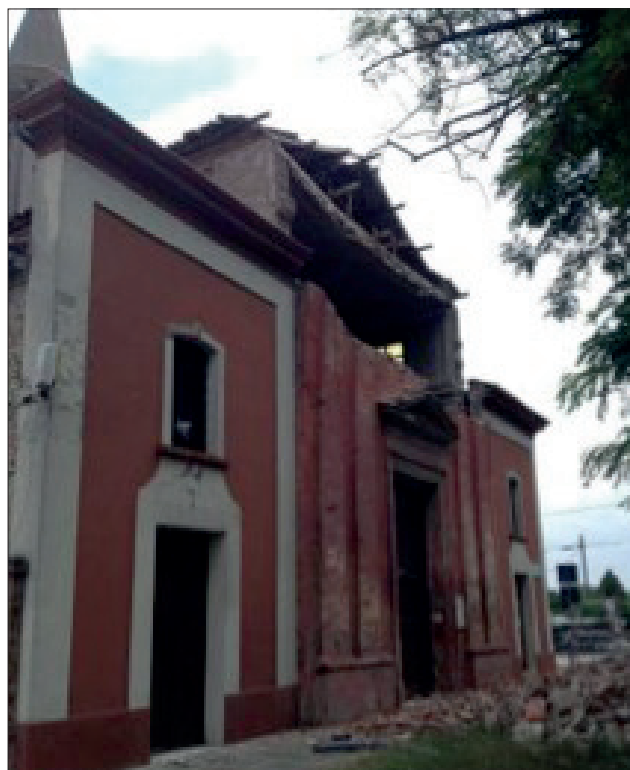
The most evident effect of the seismic action is the collapse of the upper portion of the main façade of the church, due to the lack of connection with the transversal walls. The occurred mechanism is the vertical overturning of the Façade and the collapse of the top one. The non-collapsed part of the façade is separated from the transversal walls and greatly inclined towards the churchyard. The two façades of the lateral naves are connected to the transversal walls and are lower than the main one, therefore they are less damaged (Figs. 2-3).

**FIGURE 2** The main façade

- 1) Safety of the overturning mechanism of the façade;
- 2) Ringing of the perimeter walls;
- 3) Removal of the cover;
- 4) Ringing of the original bell-tower;
- 5) Ringing and insertion of vertical ties on the more recent bell-tower.

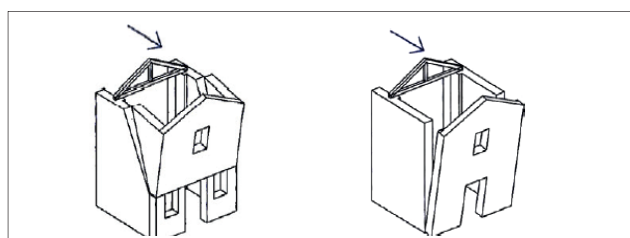
**FIGURE 3** Overturning of the façade

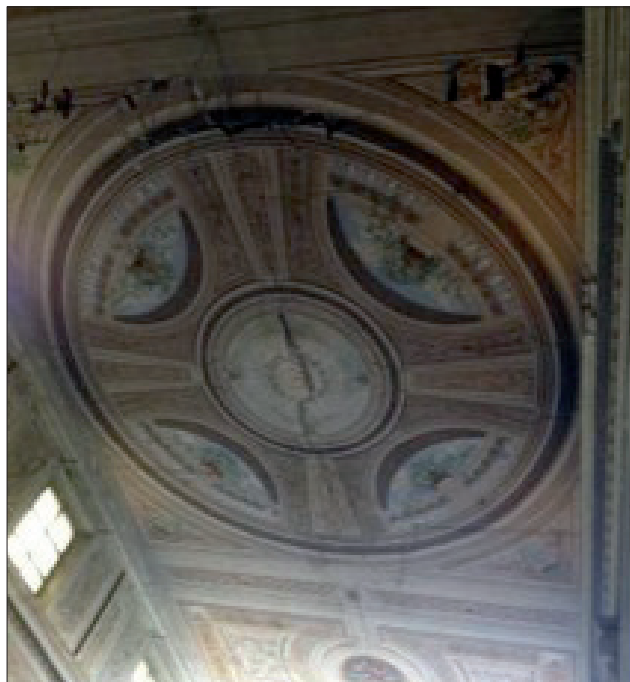
timber trusses and is severely damaged (Fig. 4). On the contrary, the frescoed ceiling of the lateral naves, which are made of “*in sheet*” arranged bricks, have collapsed in many parts, especially in the left nave (Fig. 5). In addition, the cracks’ distribution and their depth outline a dangerous condition for the entrance.

FIGURE 4 The false ceiling of the central nave

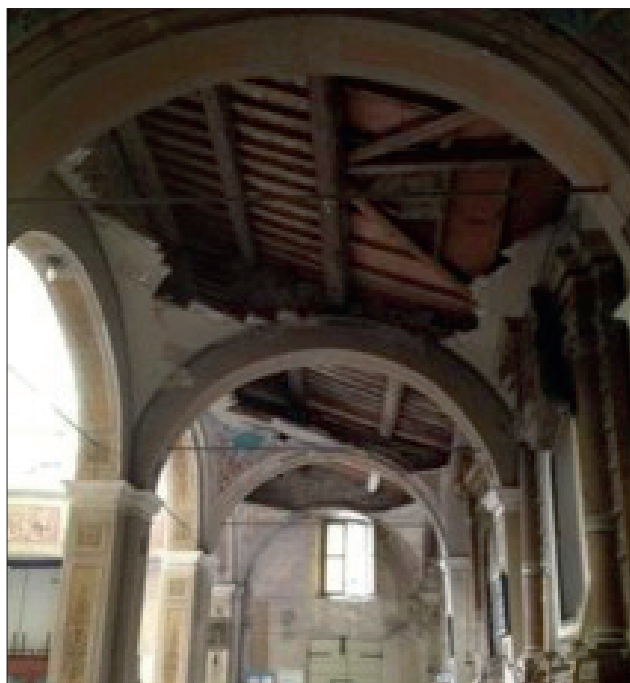
FIGURE 5 The collapsed vaults of the left nave

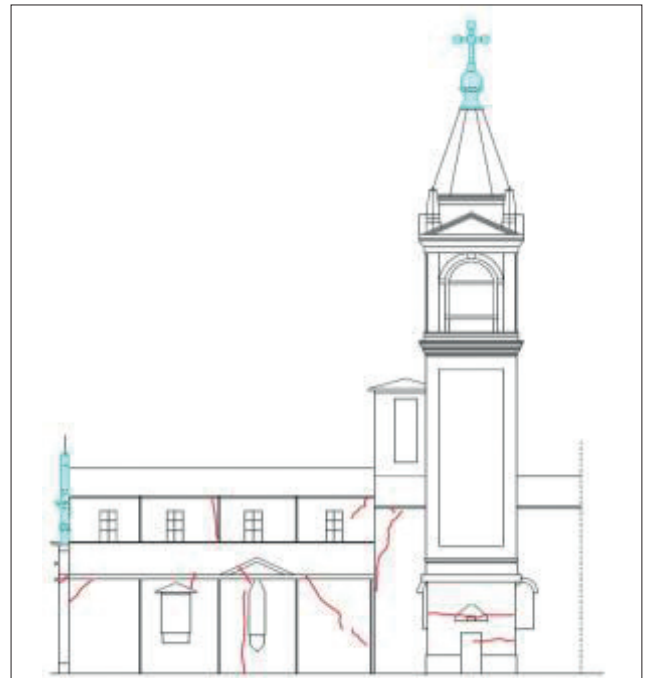
The cracks’ pattern (Figs. 6-8) related to the façades shows a rather critical situation: in addition to the overturning mechanism, many other deep cracks are visible, which are particularly severe. Moreover, a passing through vertical crack located between the second and third arch has been surveyed, also by using a thermal imaging camera (Figs. 9-10).

**FIGURE 7** Cracks on the east side

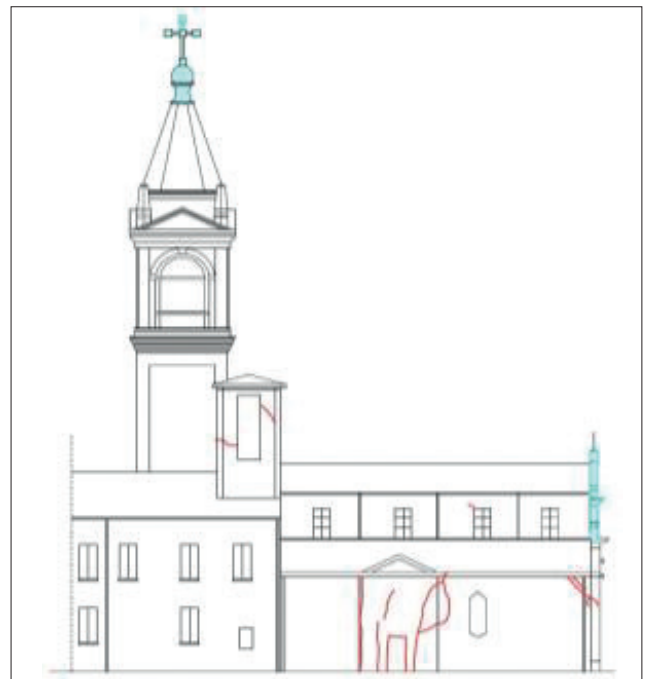
**FIGURE 8** Cracks on the west side

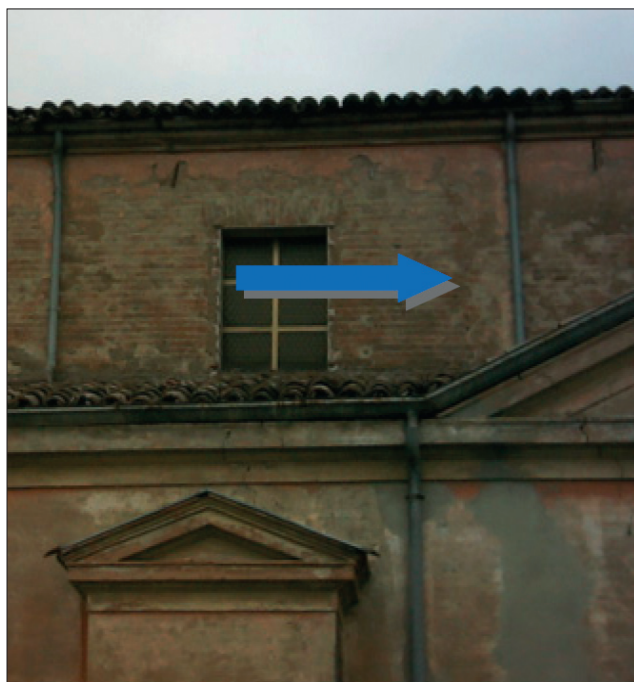
**FIGURE 9** Passing through vertical crack

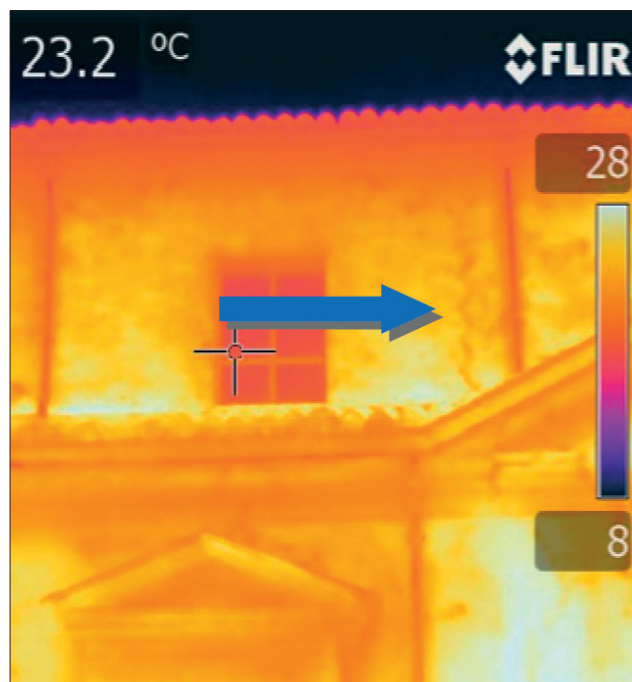
**FIGURE 10** Passing through vertical crack (thermal imaging camera)

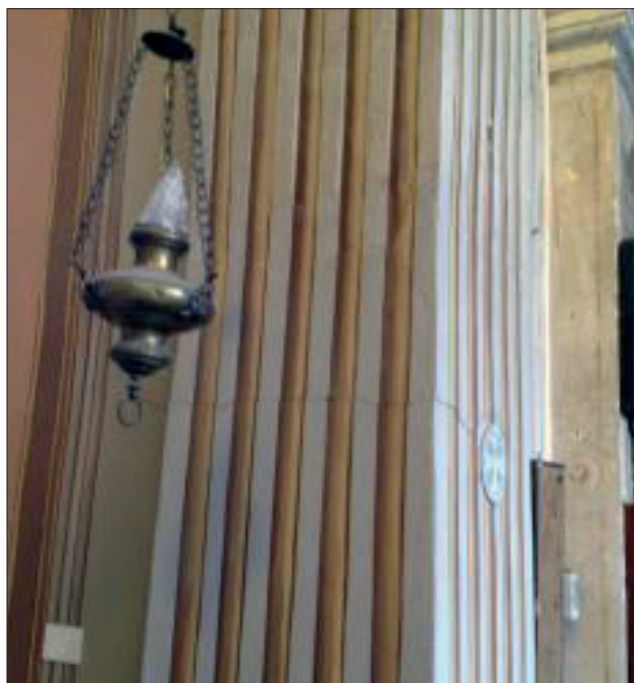
Other evident cracks are located between the central nave and the apse, where the walls seem unconnected to each other. A horizontal crack at about 2 meters from the ground level is surveyed on the pilaster on the right of the apse, in addition to a slight rotation. Moreover, diagonal cracks on the doors and separation of the corner have been evidenced on the wall located on the right of the apse (Fig. 11). On the contrary, on the left side of the apse, the presence of the oldest tower has provided a connection function between the two walls. In any case, the sacristy wall has been damaged because of the hammering action of the more rigid structure of the oldest tower on it (Fig. 12). Cracks are also present at the bottom wall of the apse.

**FIGURE 11** Horizontal crack on the pilaster

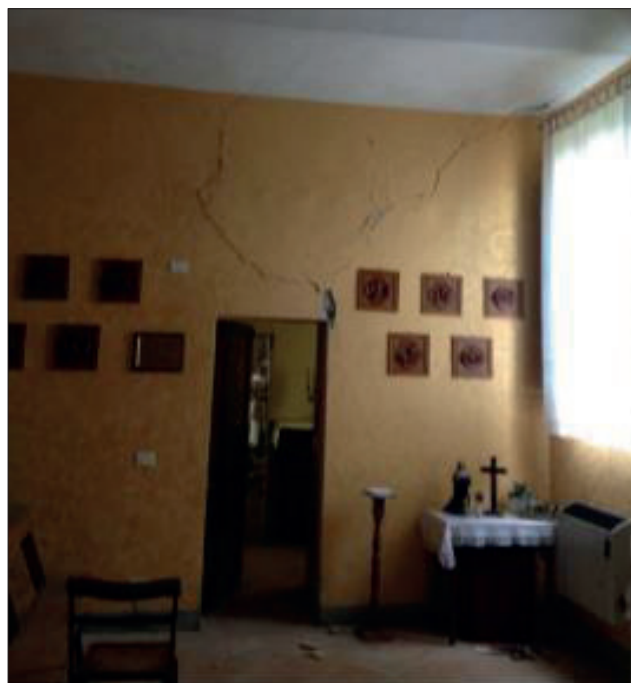
**FIGURE 12** Diagonal crack on the sacristy wall

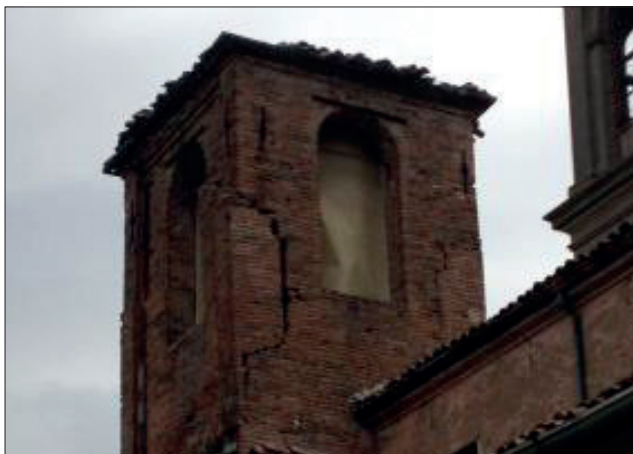
Very serious damage have been surveyed on the two towers of the church. The oldest tower – which is the original bell tower nowadays substituted from the more recent one – is about 16 meters high. With masonry structure and equipped with metallic ties in both directions, it shows a very critical situation. The separation and expulsion of the corners (cantonal) occurred, which predicts a potential global collapse of the tower and the subsequent increasing in the damage of the structures below it (Figs. 15-16).

**FIGURE 15** Separation and expulsion of the corner

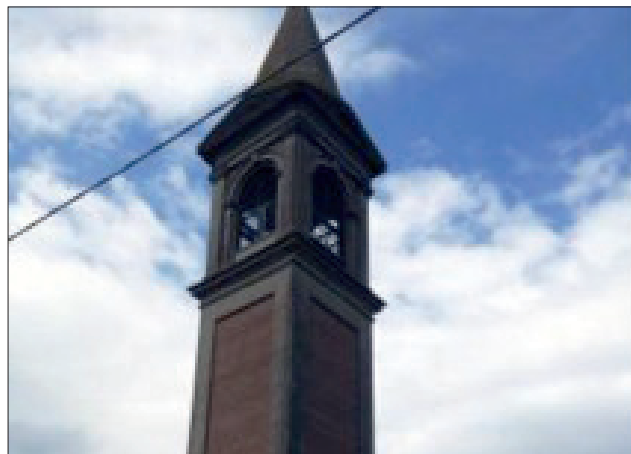
The more recent tower, being made of solid bricks, is more than 38 meters high and was built adjacent to the right side of the church using bricks and concrete. The earthquake caused the twisting of the whole structure, cutting it at about 2 meters from the ground, in correspondence of a discontinuity in the material of the basement. In addition, a minor rotation occurred (Figs. 17-18).

**FIGURE 17** The more recent bell tower

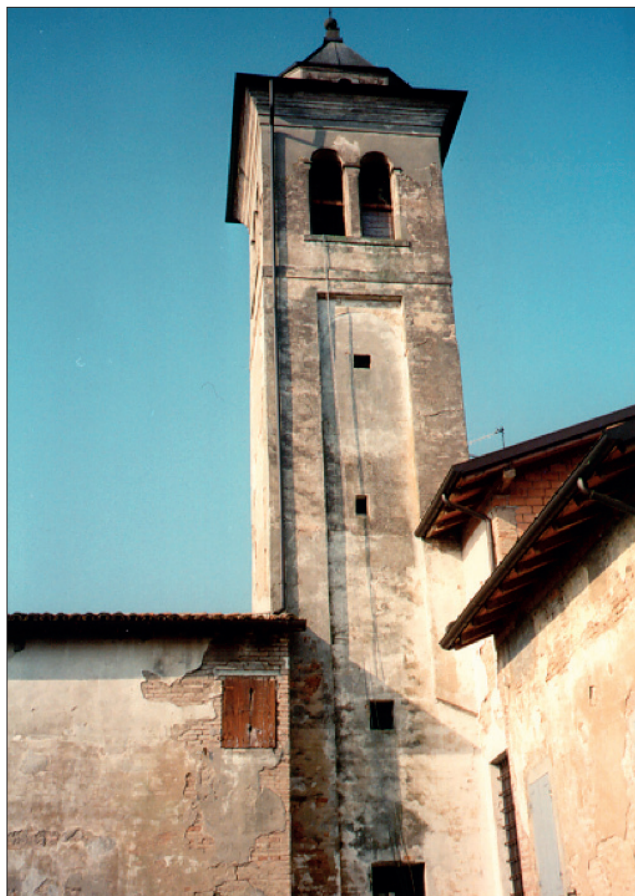
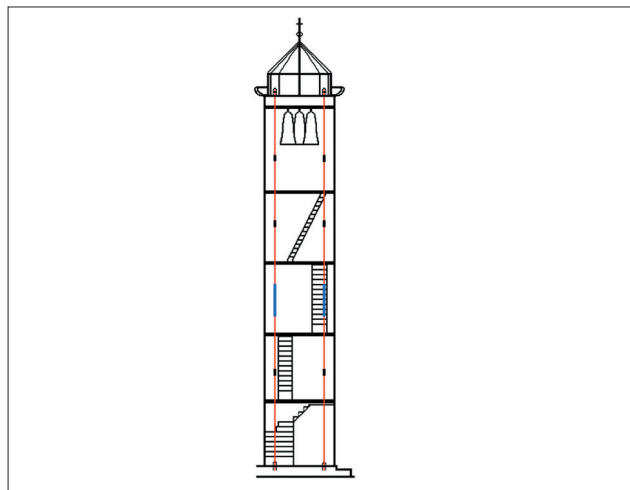
**FIGURE 24** The San Giorgio in Trignano bell-tower: consolidation system

formed under the scientific supervision of ENEA [1]. The innovative intervention – chosen as the subject of the pilot application of seismic Innovative Techniques (TIA) within the EU project ISTeCH (Development of innovative techniques for the improvement of stability of cultural heritage) – consisted in inserting four post-tensioned metal ties formed by six modular units at the inner corners of the tower, in order to increase the structure's resistance to bending without perforating the masonry (Figs. 23-24).

In series with the ties, four shape memory devices (SMAD, Shape Memory Alloy Devices) have been incorporated, tested to ensure the constancy of compression on the masonry, by maintaining the applied force at a set value. Each SMAD is composed

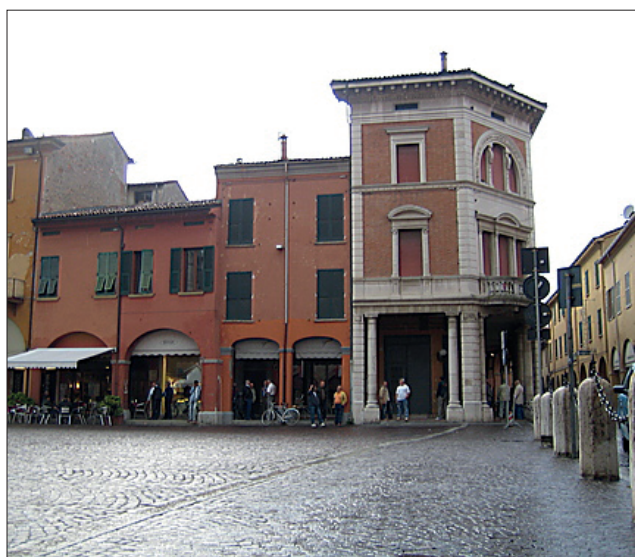
**FIGURE 1** Traditional buildings in the town of Cento

The seismic behaviour of such structures was generally good when compared to the recorded ground acceleration values: the great part of the traditional buildings showed only slight damage, particularly to chimneys, plasters or non-structural elements already

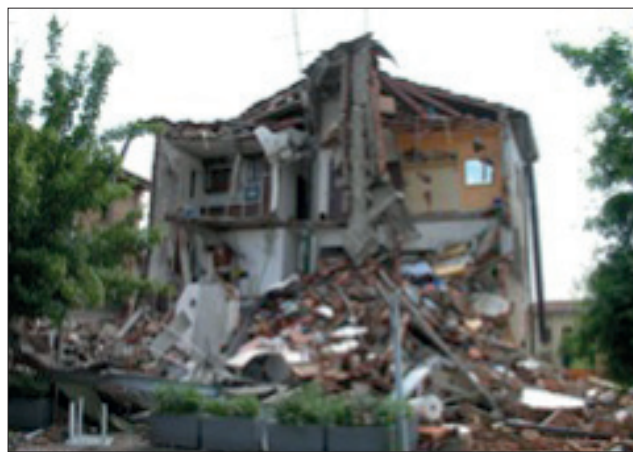
**FIGURE 4** The front part of the building has completely collapsed; the damage grade is 5

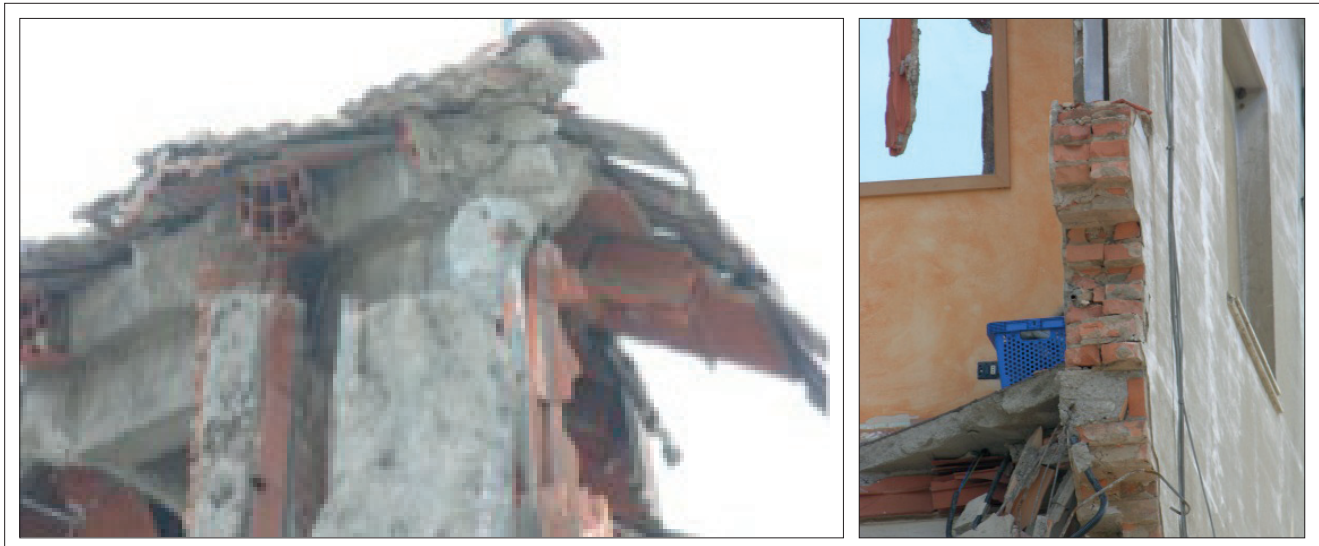
**FIGURES 5-6** Details of RC elements

ity and well preserved conditions. On the other hand, where heavy structural alterations were introduced (for example the insertion of RC floors not properly connected to the walls or the replacement of light wooden roofs with heavy RC ones), the vulnerability increased dramatically. Fig. 4 shows a case of near to total collapse (damage of grade 5 EMS98). Note the heavy roof structure bearing on slender walls, the poorly reinforced beams (Fig. 5) and ring course concrete, as well as the absence of steel reinforcement in the floor slabs (Fig. 6).

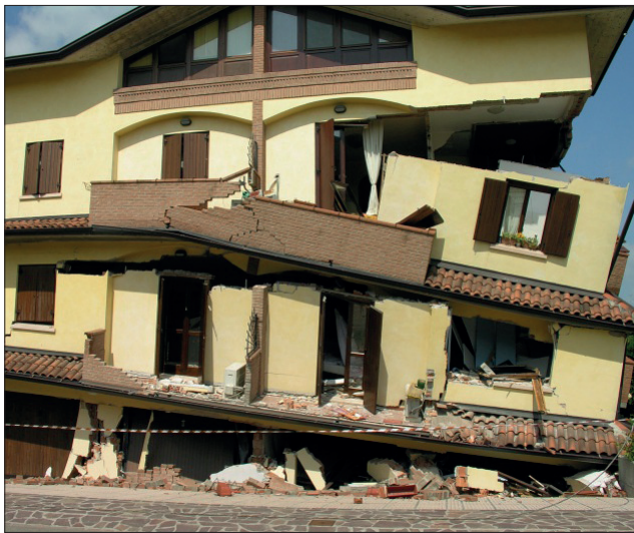
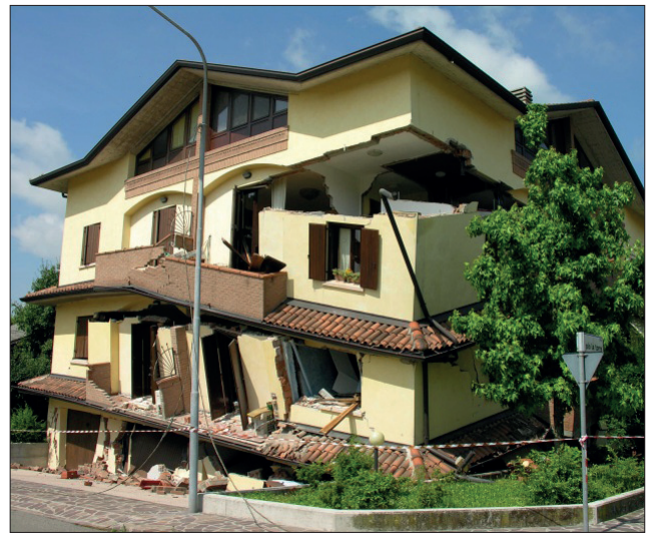
The collapse was caused by the presence of a soft storey in which there were large openings and small piers between openings and corners. Due to the absence of any reinforcements, the masonry corner pier on the right (Fig. 11) completely crushed, with the consequent opening up of the structure up to the top (Fig. 12). Even though the change in stiffness between the rigid upper floors and the ground soft storey has further aggravated the response of the building under the seismic stress, undoubtedly the main cause of the collapse depends on the type of masonry used (hollow bricks) and its inadequate dimensioning.

**FIGURES 11-12** The soft storey has collapsed, the damage grade is 5

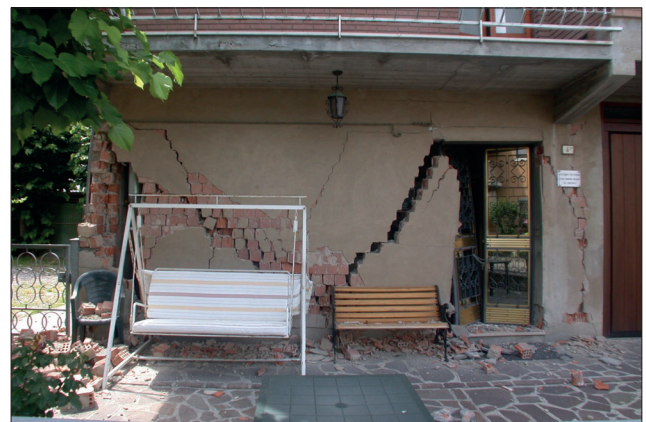
The weakness of ground floors walls built in perforated bricks is again dramatically shown in Fig. 13, where the failure reached almost the collapse. Making of niches in load-bearing walls, containing pipelines and boiler (Fig. 13, on the left), contributes considerably to increase the seismic vulnerability of masonry buildings.

**FIGURE 13** Serious failure of the walls, the damage is grade 4

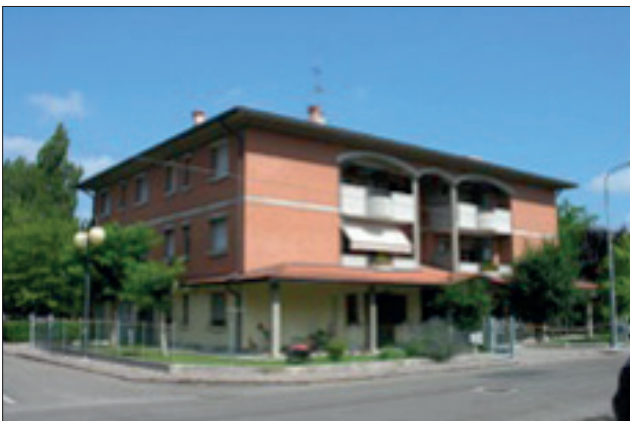
**FIGURE 16** Example of mixed structure

In recently erected buildings, the structure is often provided with RC columns and beams, but they are never placed in all the four sides of the building, in order to perform as a moment resistant frame. In other cases (Fig. 16), when a sort of RC frame is present, the beams run in the thickness of the floor slab (“thickness beam” is the equivalent Italian technical term), making the beam-column joints very vulnerable to lateral loads. This type of structure performed badly and suffered heavy damage (Fig. 17).

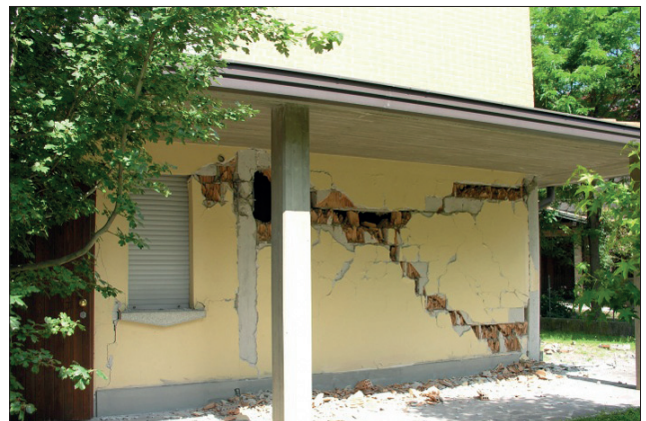
**FIGURE 17** Damage to ground floor wall

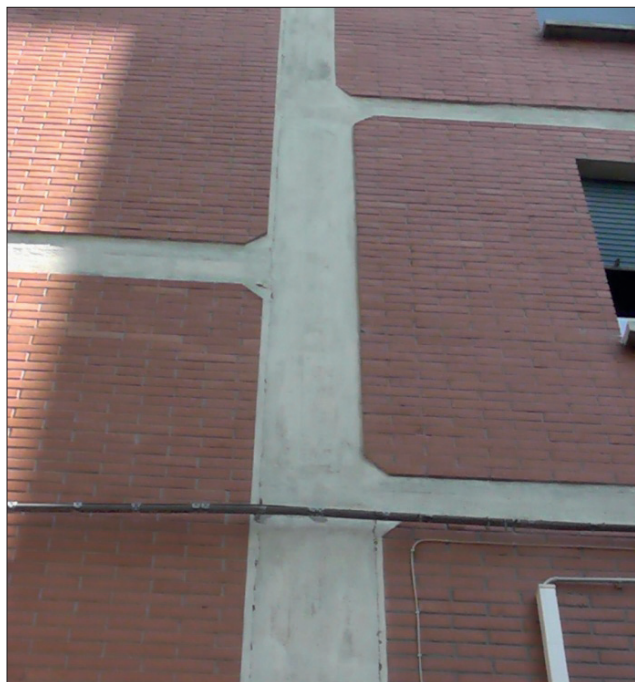
**FIGURE 26** Separation between adjacent buildings

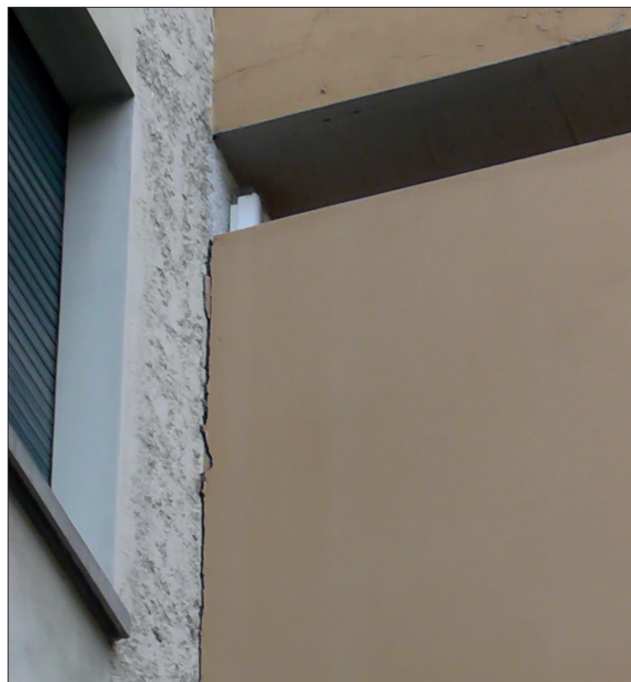
In particular, in the apartments on the first floor of the buildings located at the two ends of the aggregate, the damage to cladding was stronger, making the overturning of the cladding itself possible in case of aftershocks, with consequent danger to the occupants. Some apartments (civic numbers 5, 7 and 17) have also been declared usable after prompt interventions thanks to the separation of the parapet of the balcony.

**FIGURE 27** Detachment of the parapet of some balconies

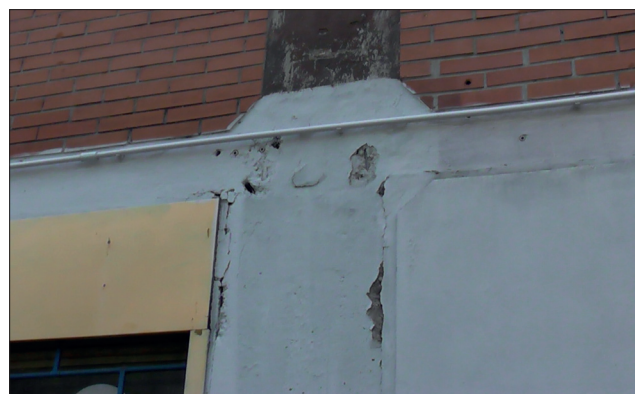
**FIGURE 28** Separation between cladding and structure elements

With regard to the detachment of plaster, observed in some parts of the façades, and the damage to covering structures and chimneys, the urgent removal of loose or damaged parts was requested to the Fire Department, in order to ensure the safety of passers-by. As a result of these actions, the occupants of all the usable units were

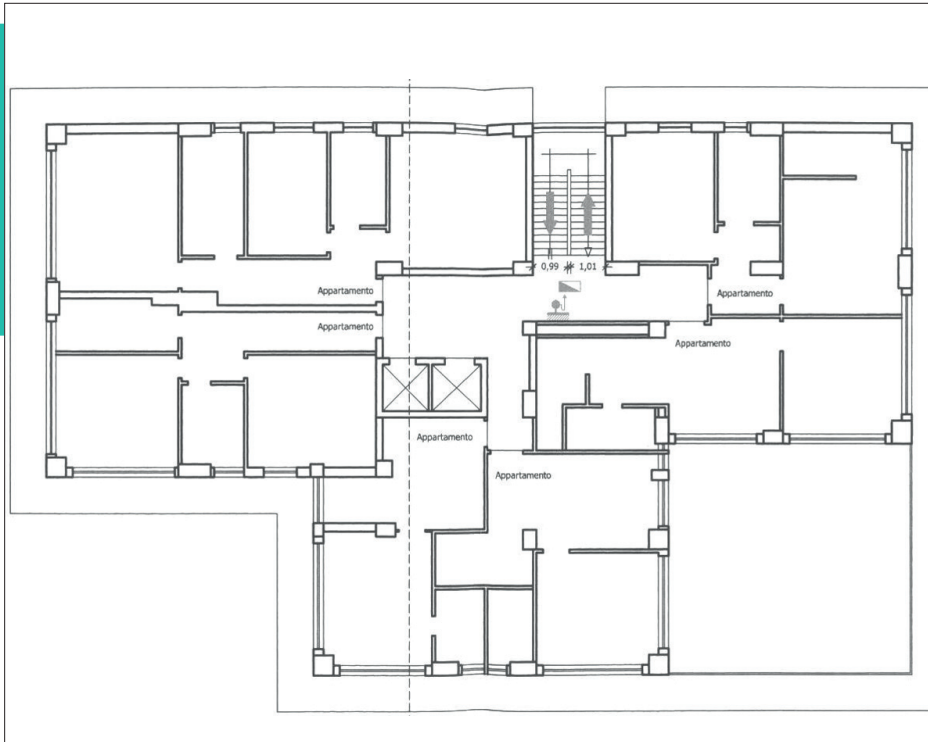
**FIGURE 31**  
In plan distribution: first floor

about 150 people (Fig. 29). The area in plan is about 500 m<sup>2</sup>. A television aerial, about 9 m high, is placed at the roof level (Fig. 29a). Both separation walls and cladding are made of hollow bricks. The façades are covered by mosaic and plaster layers in vertical and horizontal direction, respectively (see Fig. 29b). The survey, which has been carried out at all the levels of the building, evidenced some structural lacks against the seismic actions, being the building realised before the application of the anti-seismic code. In fact, there are not closed frames in the two main directions; moreover, in several cases the existing frames are not complete, or intersect transversal beams far from the pillar (Fig. 30). In addition, the building shows an irregular distribution of the resistant elements, which induces an irregularity in plan, again affecting the seismic behaviour of the structure (Fig. 31).
